# SAMPLE REPORT

## EXTERIOR WALL CONDITION ASSESSMENT REPORT

May 12, 2024

**Regarding:** Exterior Wall Condition Assessment

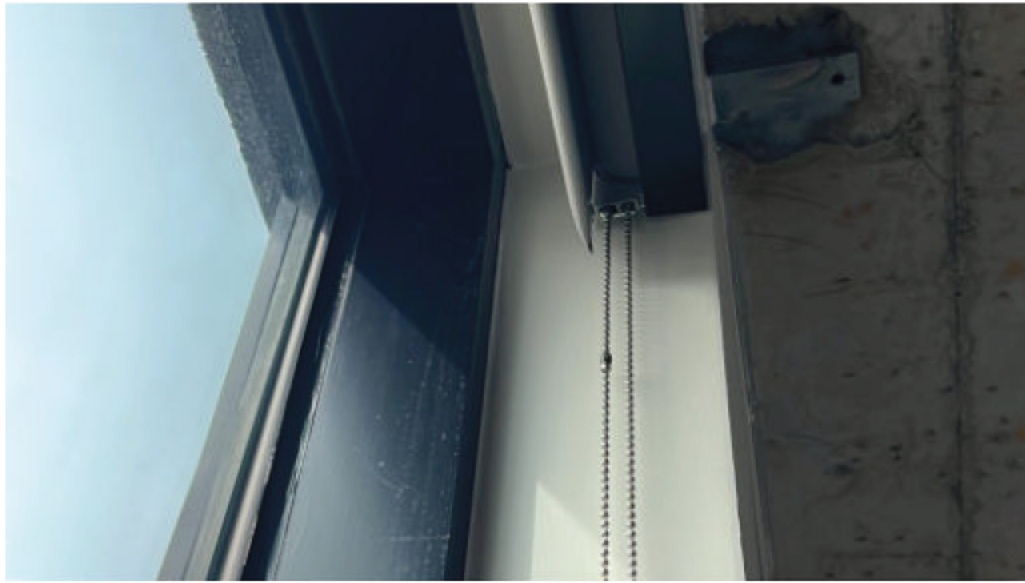
Picture 21: Common area, by air hockey table. Evidence of water intrusion

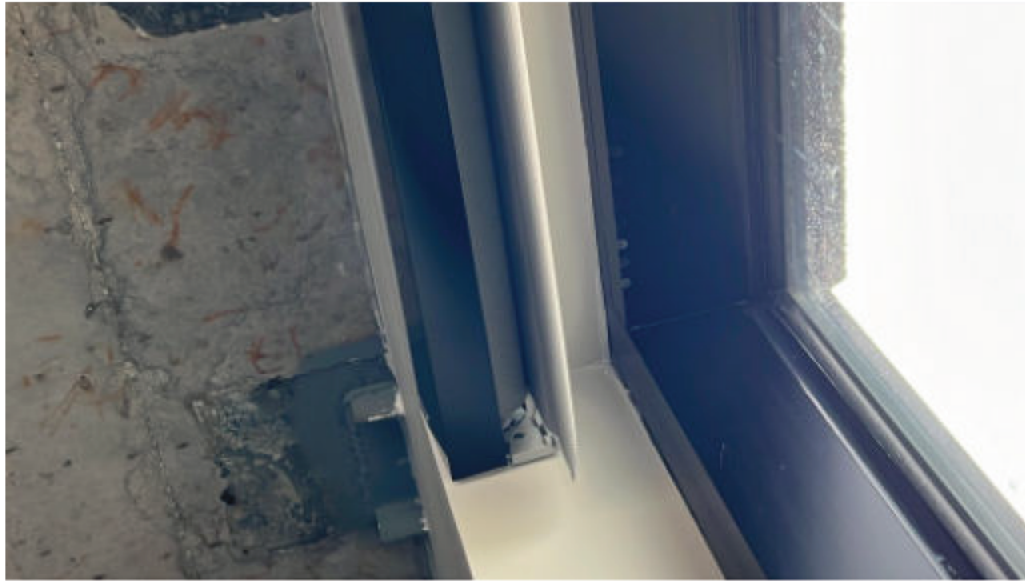
Picture 22: Common area, by air hockey table. Evidence of water intrusion

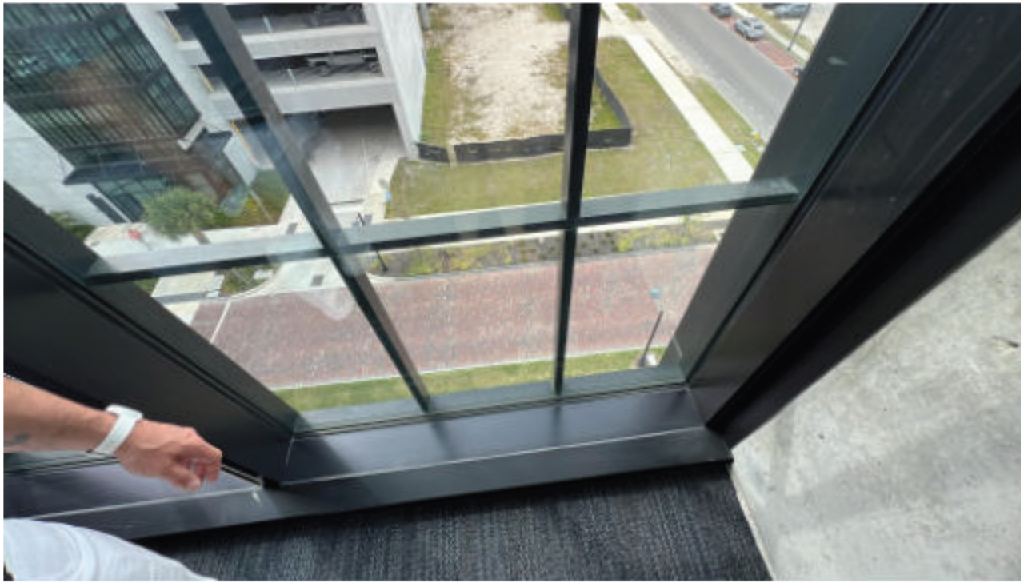
Picture 23: Common area, south elevation. Evidence of water intrusion

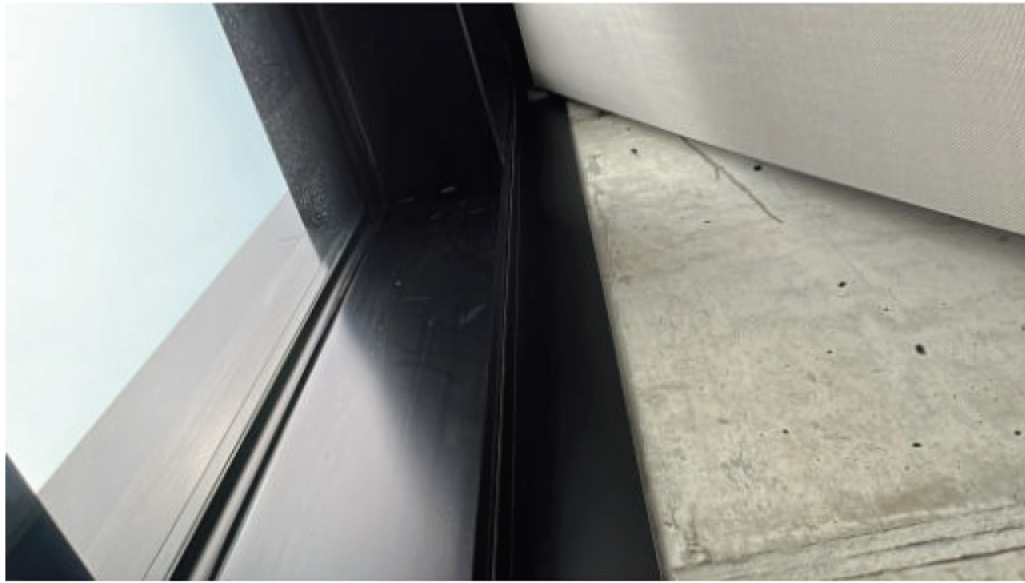
Picture 25: Common area, south elevation. Evidence of water intrusion

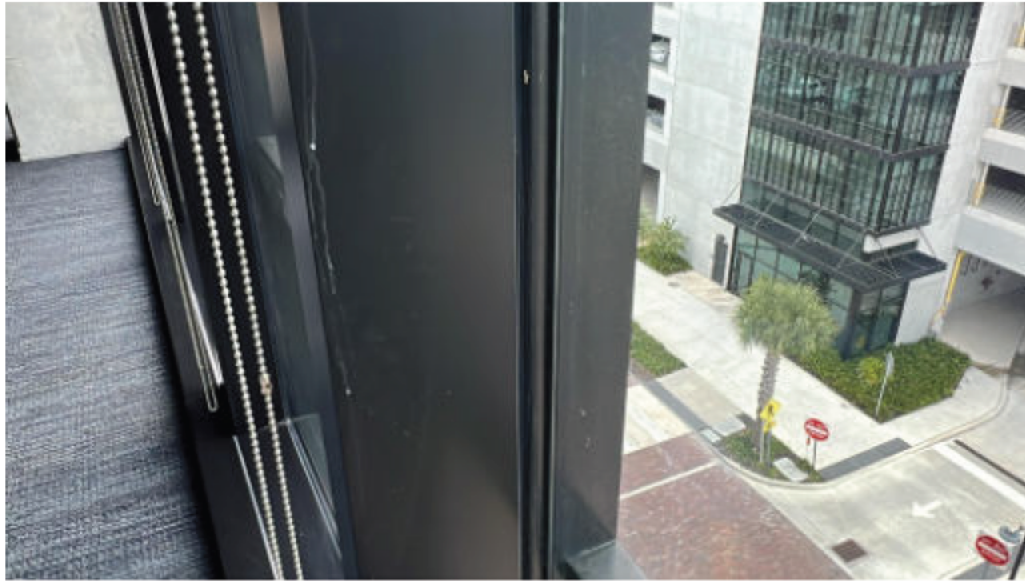
Picture 26: Common area, south elevation. Evidence of water intrusion

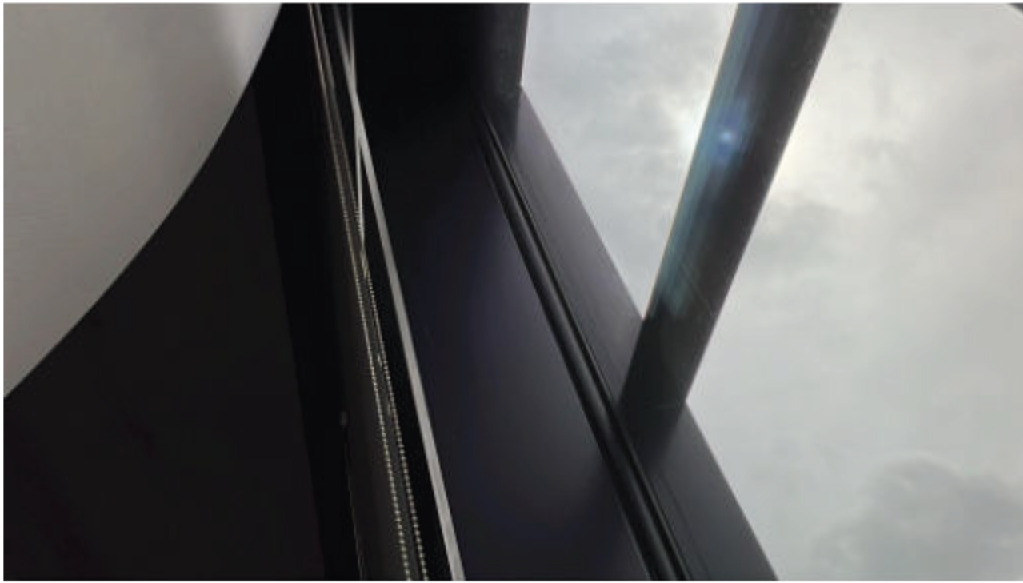
Picture 27: Common area, south elevation. Evidence of water intrusion

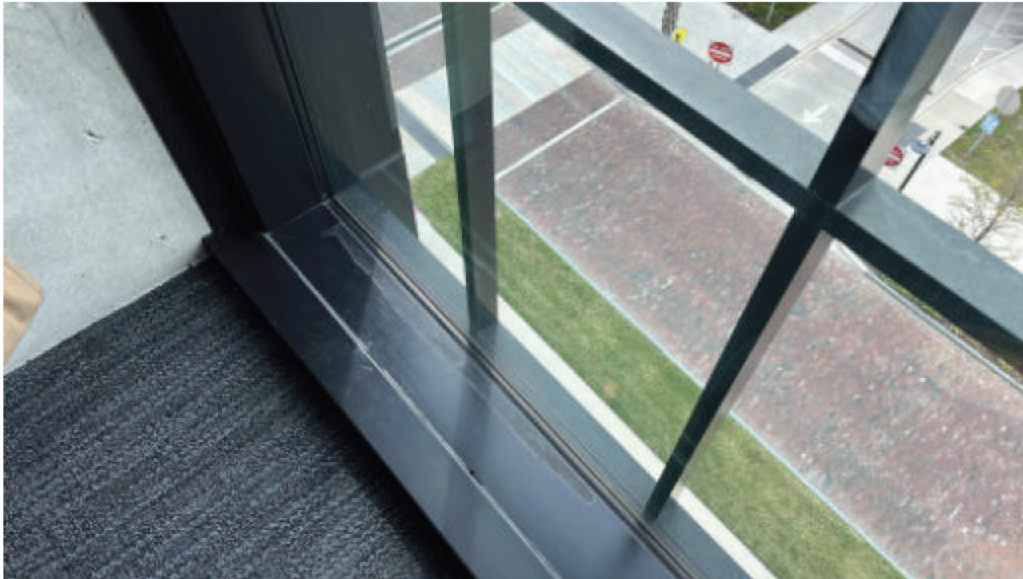
Picture 28: Common area, south elevation. Evidence of water intrusion

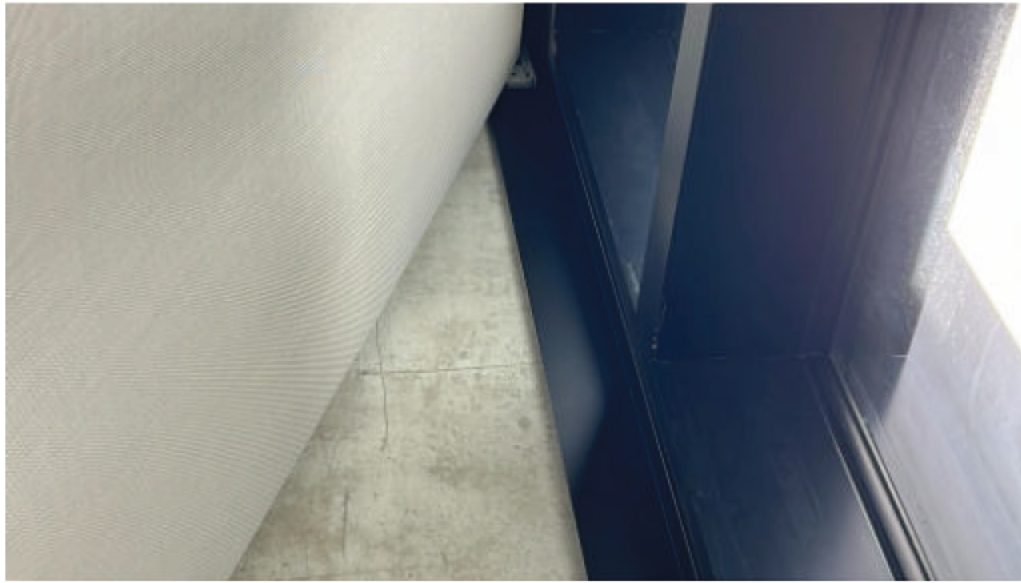
Picture 29: Common area, south elevation. Evidence of water intrusion

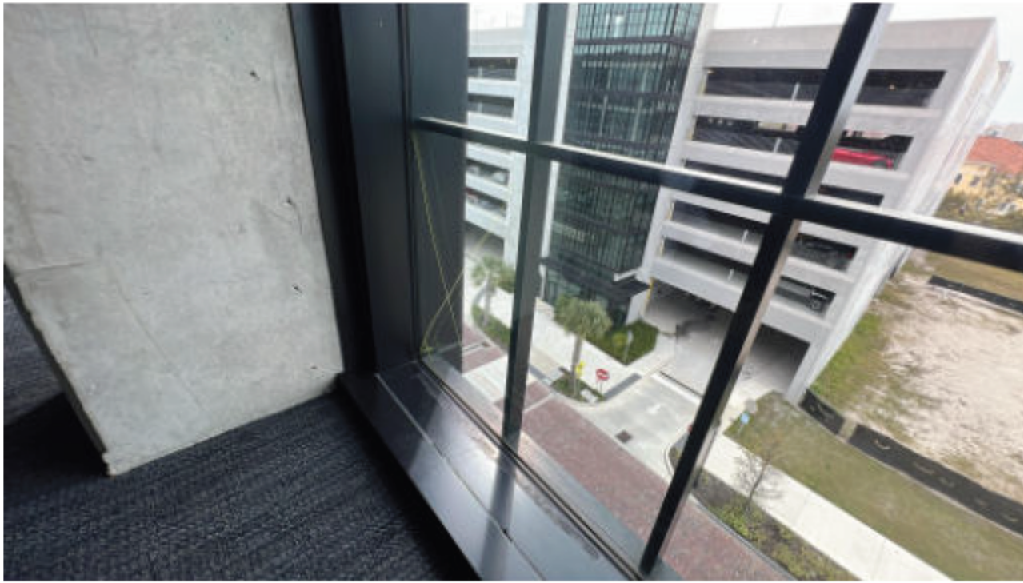
Picture 31: Common area, south elevation. Evidence of water intrusion

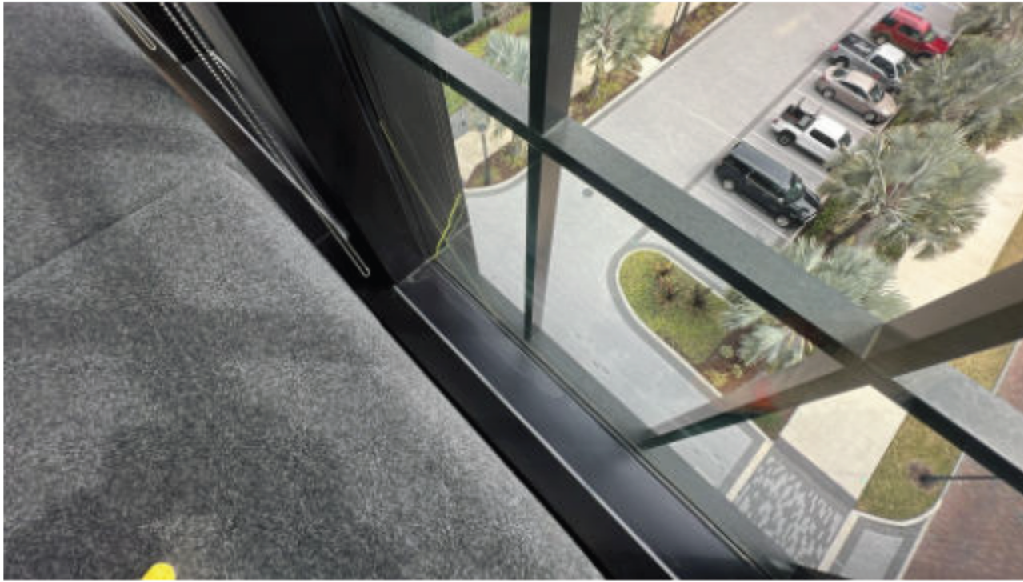
Picture 32: Common area, east elevation. Evidence of water intrusion

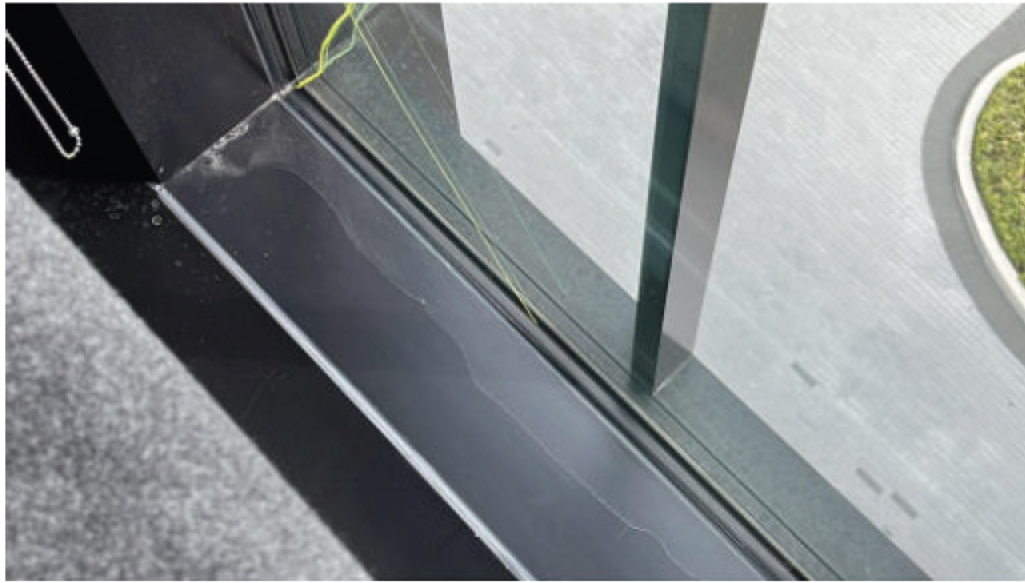
Picture 33: Common area, east elevation. Evidence of water intrusion

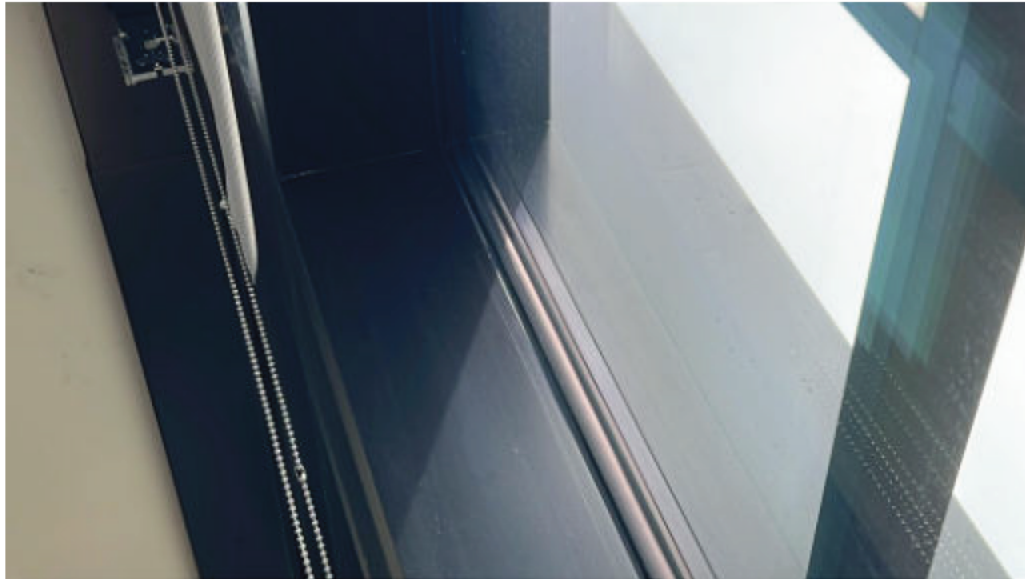
Picture 34: Common area, east elevation. Evidence of water intrusion

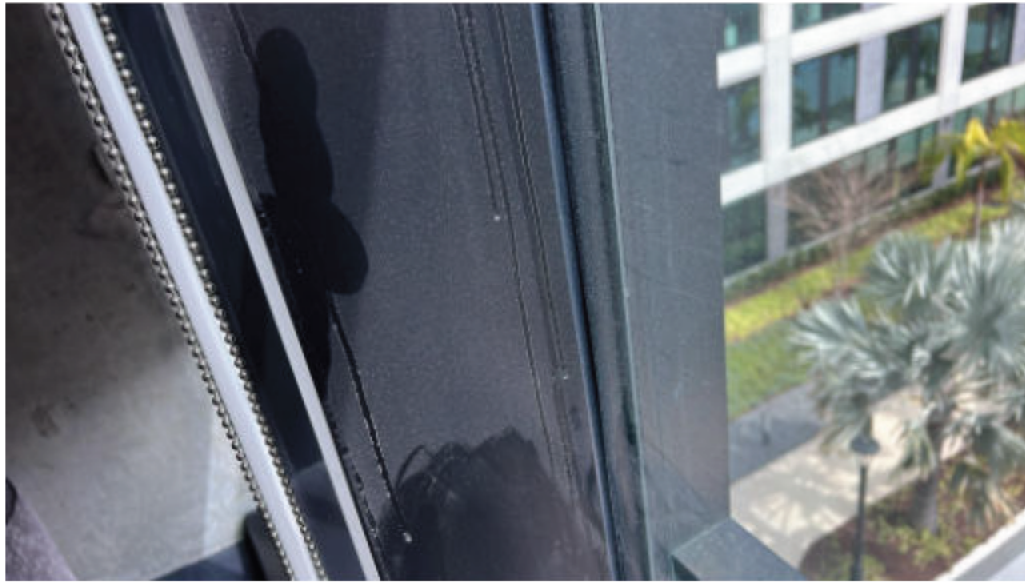
Picture 73: East elevation.  
Evidence of water intrusion

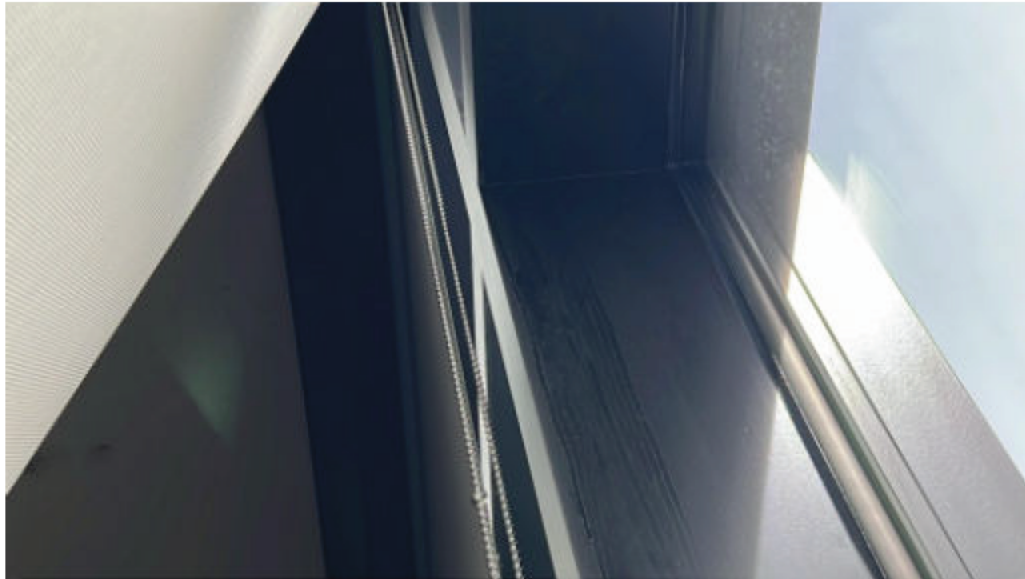
Picture 74: East elevation.  
Evidence of water intrusion

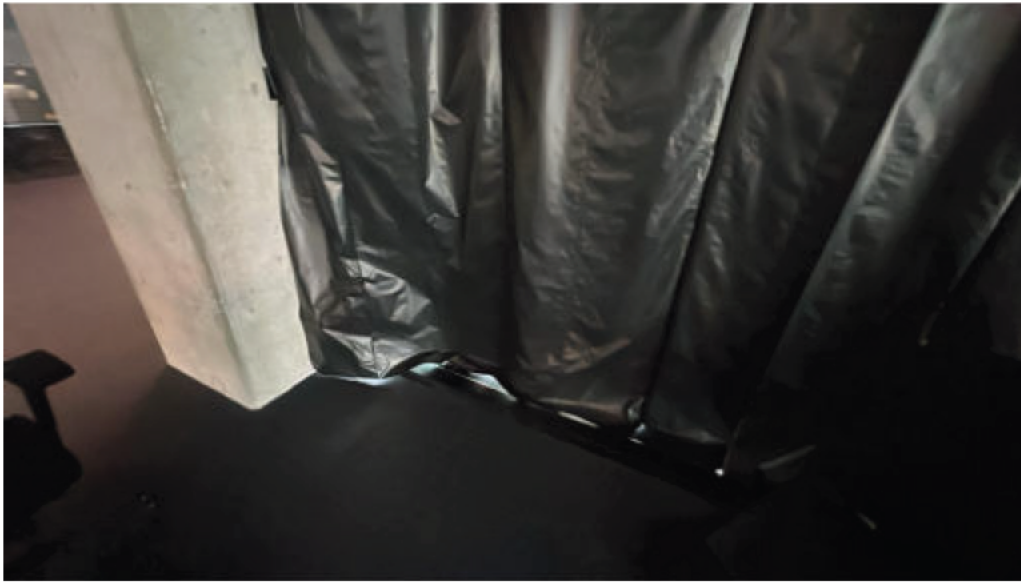
Picture 75: North Elevation.  
Evidence of water intrusion

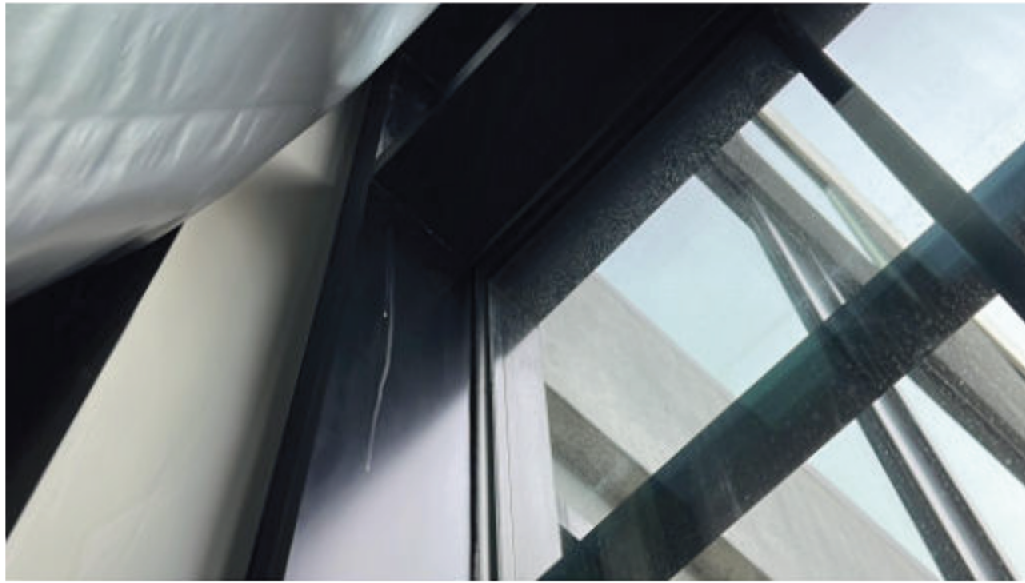
Picture 77: North Elevation.Evidence of water intrusion

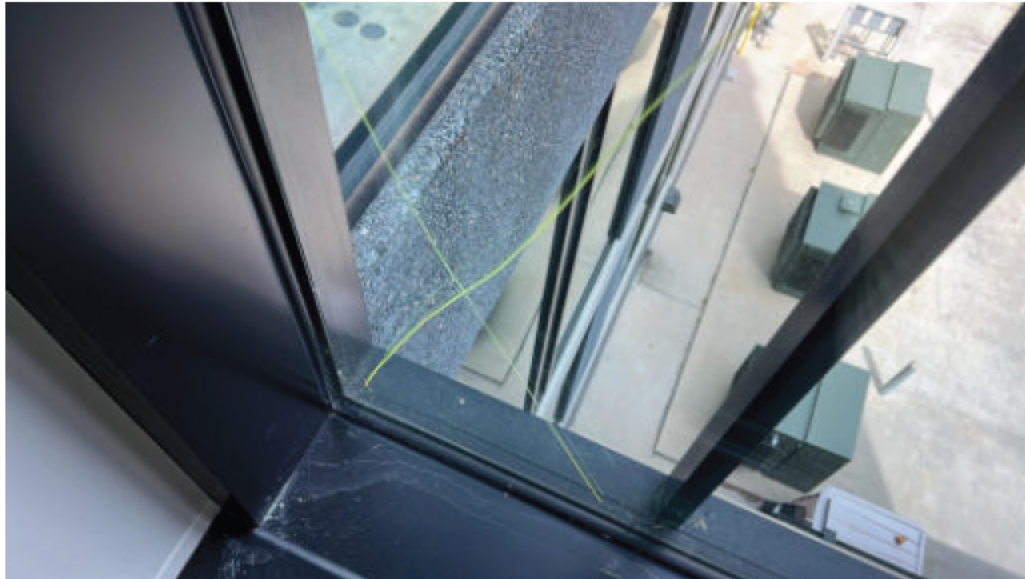
Picture 78: North Elevation. Evidence of water intrusion

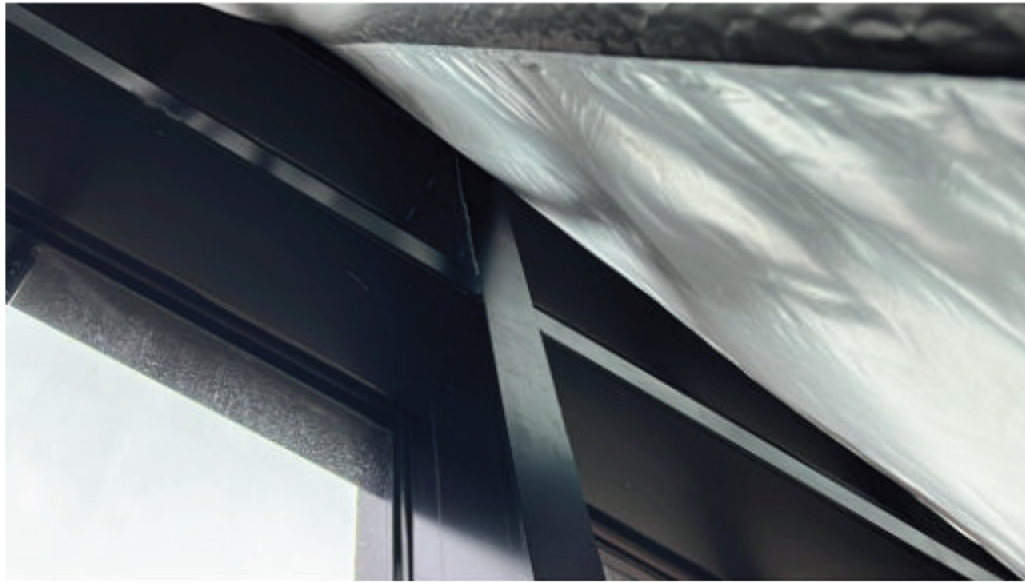
Picture 79: North Elevation.  
Evidence of water intrusion

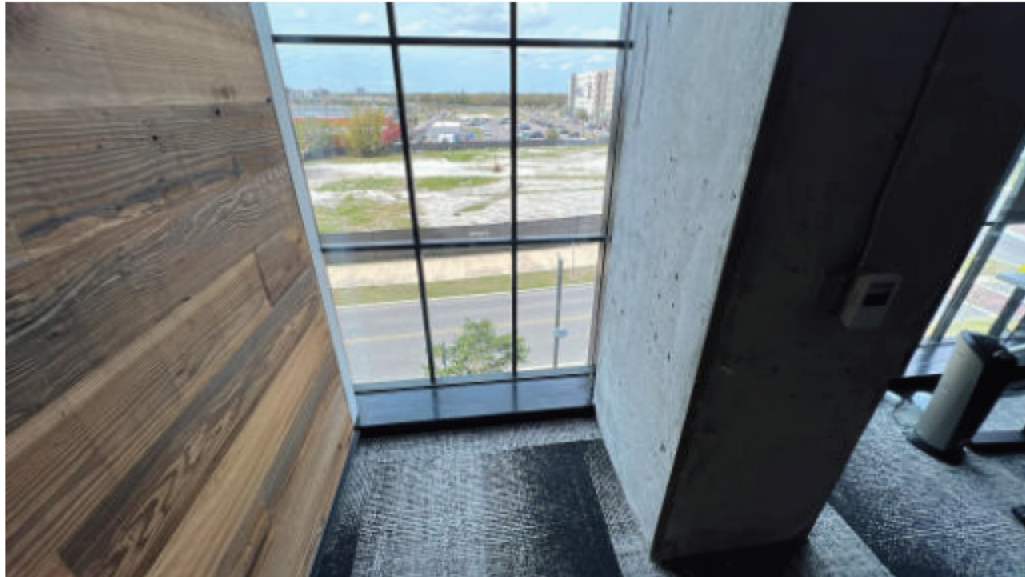
Picture 80: South elevation.  
Evidence of water intrusion

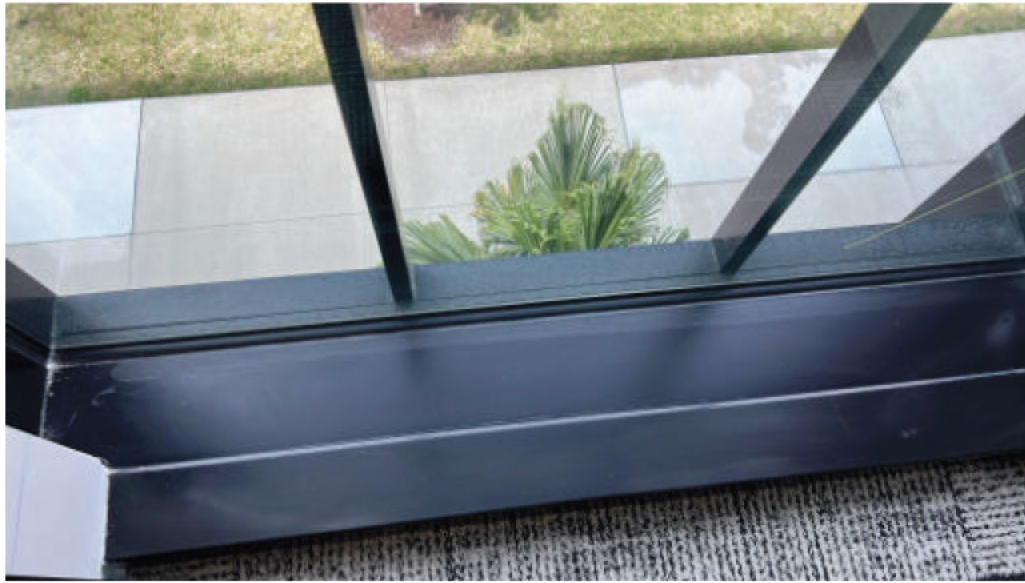
Picture 81: South elevation.  
Evidence of water intrusion

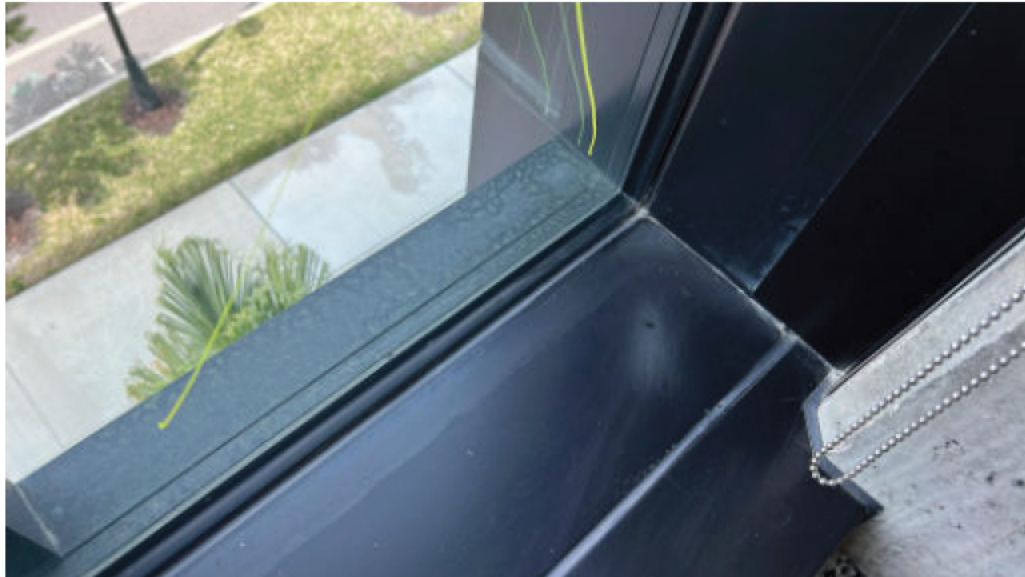
Picture 82: South elevation.  
Evidence of water intrusion

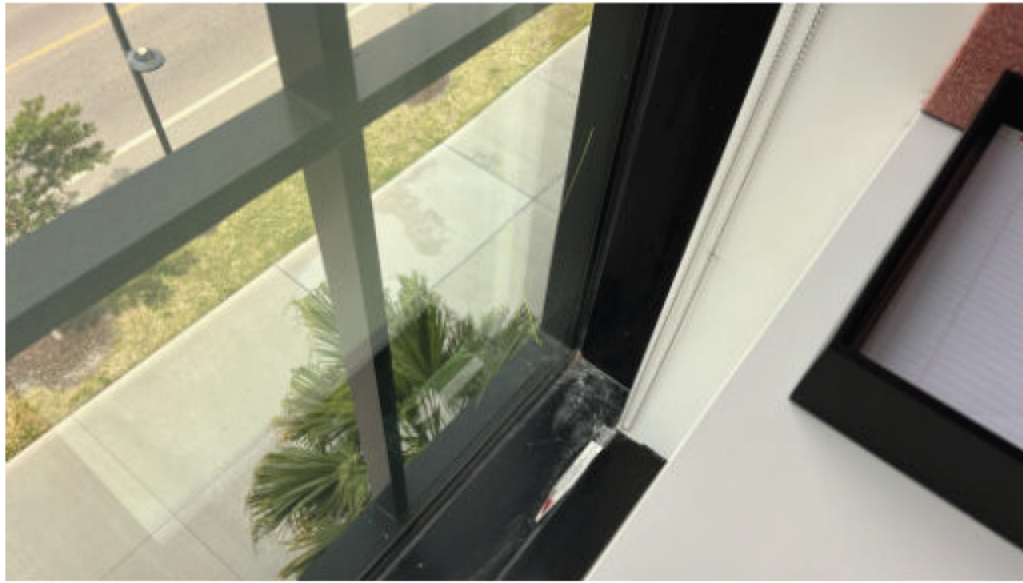
Picture 89: West elevation in conference room. Evidence of water intrusion

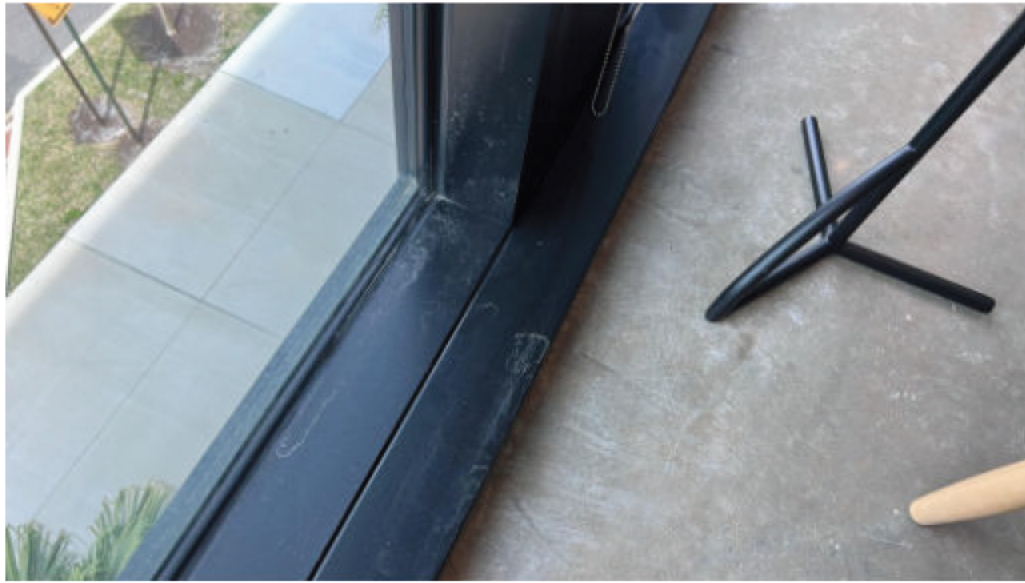
Picture 91: West elevation,  
Evidence of water intrusion

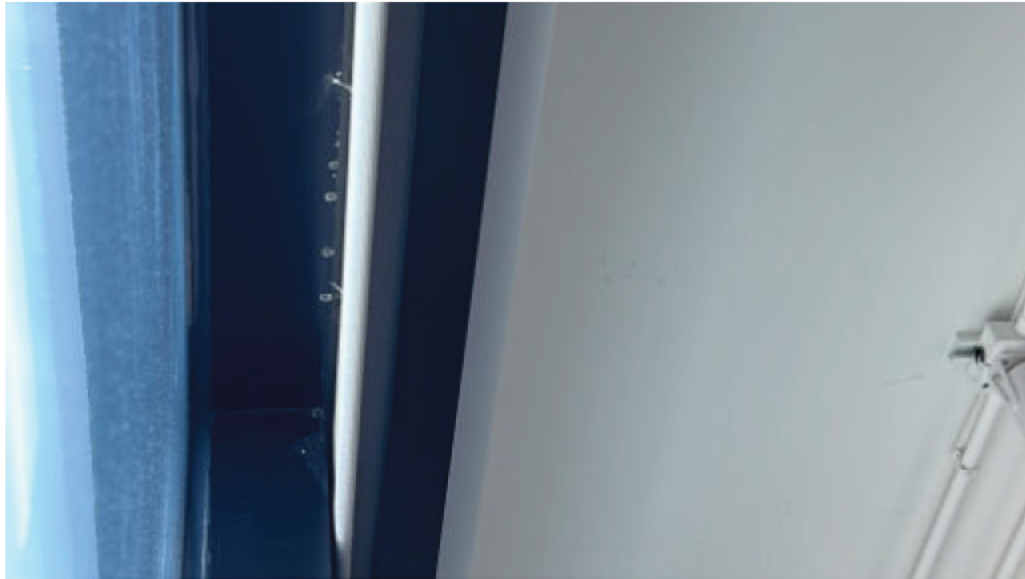
Picture 92: West elevation,  
Evidence of water intrusion

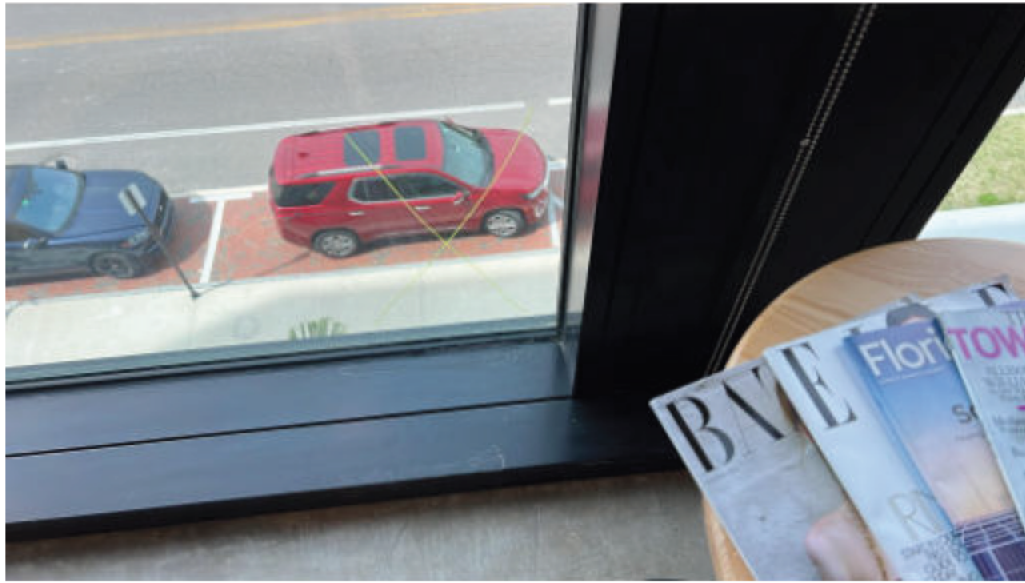
Picture 93: West elevation,  
Evidence of water intrusion

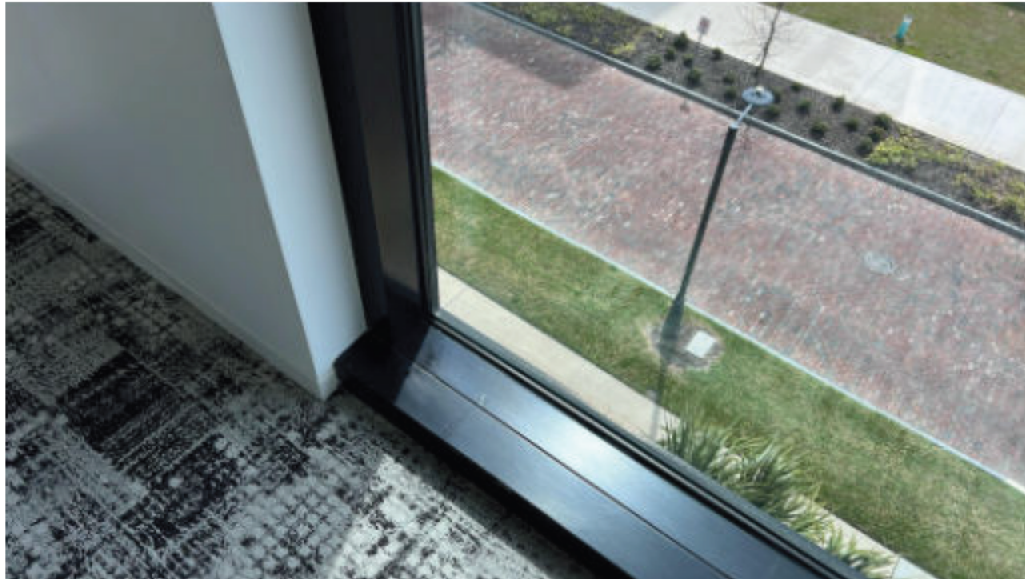
Picture 94: South elevation,  
Evidence of water intrusion

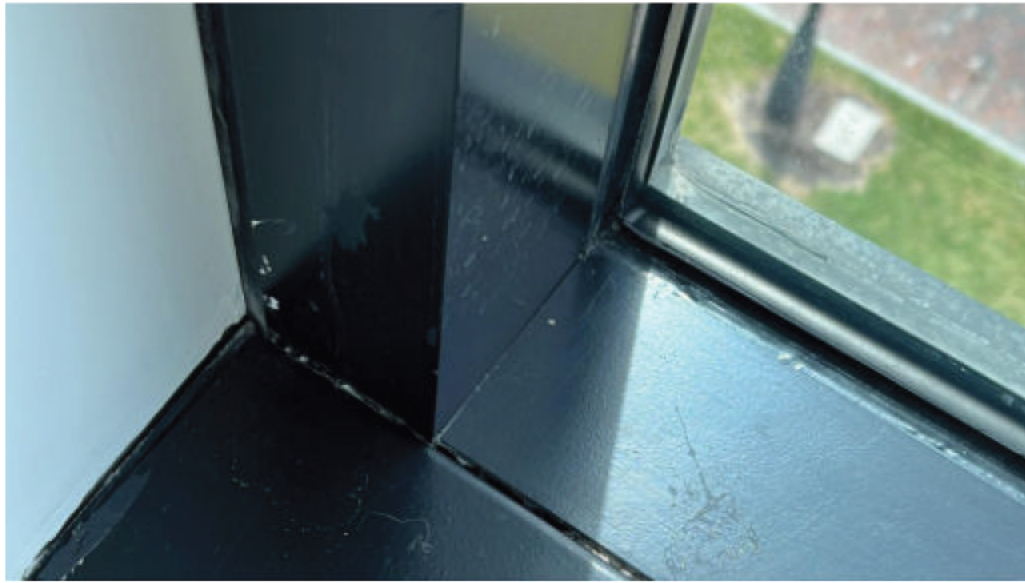
Picture 95: South elevation,  
Evidence of water intrusion

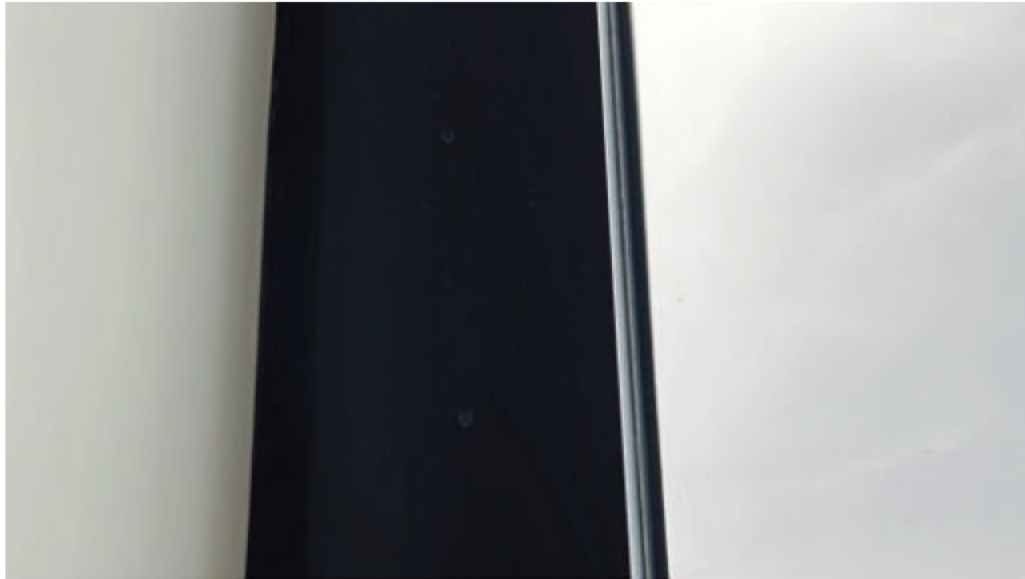
Picture 96: South elevation,  
Evidence of water intrusion

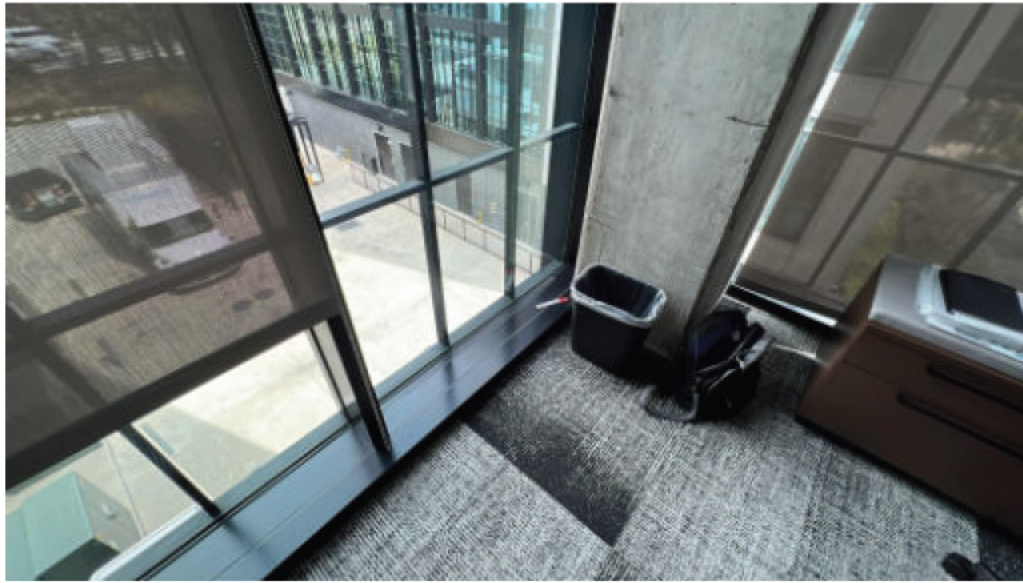
Picture 97: North elevation,  
Evidence of water intrusion

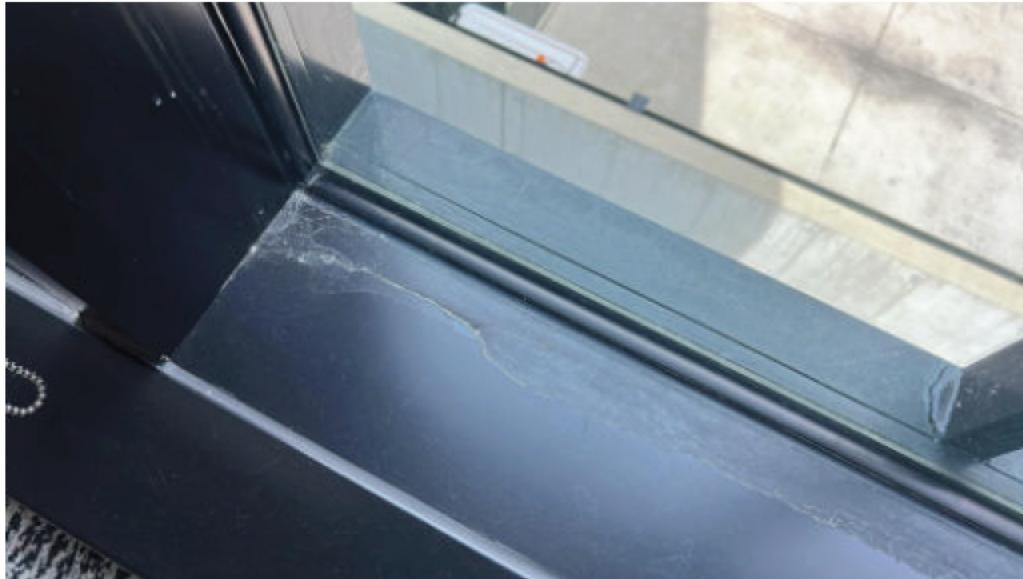
Picture 98: North elevation,  
Evidence of water intrusion

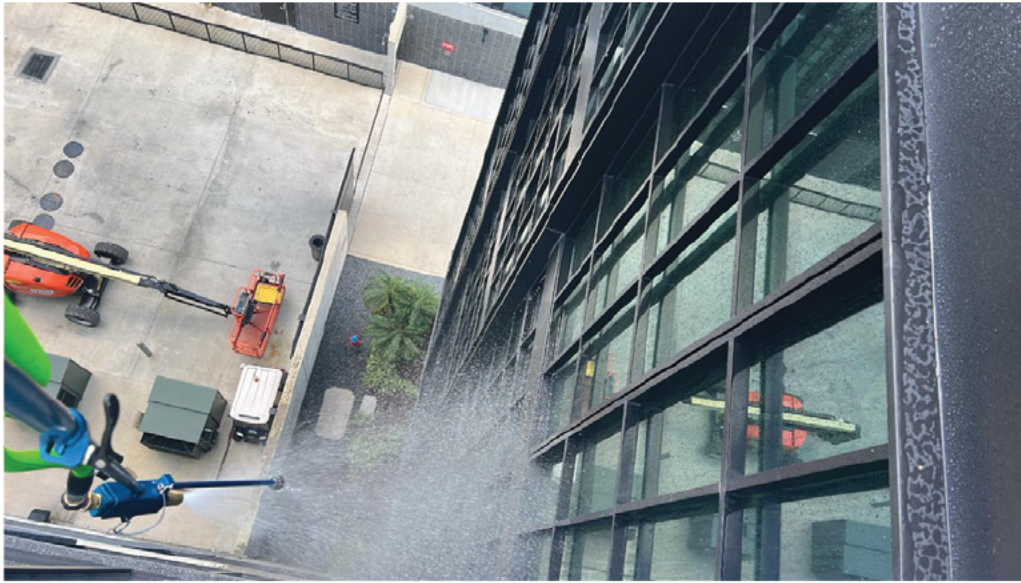
The testing began at the third floor and progressed systematically to the top floor. Water intrusion was not observed until the top of the parapet was tested. An opening in the roof membrane installed over the top of the parapet was discovered, and is likely the source of the water intrusion on the floors below.

Picture 35: Final test-  
Sprayed the 6th floor from  
the roof, and then the top of  
the 6th floor

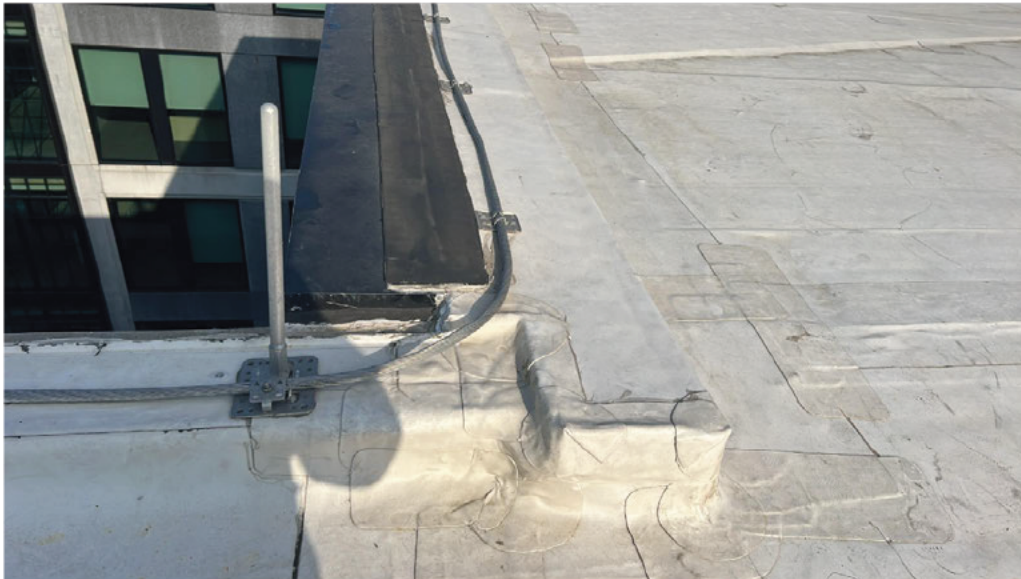
Picture 36: Leak on third  
floor is from roof.

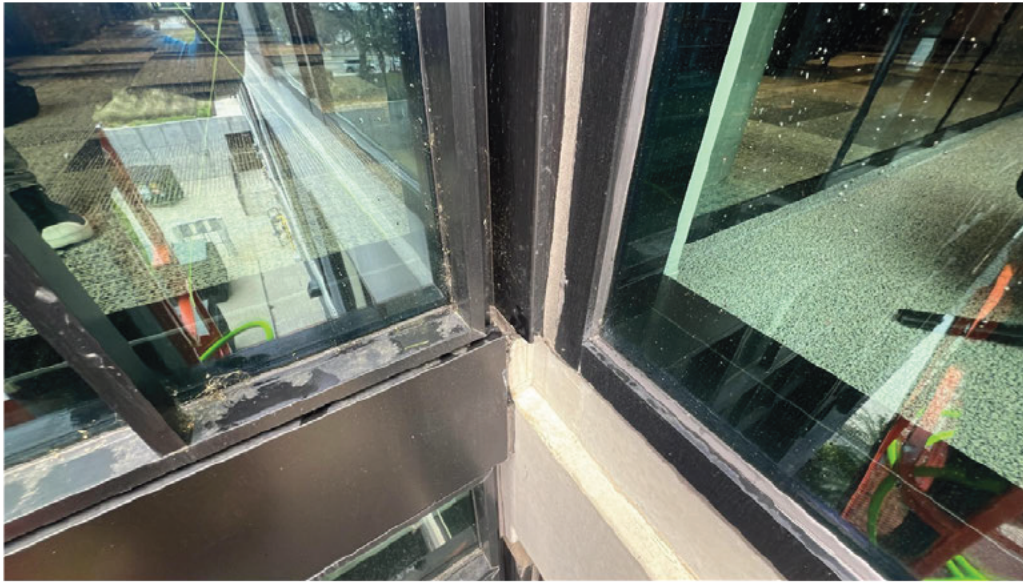
Picture 1: Hole in the sealant at corner

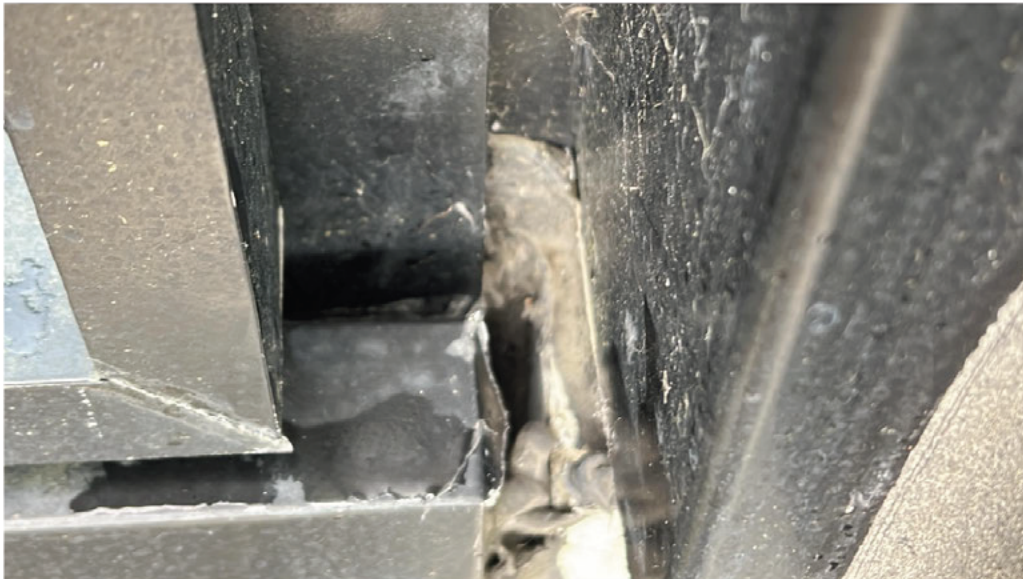
Picture 2: Hole in the sealant at corner

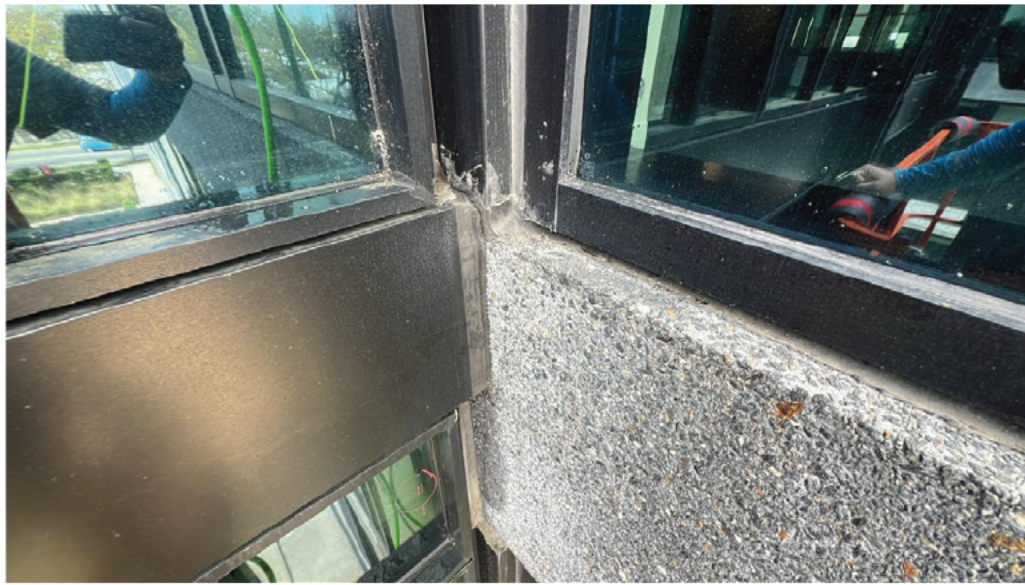
Picture 3: Pre-testing investigation at 4th floor. Sealant has voids and adhesive failure to the stone surface.

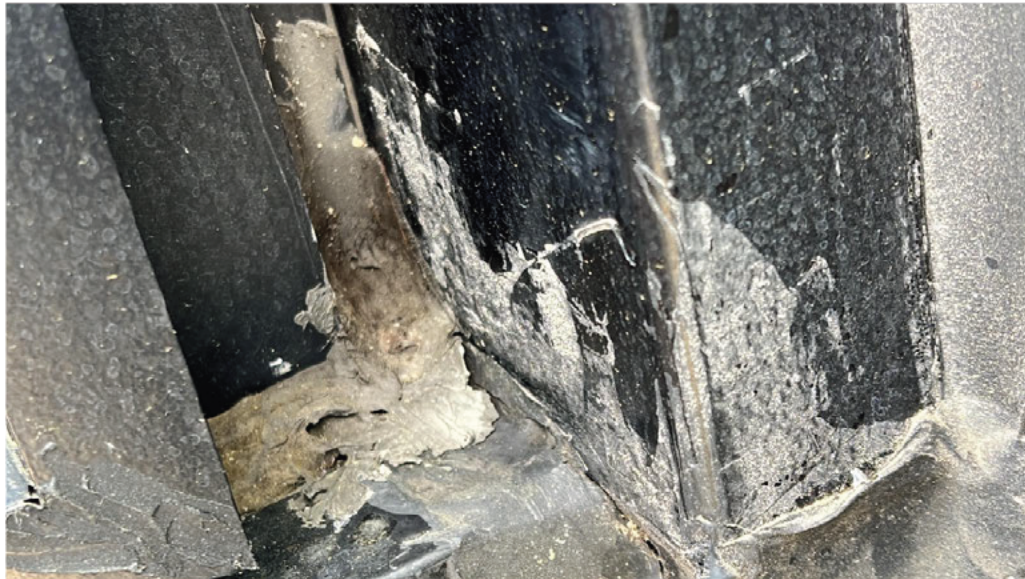
Picture 4: Pre-testing investigation at 4th floor. Sealant has voids and adhesive failure to the stone surface.

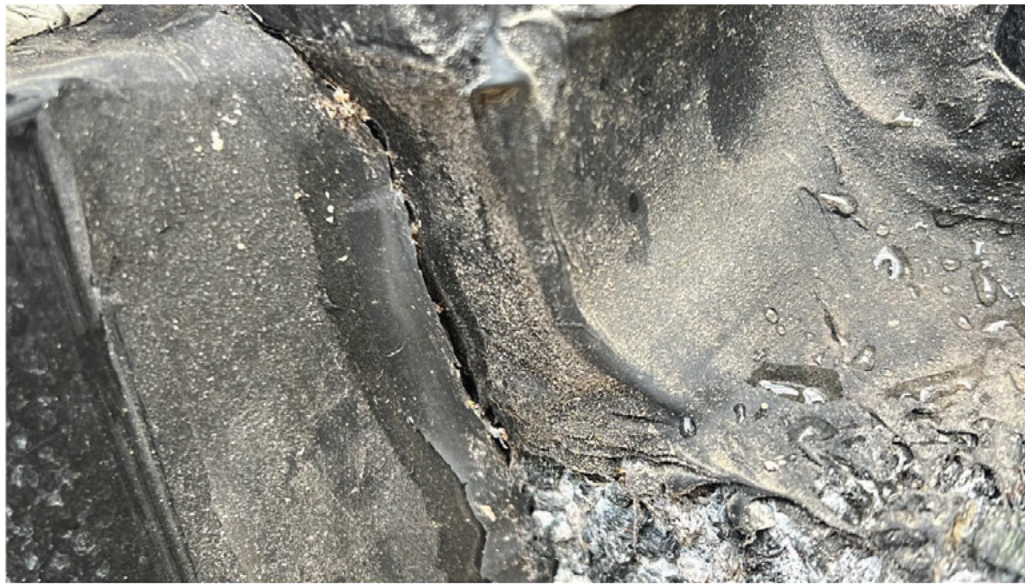
Picture 5: Pre-testing investigation at 4th floor. Sealant has voids and adhesive failure to the stone surface.
