# SAMPLE REPORT

## EXTERIOR WALL CONDITION ASSESSMENT REPORT

May 12, 2024

**Regarding:** Exterior Wall Condition Assessment

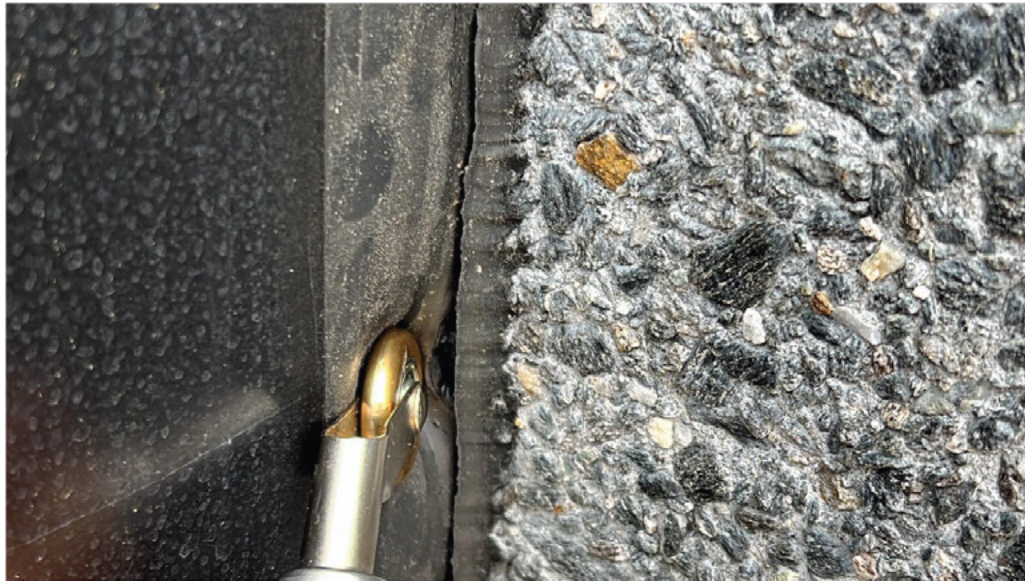
Picture 6: Pre-testing investigation at 4th floor. Sealant has voids and adhesive failure to the stone surface.

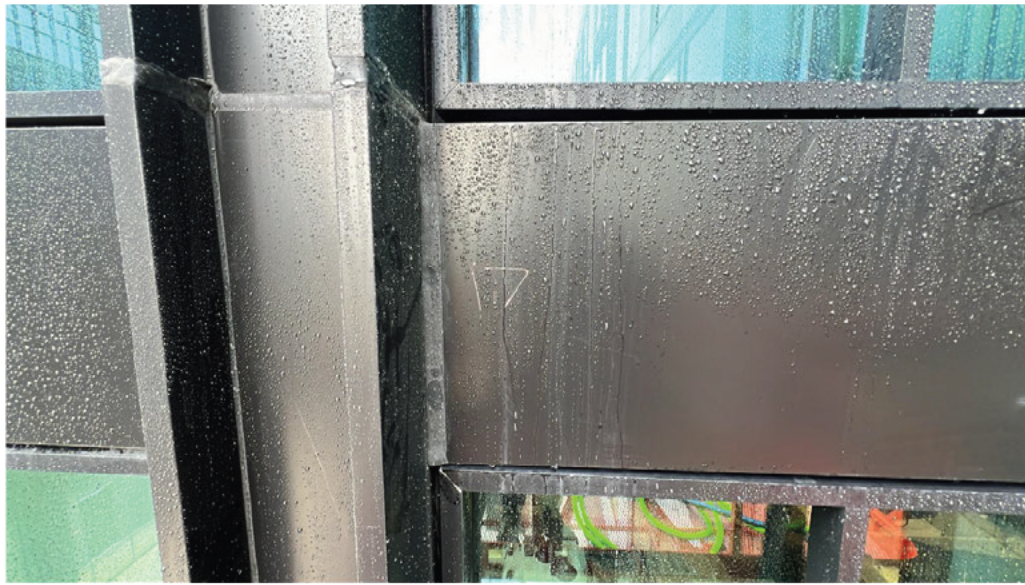
Picture 7: Investigation prior to water testing. Adhesive failure of sealant

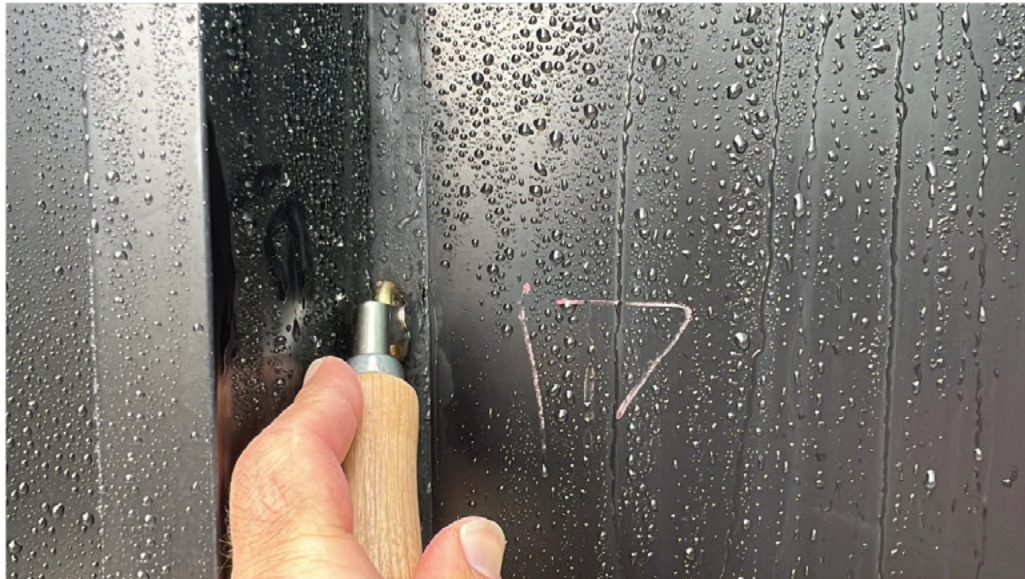
Picture 8: Investigation prior to water testing. Adhesive failure of sealant

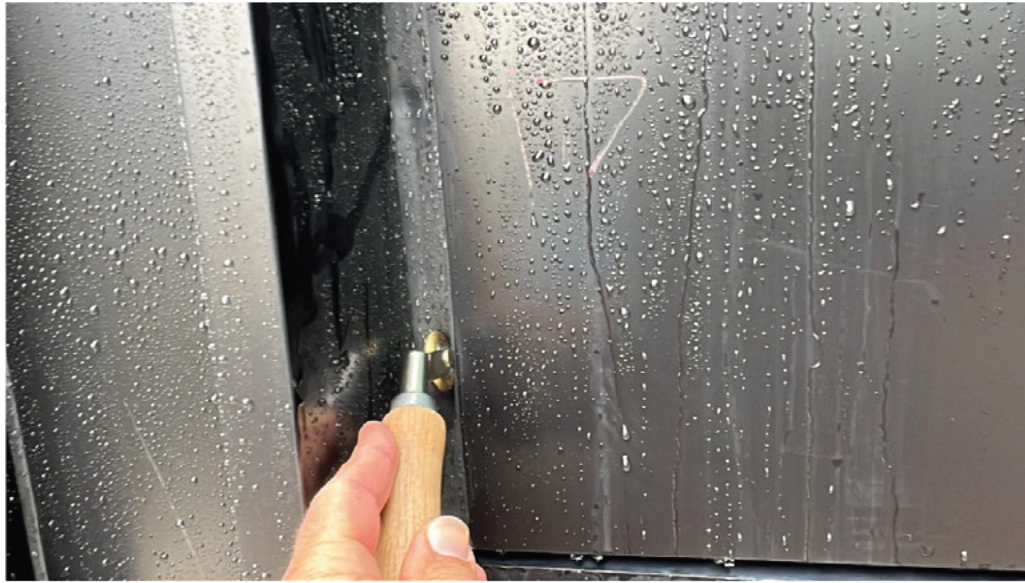
Picture 9: Investigation prior to water testing. Adhesive failure of sealant

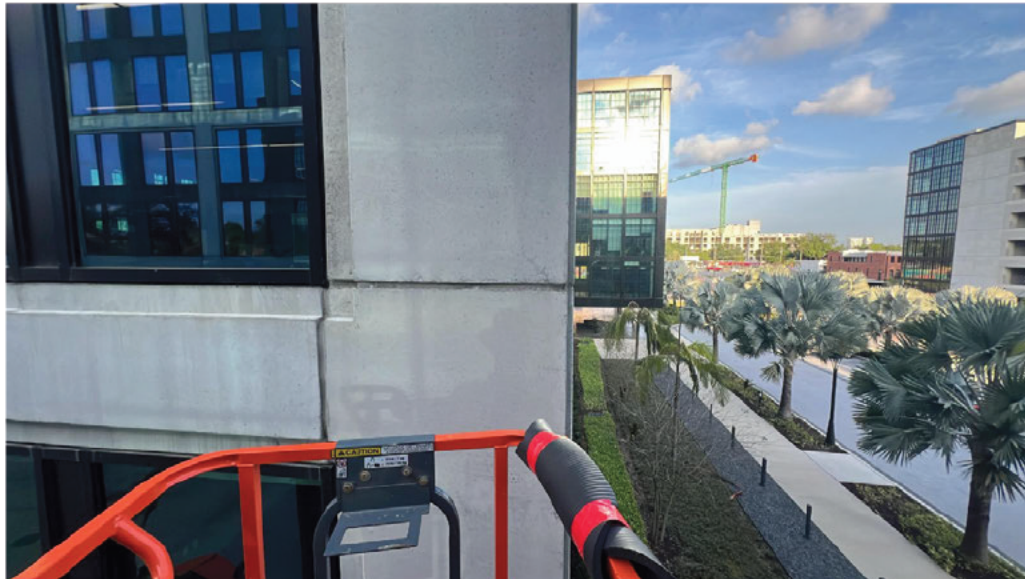
Picture 10: Adhesive failure of the sealant between precast panels.

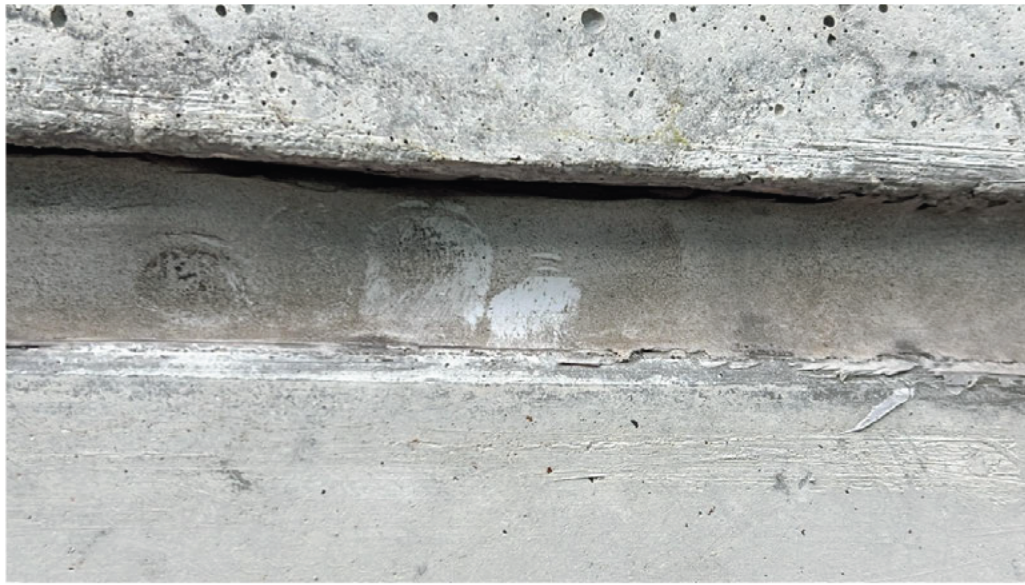
Picture 11: Adhesive failure of the sealant between precast panels.

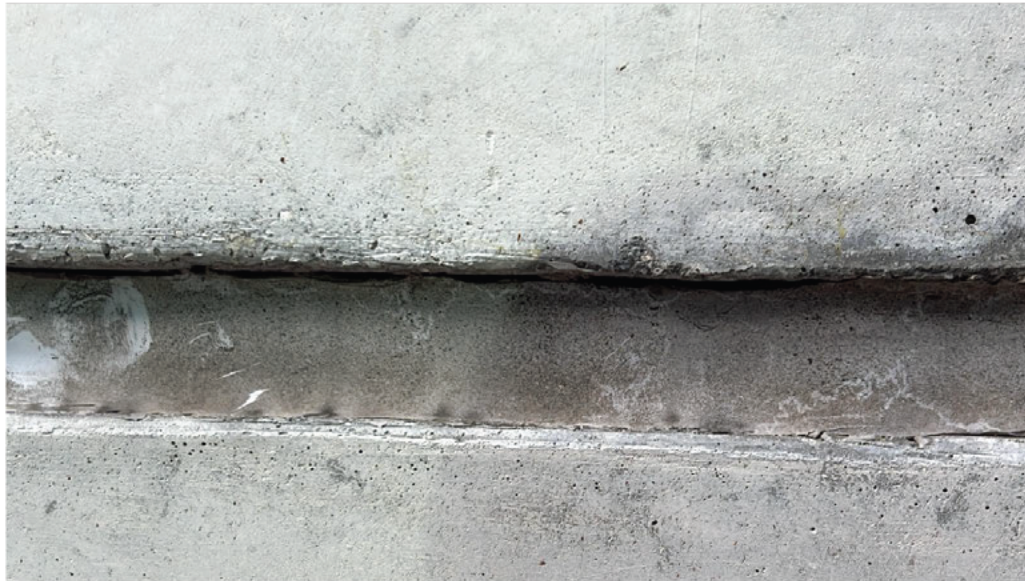
Picture 12: Adhesive failure of the sealant between precast panels.

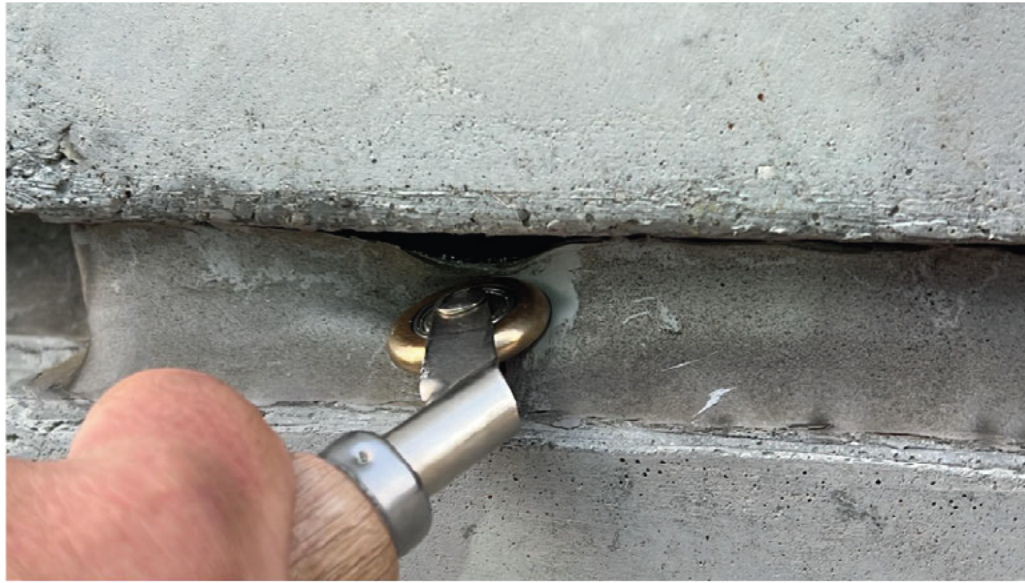
Picture 13: Adhesive failure of the sealant between precast panels.
