# ROOF REPORT

Carport Roof Condition Assessment

**Regarding:** Limited Carport Roof Condition Assessment

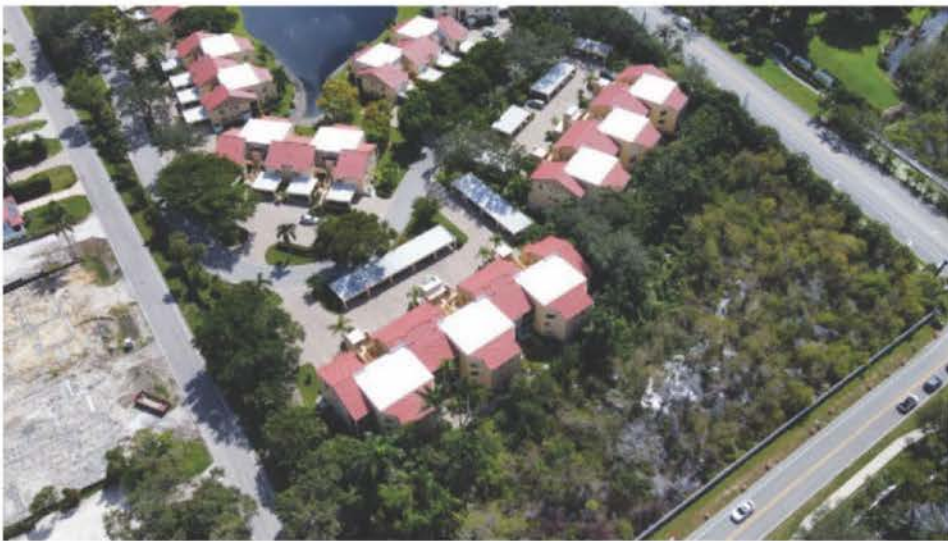
Picture 1: Aerial view
	Lat: 26.25429 Long: -81.81732 Bearing: N Date Taken: 10/05/2023 Weather: Sunny Taken By: Matthew Mullins Tags: Property Overviews

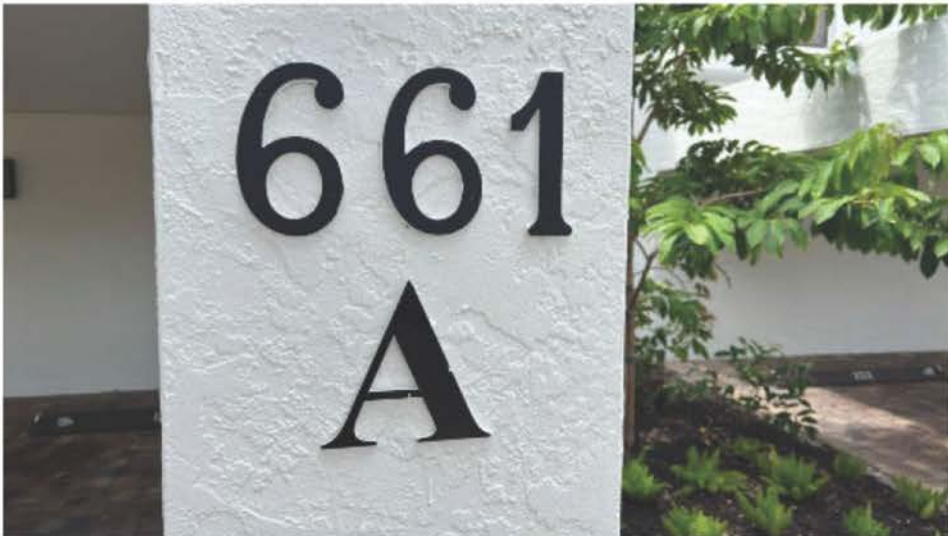
Picture 5: Overview
	Lat: 26.25339 Long: -81.81109 Bearing: W Date Taken: 10/05/2023 Weather: Partly cloudy Taken By: Matthew Mullins Tags: A-661

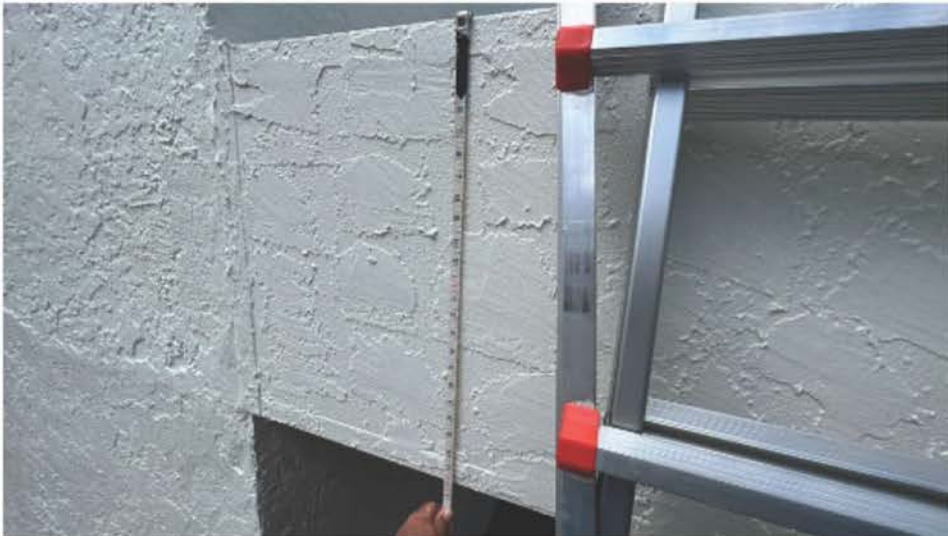
Picture 6: perimeter panels are 2' high
	Lat: 26.25343 Long: -81.81120 Bearing: NW Date Taken: 10/05/2023 Weather: Partly cloudy Taken By: Matthew Mullins Tags: A-661

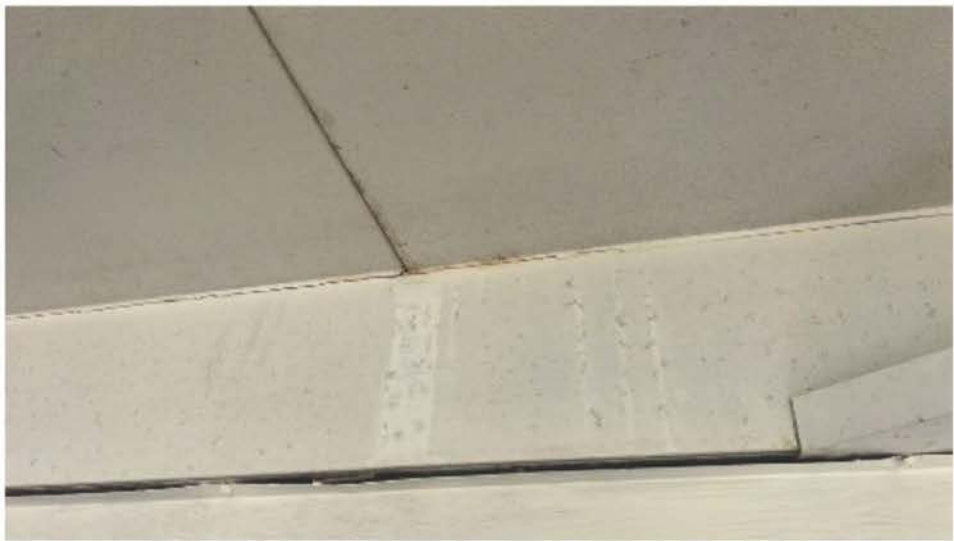
Picture 7: signs of water intrusion through the panels.
	Lat: 26.25350 Long: -81.81114 Bearing: NE Date Taken: 10/05/2023 Weather: Partly cloudy Taken By: Matthew Mullins Tags: A-661

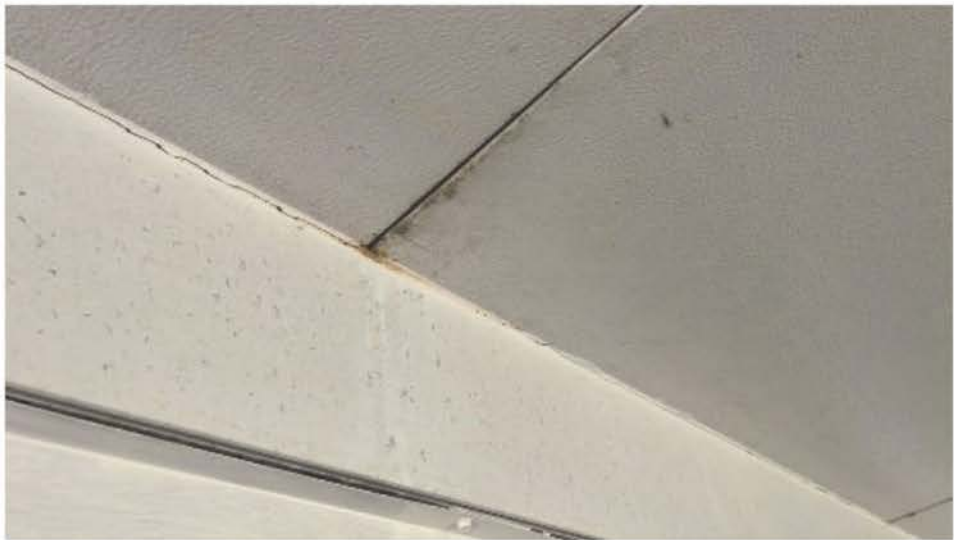
Picture 8: signs of water intrusion through the panels.
	Lat: 26.25357 Long: -81.81116 Bearing: SE Date Taken: 10/05/2023 Weather: Partly cloudy Taken By: Matthew Mullins Tags: A-661

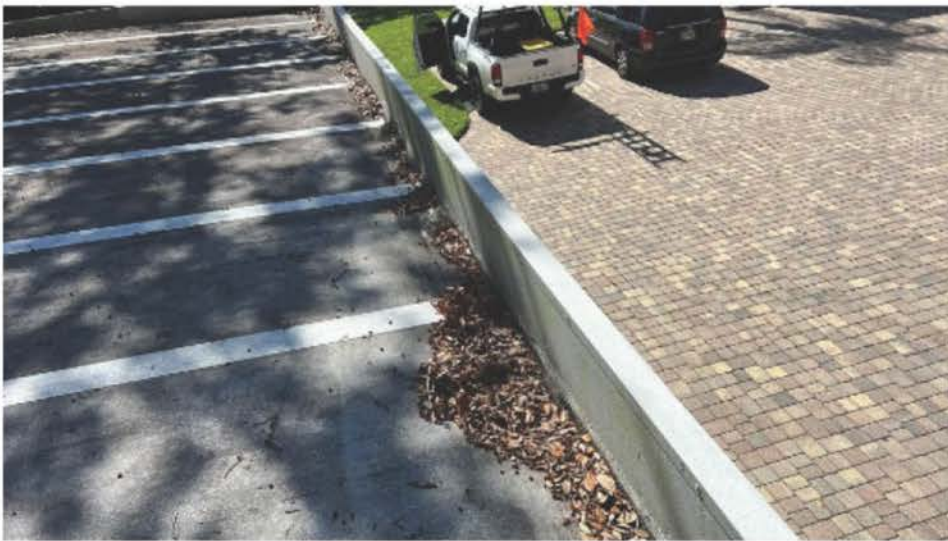
Picture 151: overview
	Lat: 26.25307 Long: -81.81576 Bearing: W Date Taken: 10/05/2023 Weather: Overcast Taken By: Matthew Mullins Tags: N-592

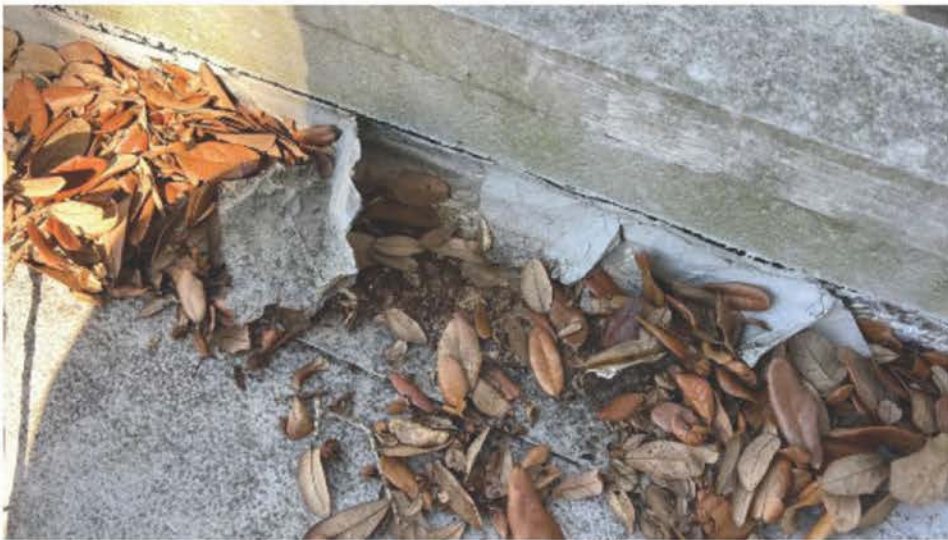
Picture 152: overview
	Lat: 26.25304 Long: -81.81573 Bearing: NE Date Taken: 10/05/2023 Weather: Overcast Taken By: Matthew Mullins Tags: N-592

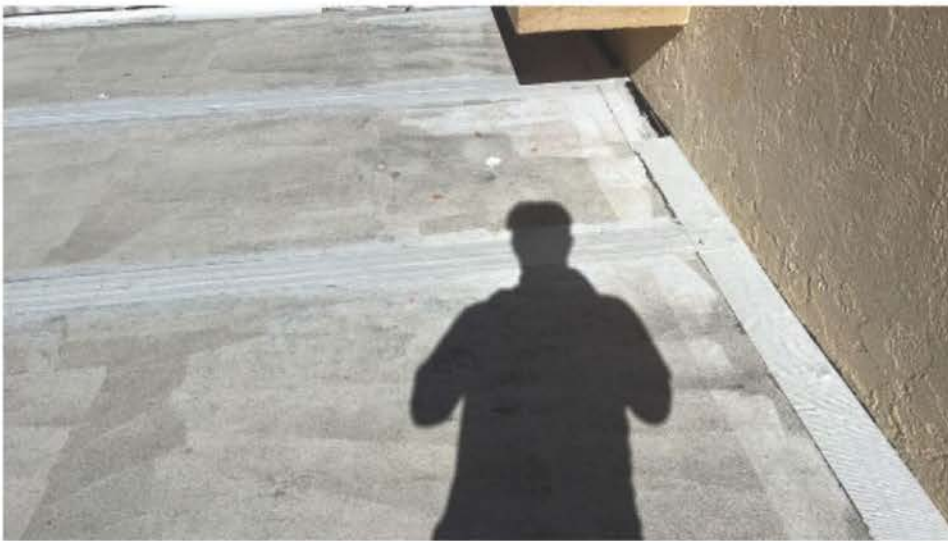
Picture 181: overview
	Lat: 26.25392 Long: -81.81590 Bearing: NE Date Taken: 10/05/2023 Weather: Patchy rain possible Taken By: Matthew Mullins Tags: P-589

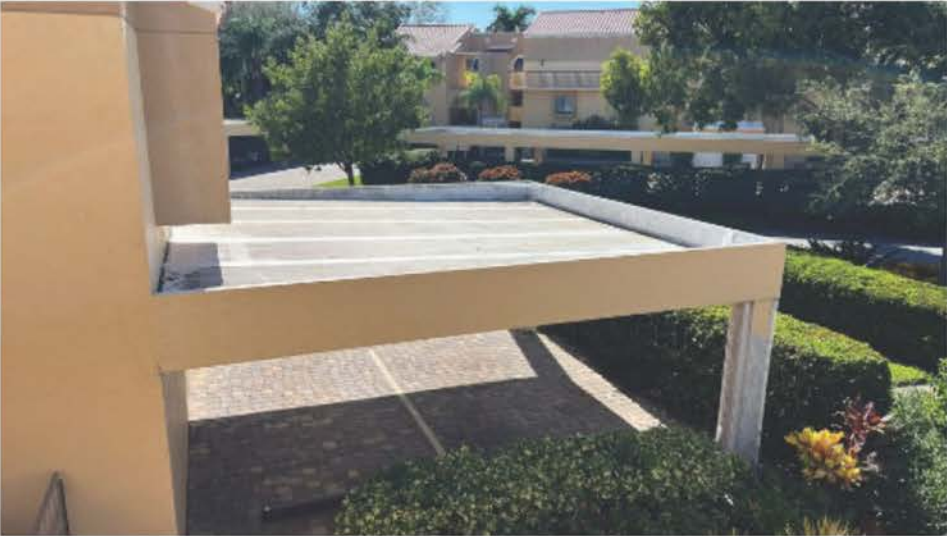
Picture 184: overview
	<p>Lat: 26.25392</p> <p>Long: -81.81590</p> <p>Bearing: W</p> <p>Date Taken: 10/05/2023</p> <p>Weather: Patchy rain possible</p> <p>Taken By: Matthew Mullins</p> <p>Tags: P-589</p>

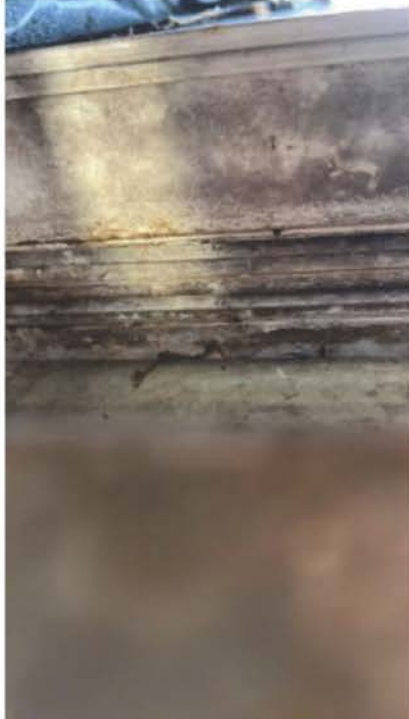
Picture 187: view through gutter outlet- (2) 2x7 aluminum beams

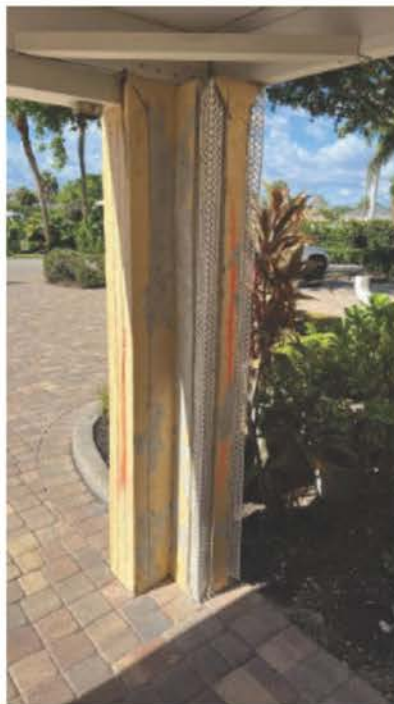
Picture 188: stucco corner bead replacement in progress
