[REDACTED] Condominium Association, Inc.

Regarding: [REDACTED] Condominium Structural Assessment
4.24-[REDACTED]

1. Purpose and Scope

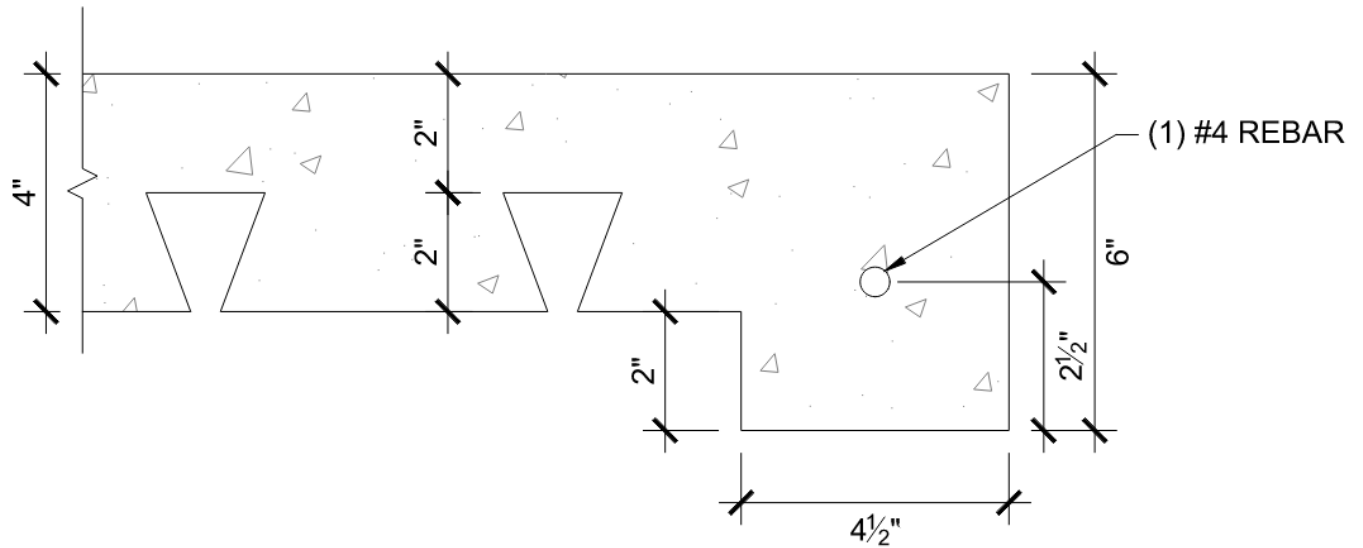
Concrete was removed from the slab edges of the balconies of units 4641, 4521, and 4543 ██████████ to determine existing conditions. The investigation revealed that the existing drop beam is 4.5 inches wide and 6 inches deep, with a #4 reinforcing steel bar 2.5 inches from the bottom of the beam. The balcony slab is a composite slab, assumed to be Epicore, and is 2 inches deep with a 2-inch topping slab. Please refer to the image below, and See Exhibits B, C, and D.

During the destructive investigation, Dynamic observed corrosion on the Epicore metal and corrosion on the reinforcing steel bar in the beam.

Based on our assessment and analysis, sliding glass doors should not be installed at the edge of the balcony without reinforcing the beam.

Balconies that have had a sliding glass door installed should be temporarily shored until permanent reinforcement can be installed.

The beam can be reinforced with a steel 2x2x3/8 steel angle and a steel column at the midpoint.

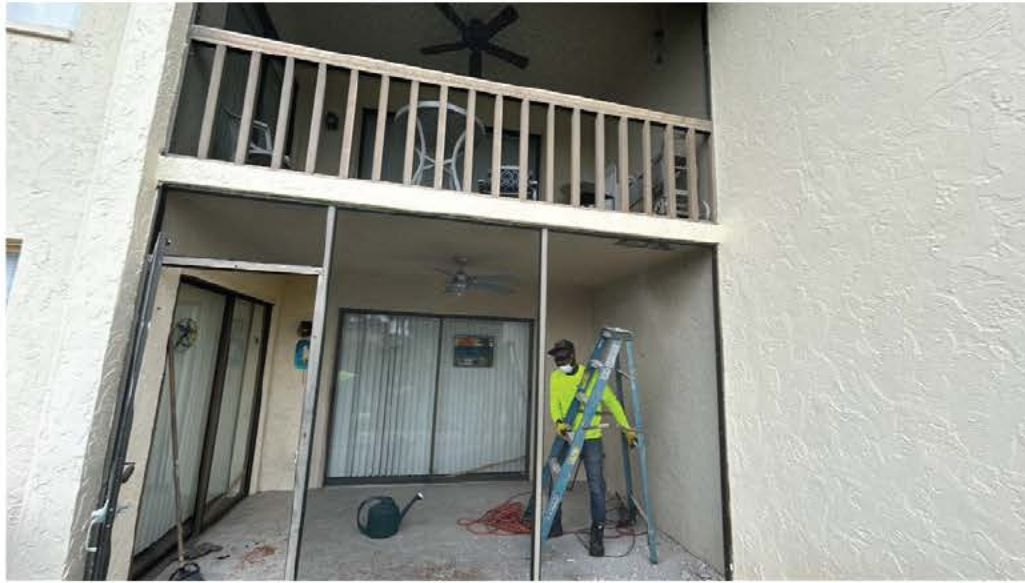
Media 1: Unit overview

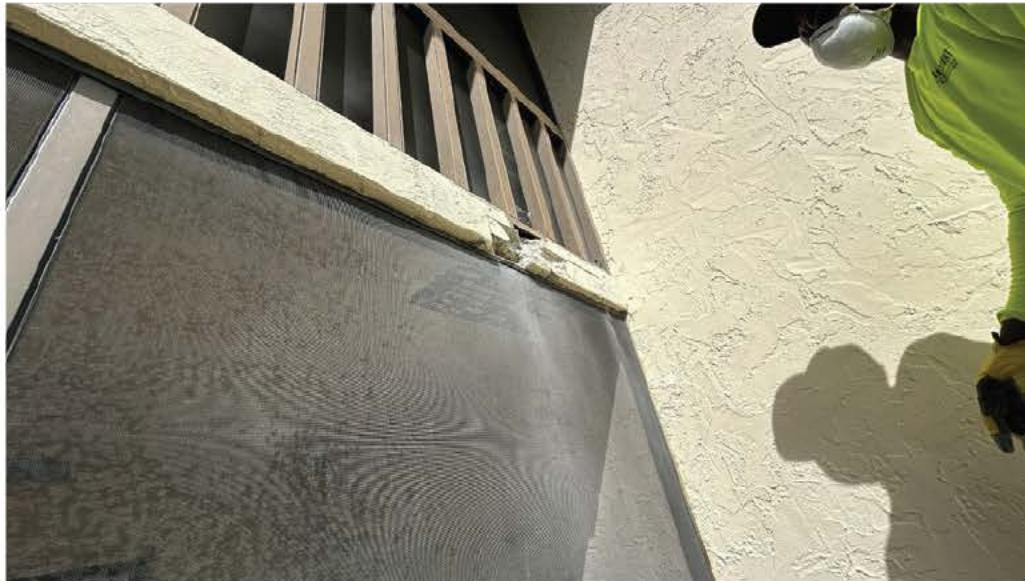
Media 2: Demolition of slab edge

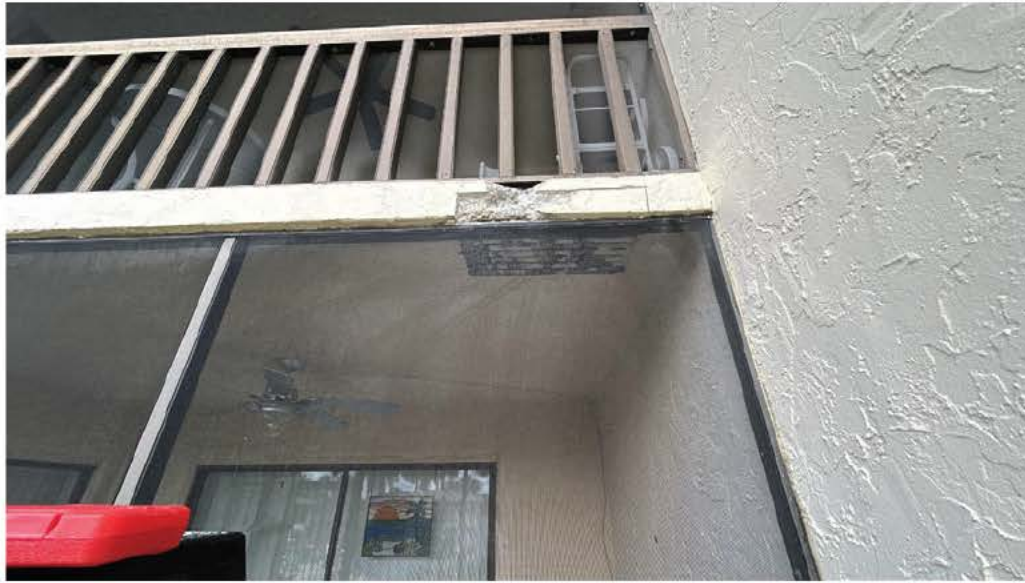
Media 3: Demolition of slab edge

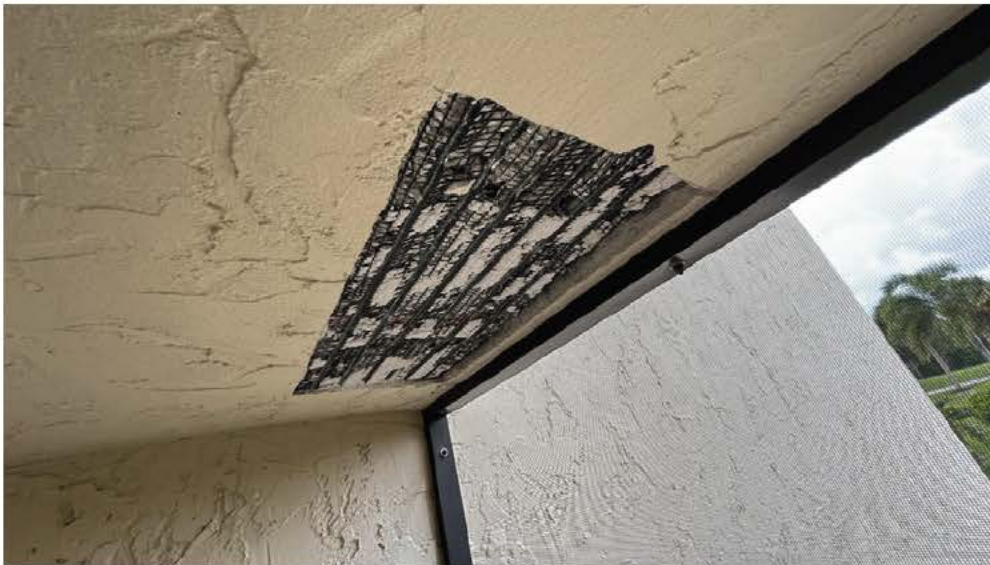
Media 4: Existing lathe over furring strip

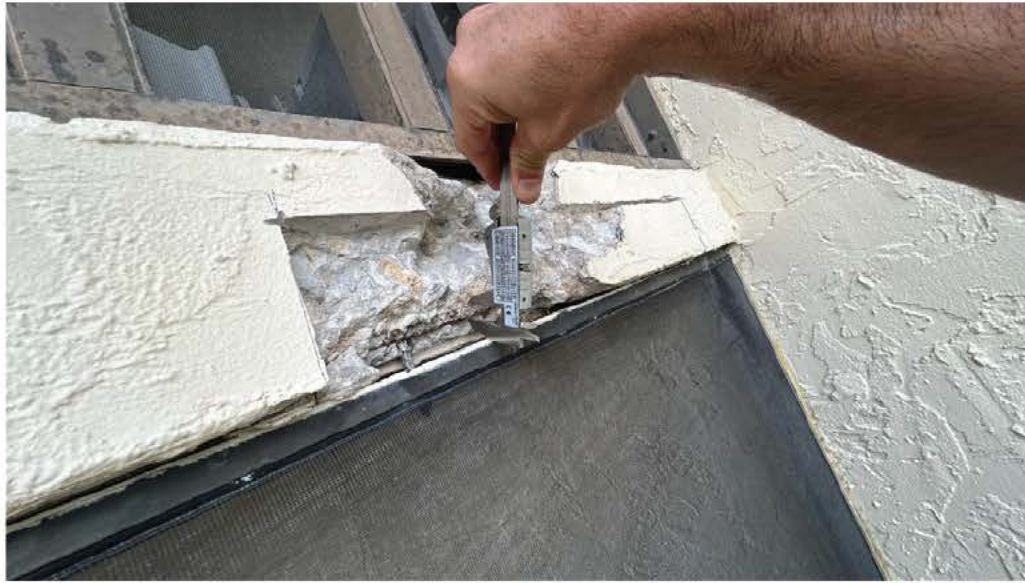
Media 5: Steel reinforcement micrometer measurement

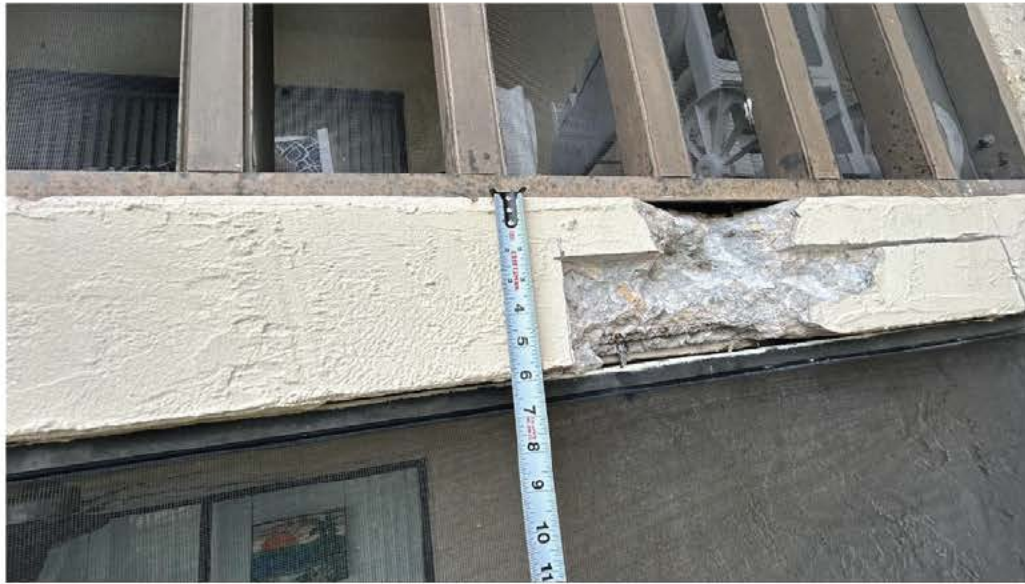
Media 6: Slab edge depth measurement

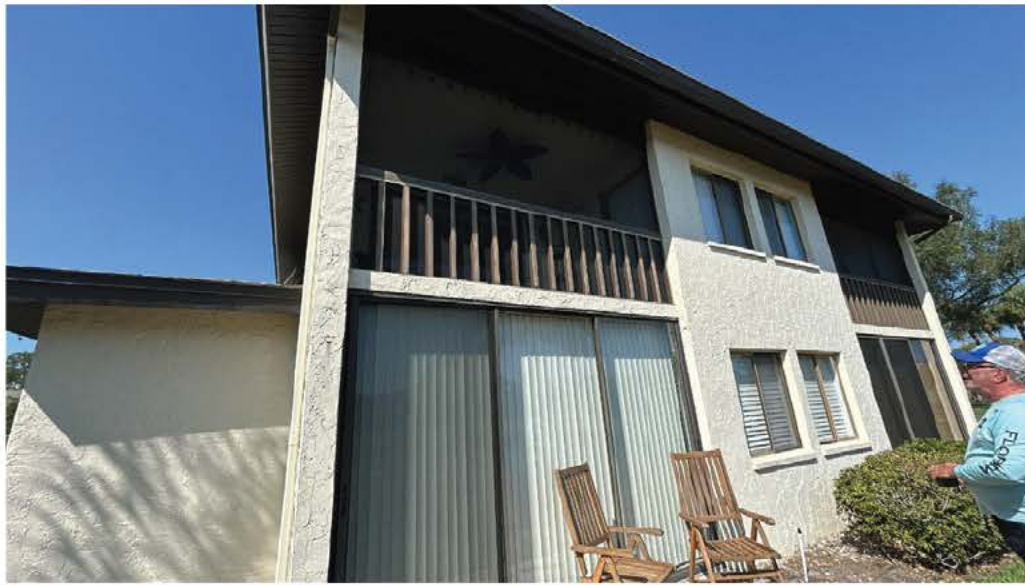
Media 1: Unit overview

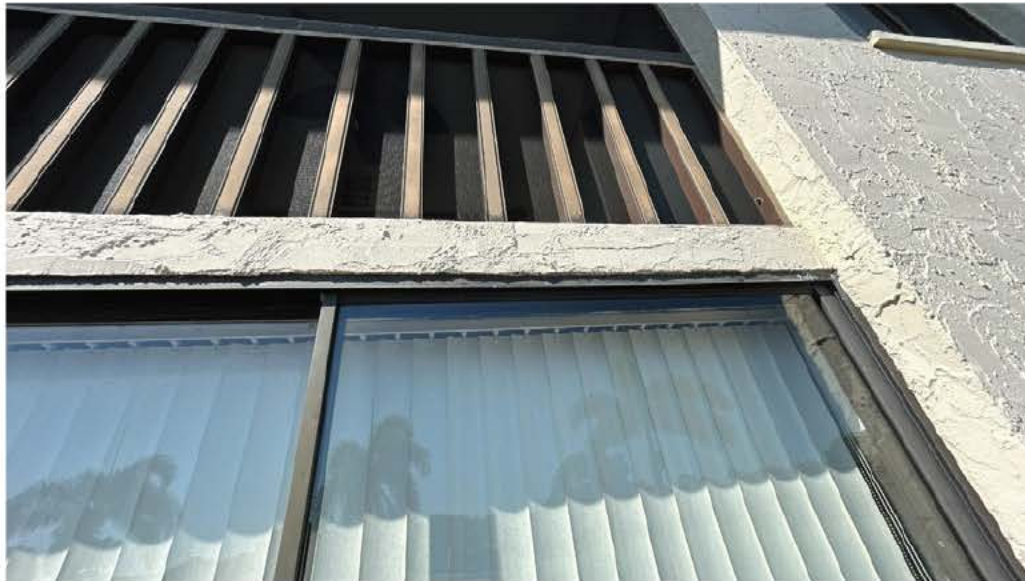
Media 2: Slab edge view

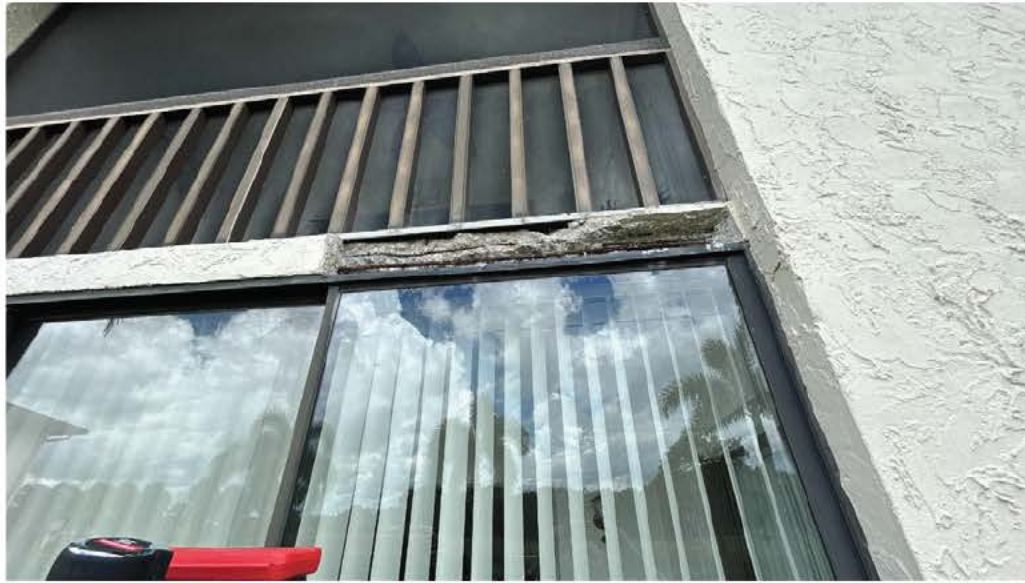
Media 3: Slab edge damaged
concrete removed

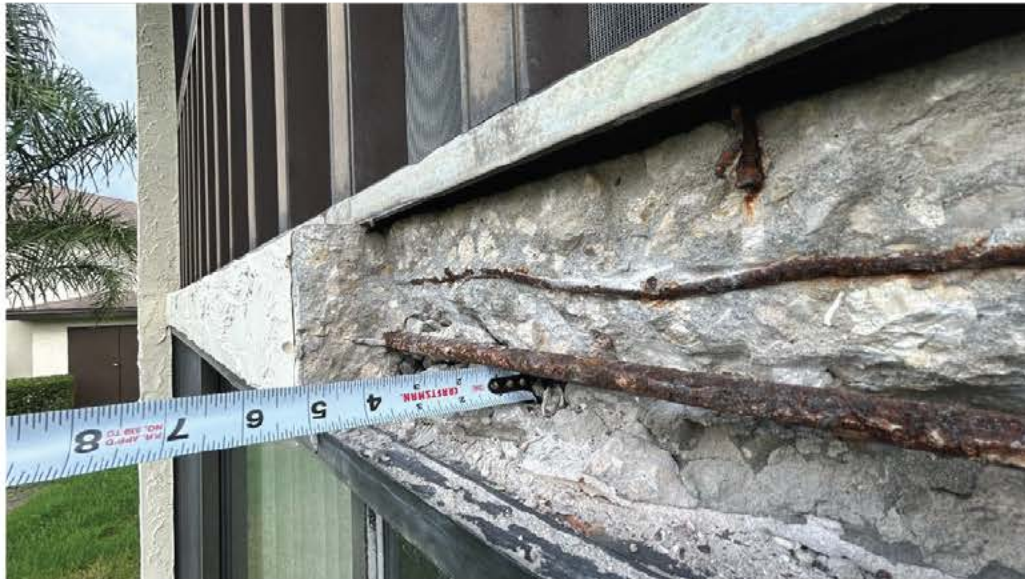
Media 4: Steel reinforcement
depth

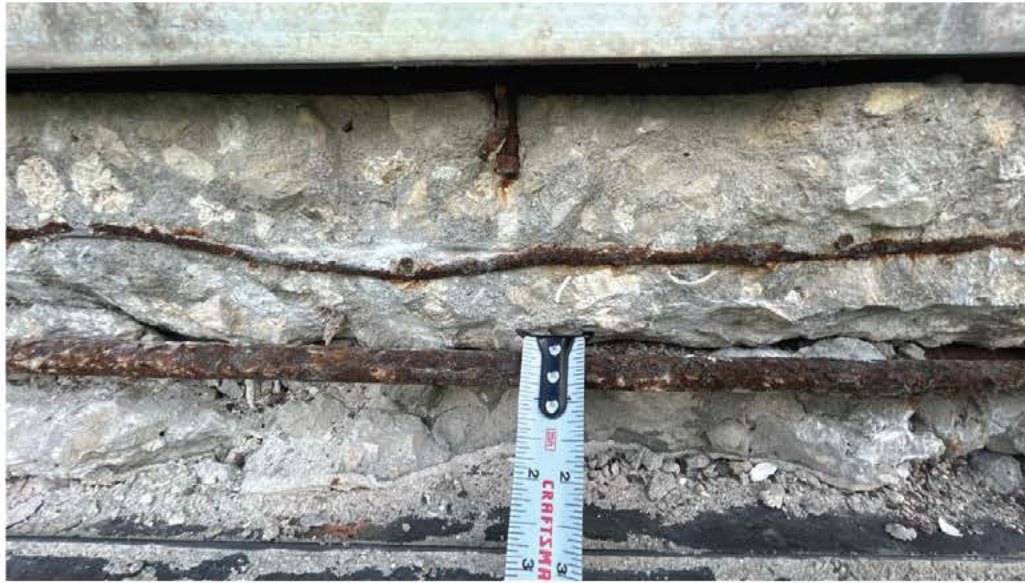
Media 5: Epicore depth in slab edge

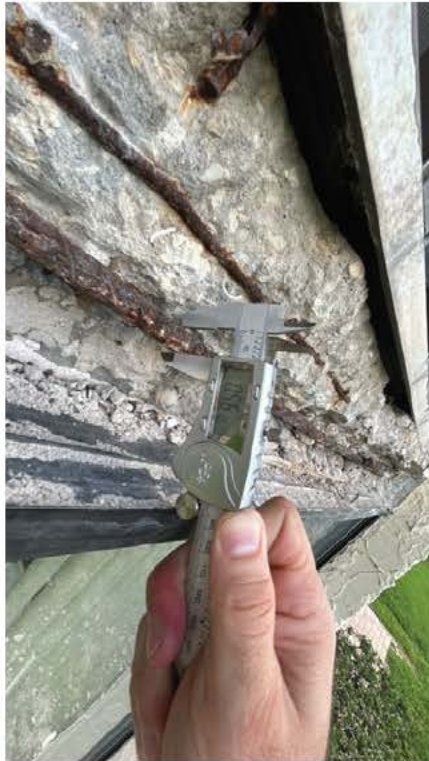
Media 6: Micrometer reading of steel reinforcement

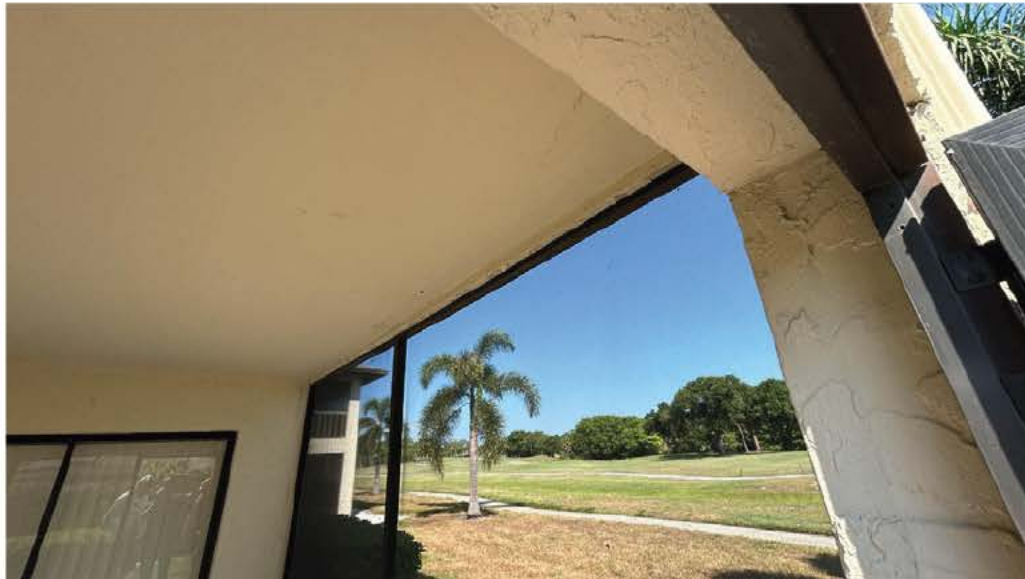
Media 2: Existing condition
at underside of balcony

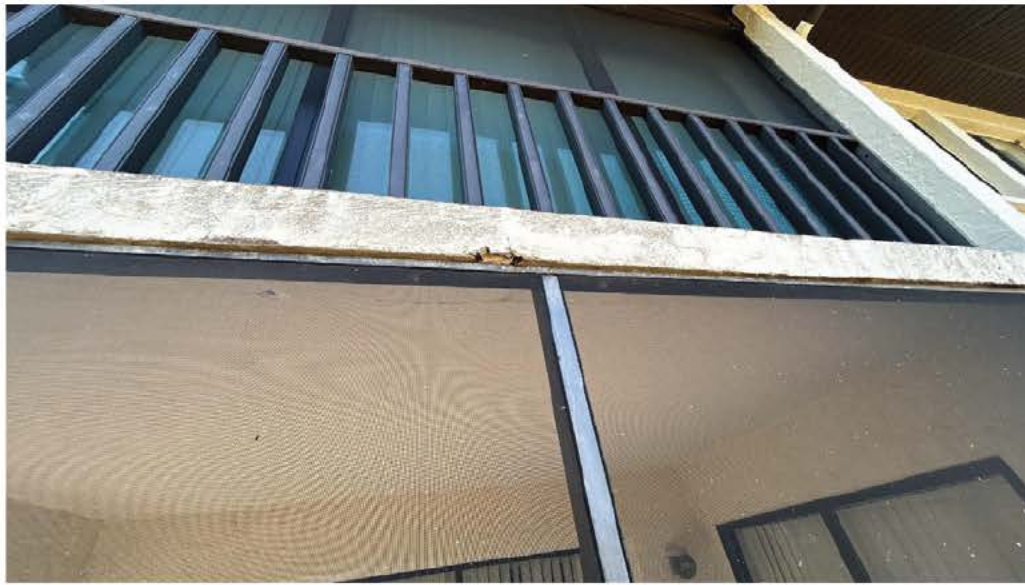
Media 3: Existing condition
at balcony slab edge

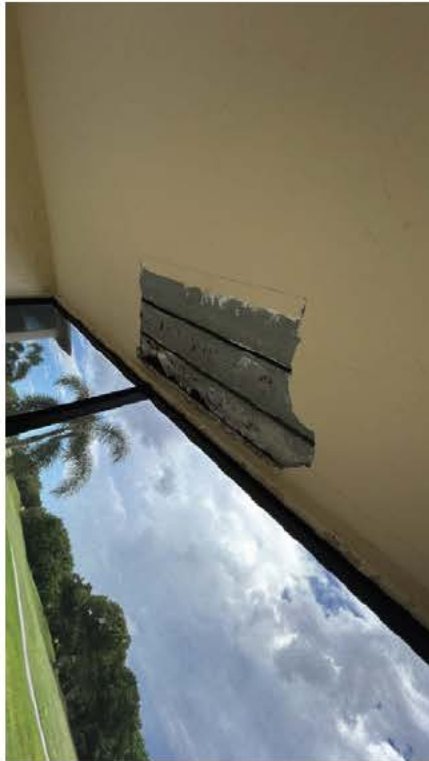
Media 4: Exposed underside of
balcony showing Epicore
decking.

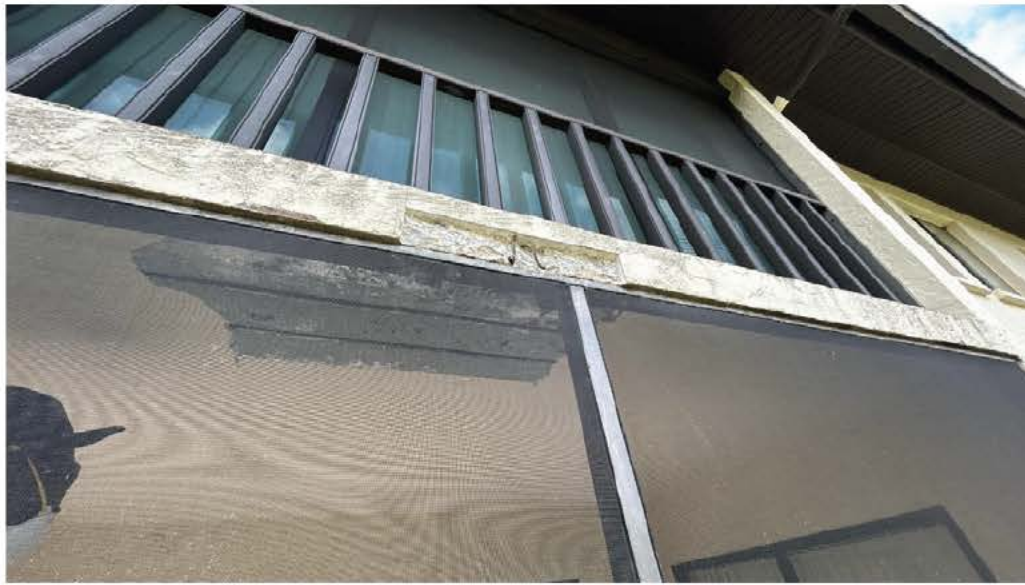
Media 5: Opened slab edge face showing rebar chair.

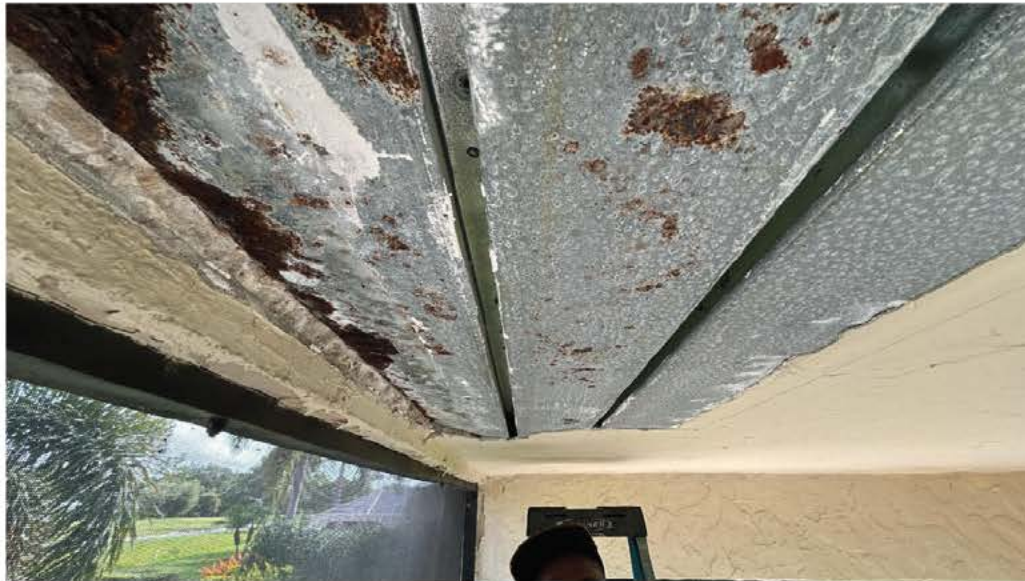
Media 6: Epicore decking showing signs of corrosion at the edge.

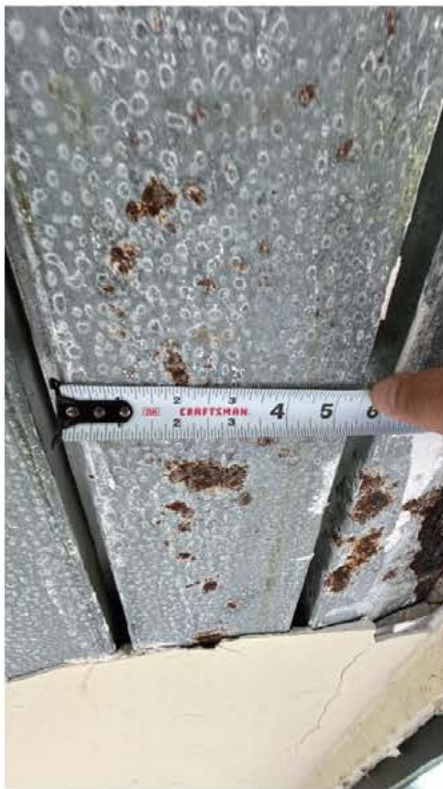
Media 7: Width of Epicore panels

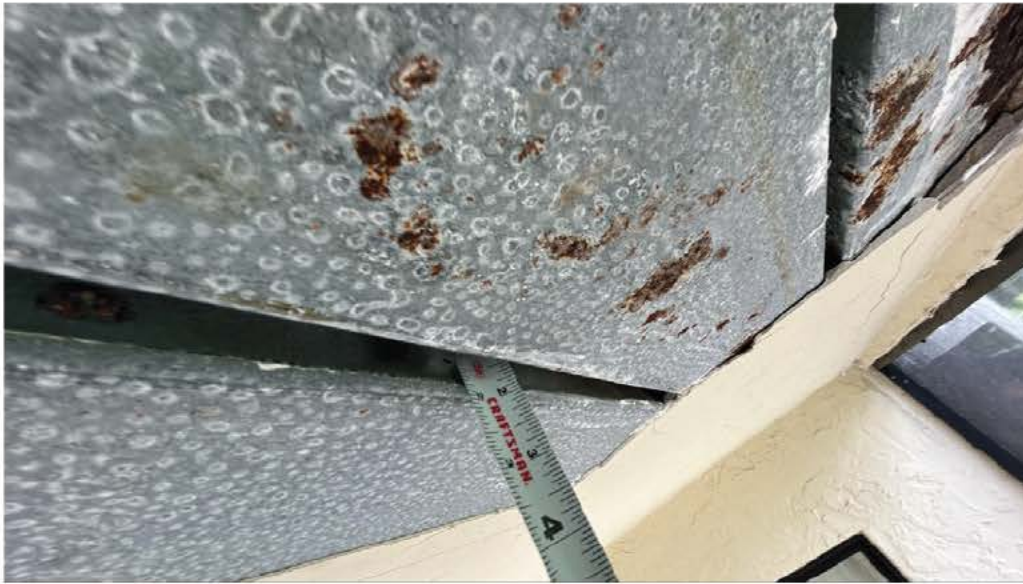
Media 8: Depth of Epicore panels.

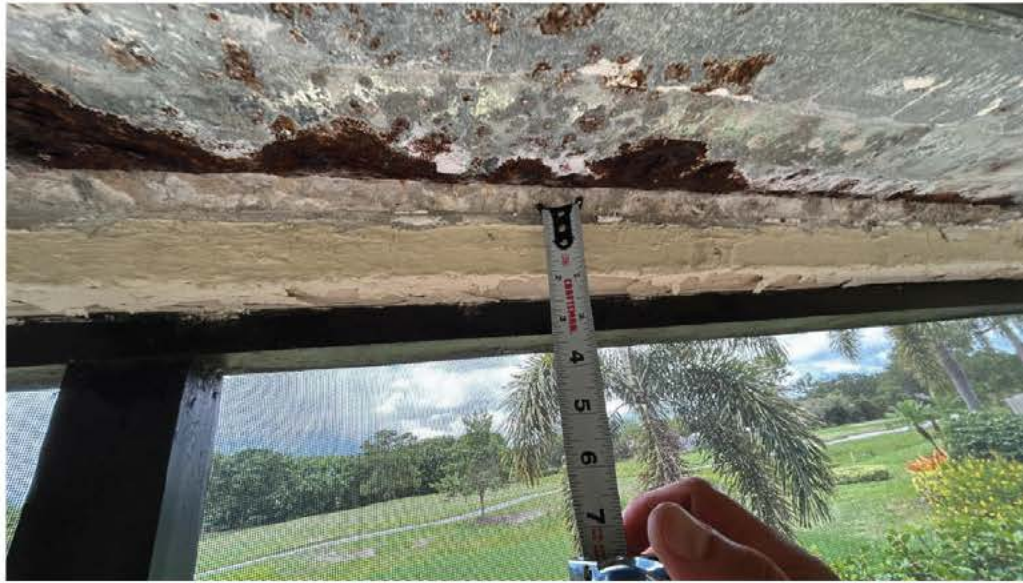
Media 9: Depth of potential drop beam to edge of cementitious stucco material.

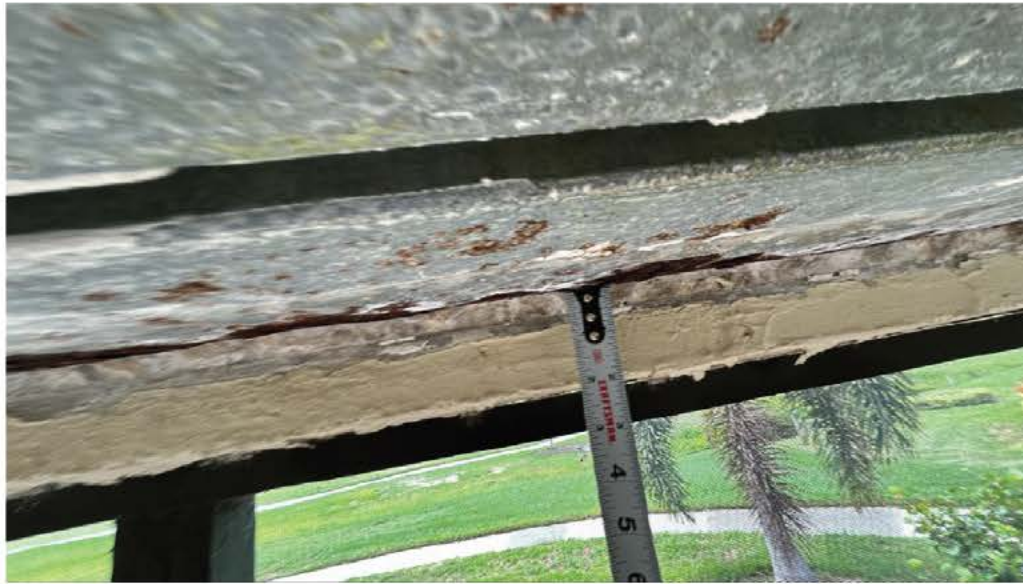
Media 10: Depth of drop beam to Epicore decking.

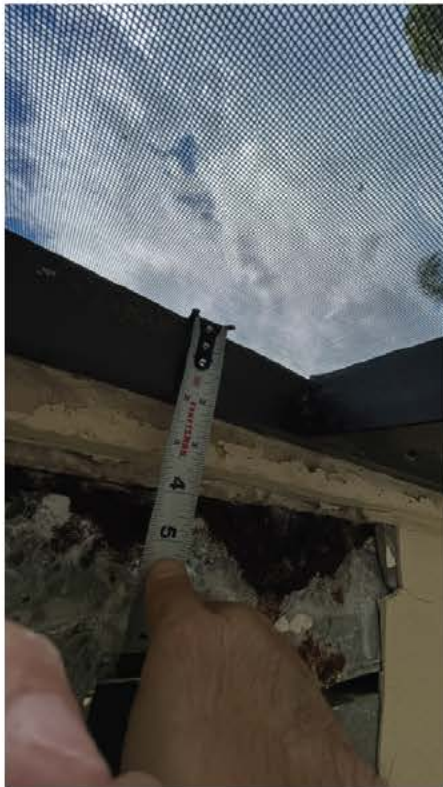
Media 11: Width of drop beam on interior of unit at screen cage.

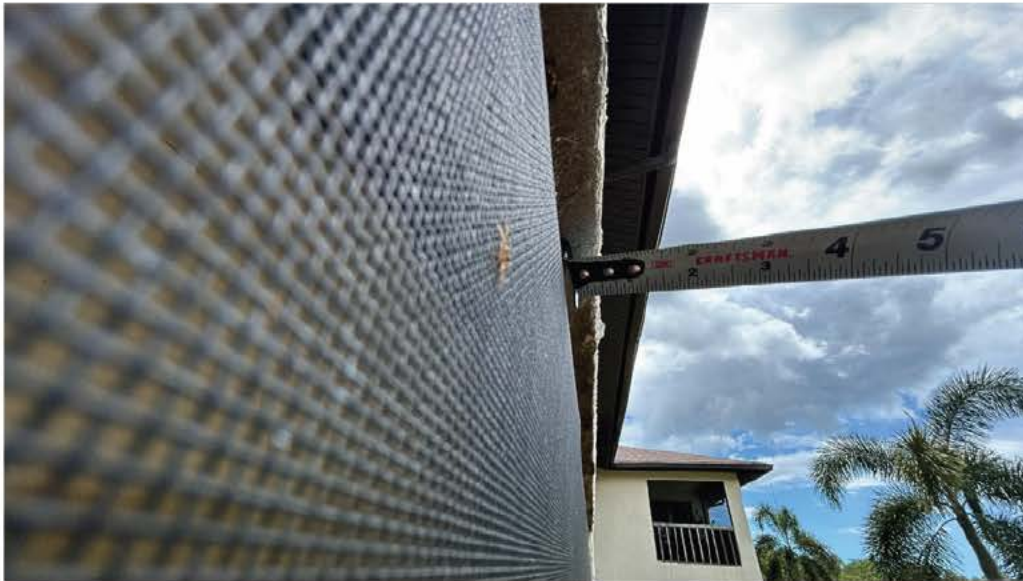
Media 12: Width of drop beam at exterior of screen cage.
