# SAMPLE CLIENT

PHASE I MILESTONE  
INSPECTION REPORT

**Regarding:** Phase I Milestone Inspection

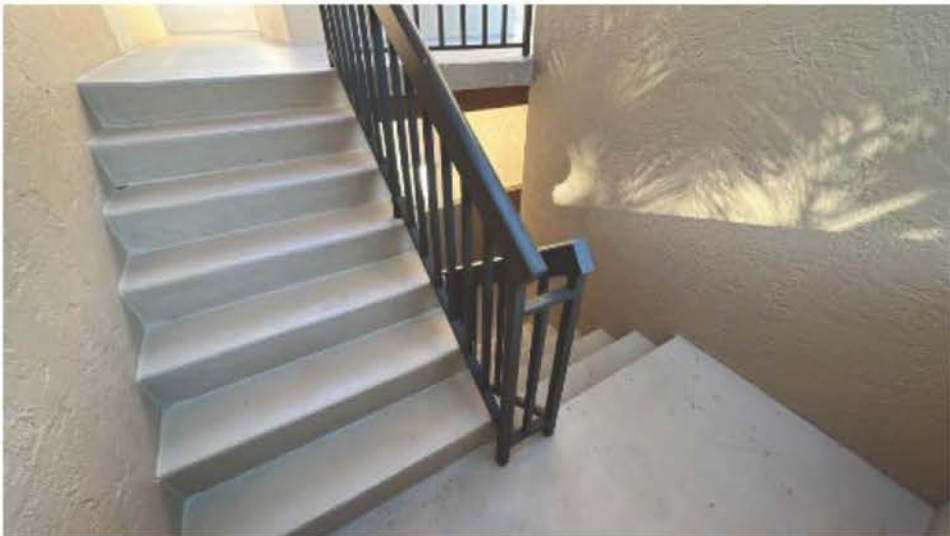
4.5. Cracks and spalls are present in the reinforced concrete, indicative of hidden concrete deterioration.

Picture 28: minor cracking along slab edge of third floor walkway
	Lat: 26.25313 Long: -81.81593 Bearing: W Date Taken: 10/06/2023 Weather: Sunny Taken By: Matthew Mullins Tags: N-592

- 6.6.1. Resecure loose guardrails. This should include securing the loose rail-to-wall connections, loose top rails, and re-setting the railing posts in the grout pockets.
- 6.6.2. Secure screen enclosures that have corroded anchors. This should include replacing screen enclosures on private balconies with corroded anchors, or at a minimum, replacing the corroded anchors.
- 6.6.3. Replace damaged wood beams between the windows of the master bathrooms.
- 6.6.4. Replace the damaged wood beams on the balconies supporting the roof.
- 6.6.5. Repair the deteriorated concrete at isolated locations in accordance with ICRI standards and guidelines.

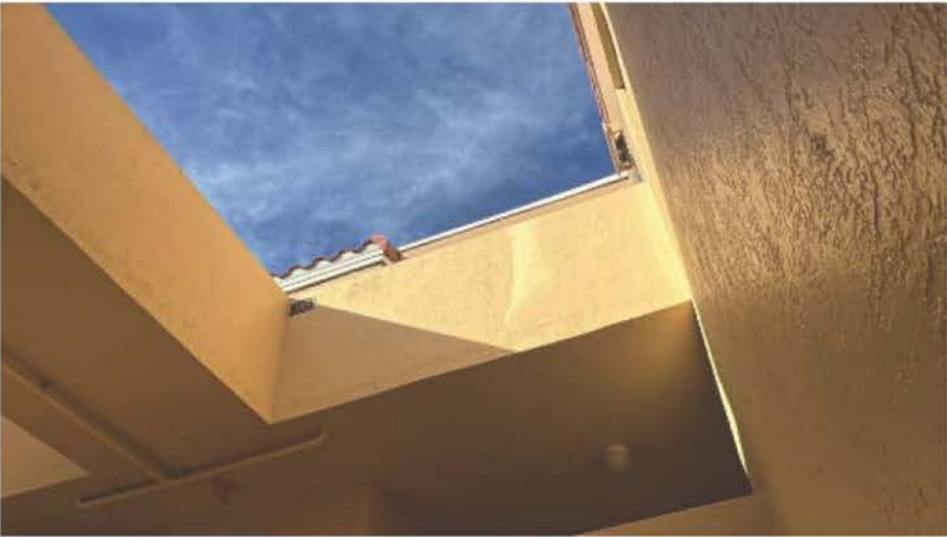
Picture 29: minor cracking along slab edge of third floor walkway
	Lat: 26.25314 Long: -81.81602 Bearing: SW Date Taken: 10/06/2023 Weather: Sunny Taken By: Matthew Mullins Tags: N-592

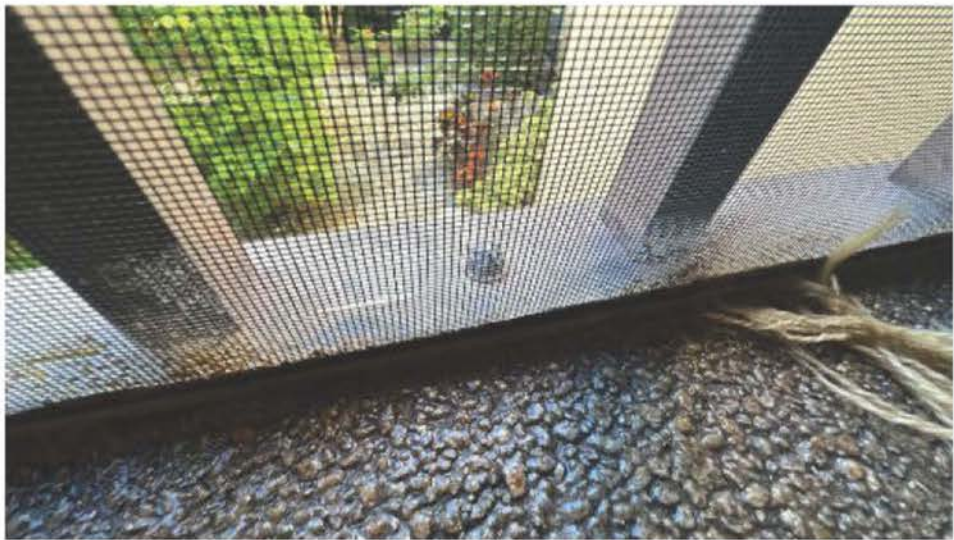
- 4.2. The anchors securing the screen enclosures are corroded.

<p>Picture 36: Screen enclosure anchors are corroded</p>
	<p>Lat: 26.25327</p> <p>Long: -81.81637</p> <p>Bearing: W</p> <p>Date Taken: 10/06/2023</p> <p>Weather: Sunny</p> <p>Taken By: Matthew Mullins</p> <p>Tags: 202 ,N-592</p>

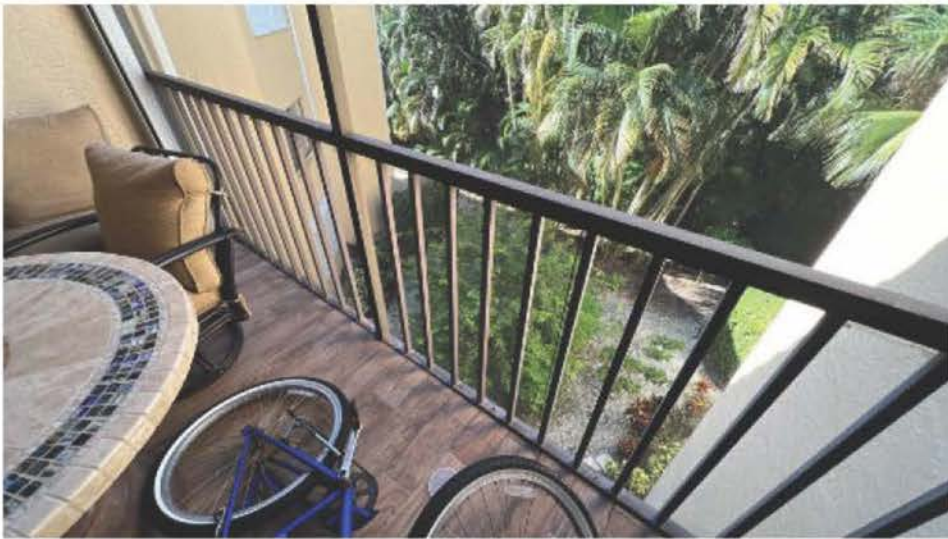
<p>Picture 39: Screen enclosure anchors are corroded</p>
	<p>Lat: 26.25336</p> <p>Long: -81.81629</p> <p>Bearing: SW</p> <p>Date Taken: 10/06/2023</p> <p>Weather: Sunny</p> <p>Taken By: Matthew Mullins</p> <p>Tags: 302 ,N-592</p>

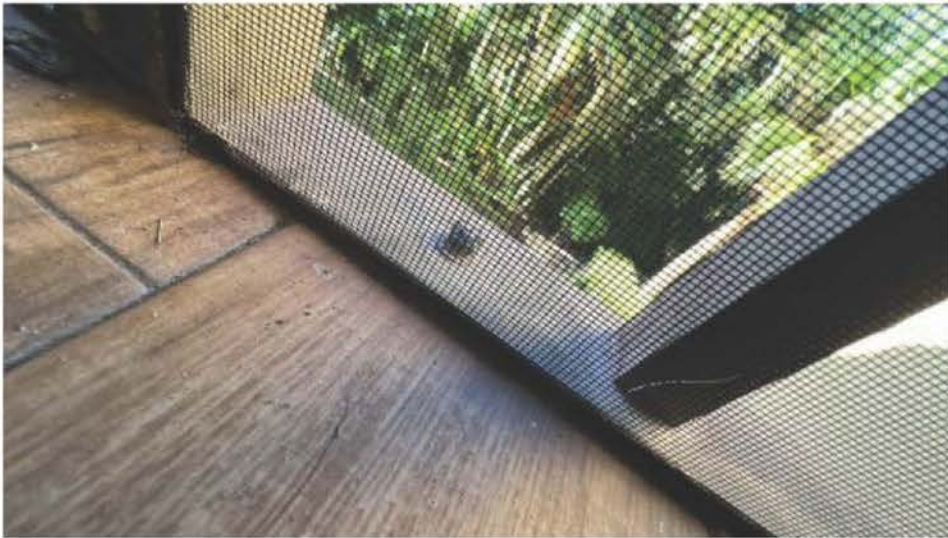
<p>Picture 40: Screen enclosure anchors are corroded</p>
	<p>Lat: 26.25335</p> <p>Long: -81.81629</p> <p>Bearing: SW</p> <p>Date Taken: 10/06/2023</p> <p>Weather: Sunny</p> <p>Taken By: Matthew Mullins</p> <p>Tags: 302 ,N-592</p>

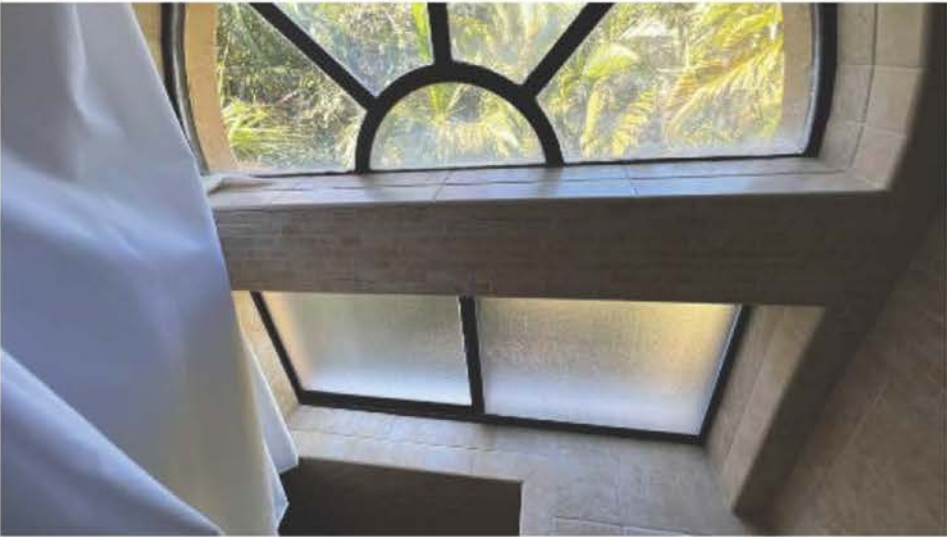
4.4. The finishes over the beam between the windows in the master bathroom are cracked, indicative of hidden wood frame damage.

Picture 41: Wood beam in bathroom appears to be damaged
	Lat: 26.25339 Long: -81.81635 Bearing: SW Date Taken: 10/06/2023 Weather: Sunny Taken By: Matthew Mullins Tags: 302 ,N-592

- 6.5.1. Remove the finishes and investigate the cause of cracking in the beams between the windows in the bathrooms. Based on our knowledge of previous similar repairs and the buildings' construction, these cracks are likely the result of damage to the structural wood beams.

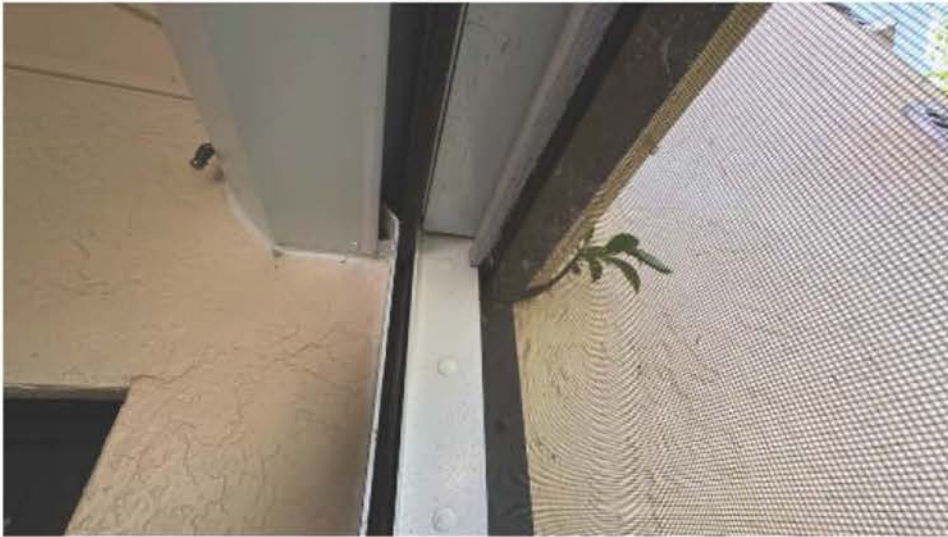
4.3. The wood beam supporting the roof trusses is damaged.

- 5.2. Strength losses during early stages of wood decay can be considerable. By the time weight losses resulting from decay have reached 10%, most strength losses may be expected to exceed 50%. At such weight losses (10% or less), decay is detectable only microscopically. It may be assumed that wood with visually discernible decay has been greatly reduced in all strength values<sup>1</sup>.

Picture 45: Plant is growing out of beam. Indicates damage to the beam
	Lat: 26.25348 Long: -81.81637 Bearing: S Date Taken: 10/06/2023 Weather: Sunny Taken By: Matthew Mullins Tags: 301 ,N-592

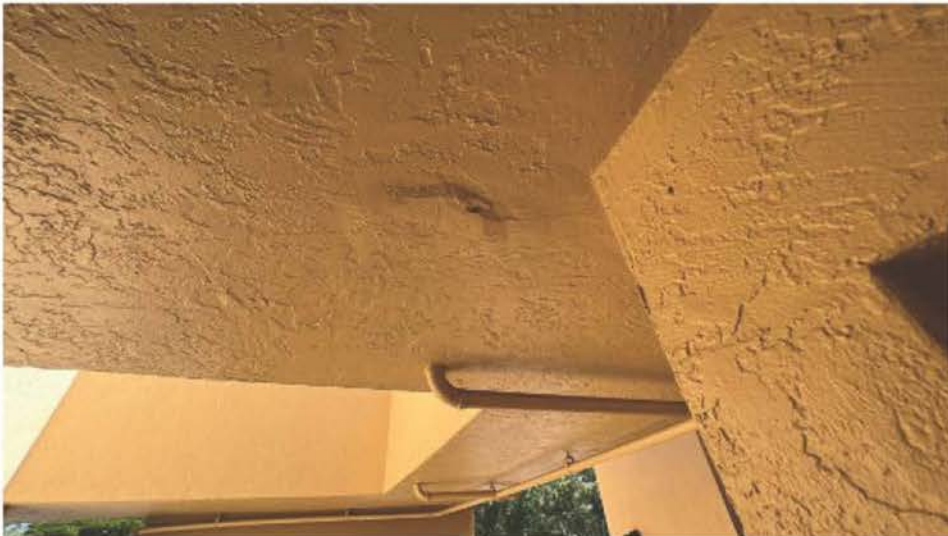
- 5.3. Concrete deterioration is caused by a variety of reasons, but the most common cause in coastal regions is corrosion of the reinforcing steel. [REDACTED]  
[REDACTED]  
[REDACTED]  
[REDACTED]  
[REDACTED]  
[REDACTED] Concrete deterioration will compromise the structural integrity of the building and will become substantial structural deterioration over time, if not addressed<sup>2</sup>.

Picture 46: Concrete spall outside 205
	Lat: 26.25312 Long: -81.81608 Bearing: E Date Taken: 10/06/2023 Weather: Sunny Taken By: Matthew Mullins Tags: N-592 ,205
