Regarding: Roof Moisture Survey
4.24-XXXX

Dynamic Engineering Design & Inspection (Dynamic) recently performed a Infrared Roof Moisture Survey at Condo at your request for [REDACTED] This report includes the results of our survey.

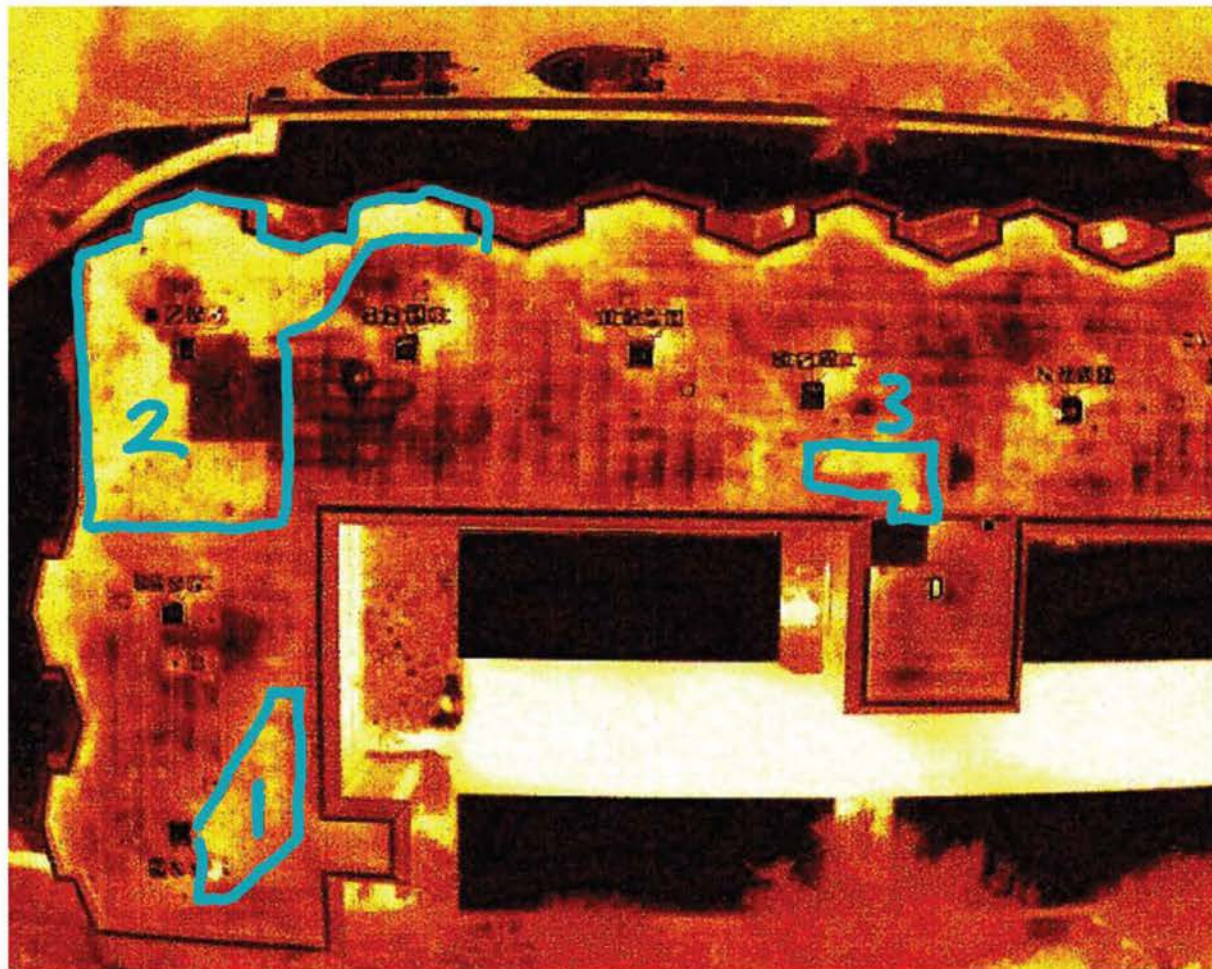
Picture 3: Thermogram of [REDACTED] Thermal anomalies consistent with wet insulation outlined in blue.
1: Approximately 86 sf.
2: Approximately 1,560 sf.
3: Approximately 86 sf.

1. remove the existing roof covering entirely, or only at areas with wet LWIC
2. replace all damaged LWIC
3. remediate (dry or replace) all wet LWIC
4. Install a new roof covering with an applicable Florida Product Approval, complete with flashings.

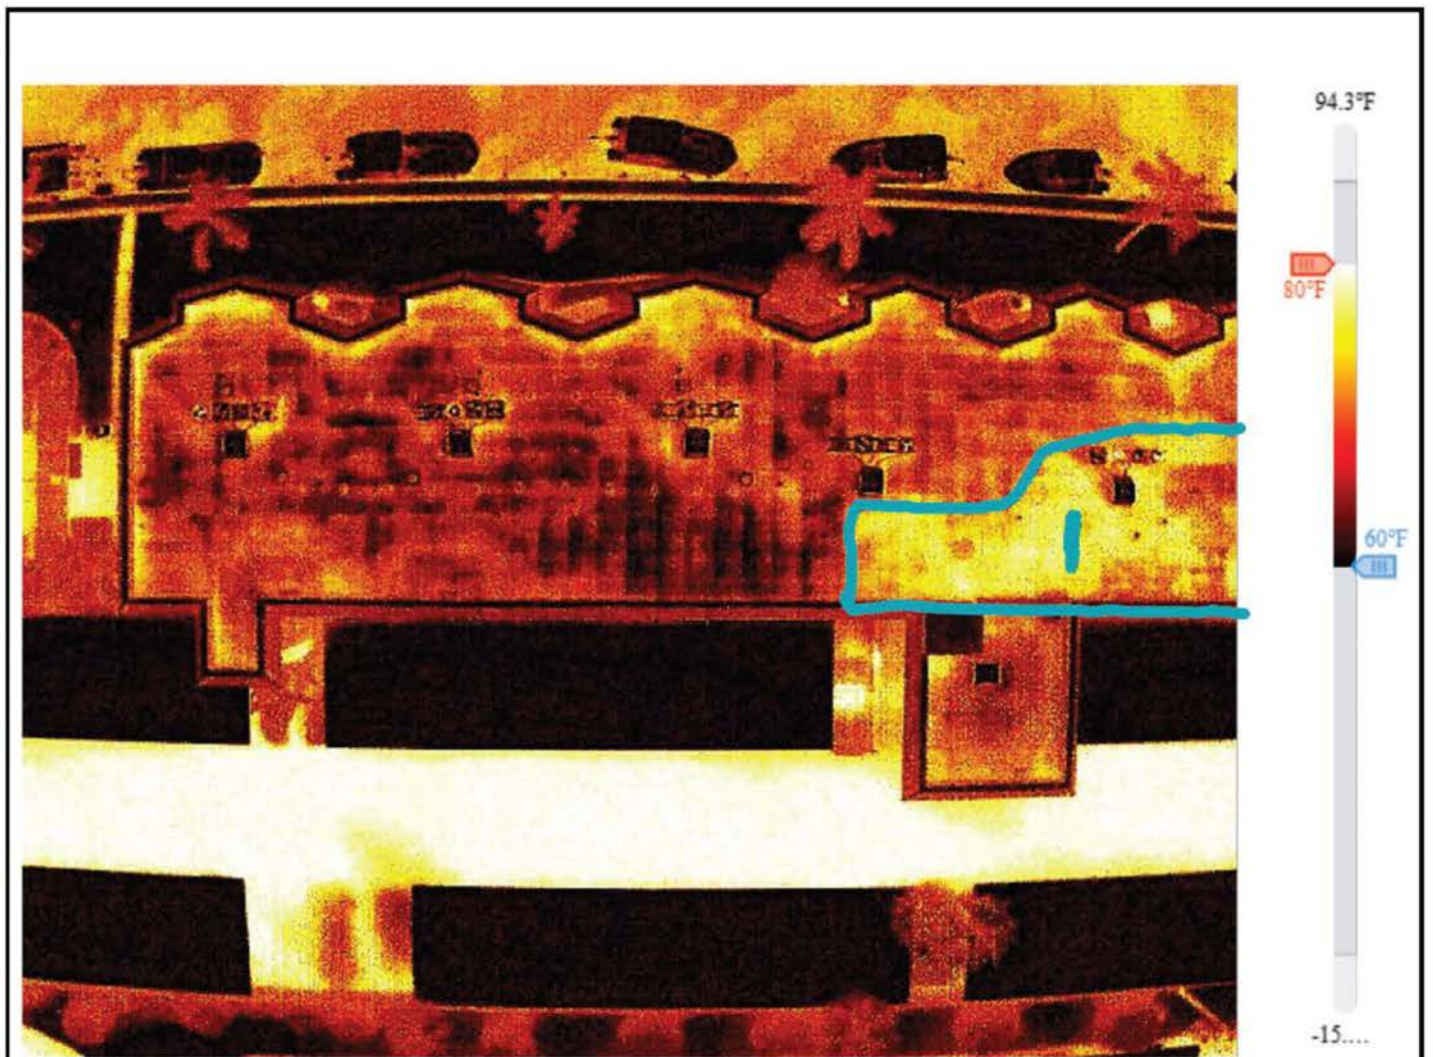
Picture 6: Thermogram of The [REDACTED] Thermal anomalies consistent with wet insulation outlined in blue.
1: Approximately 1,205 sf.

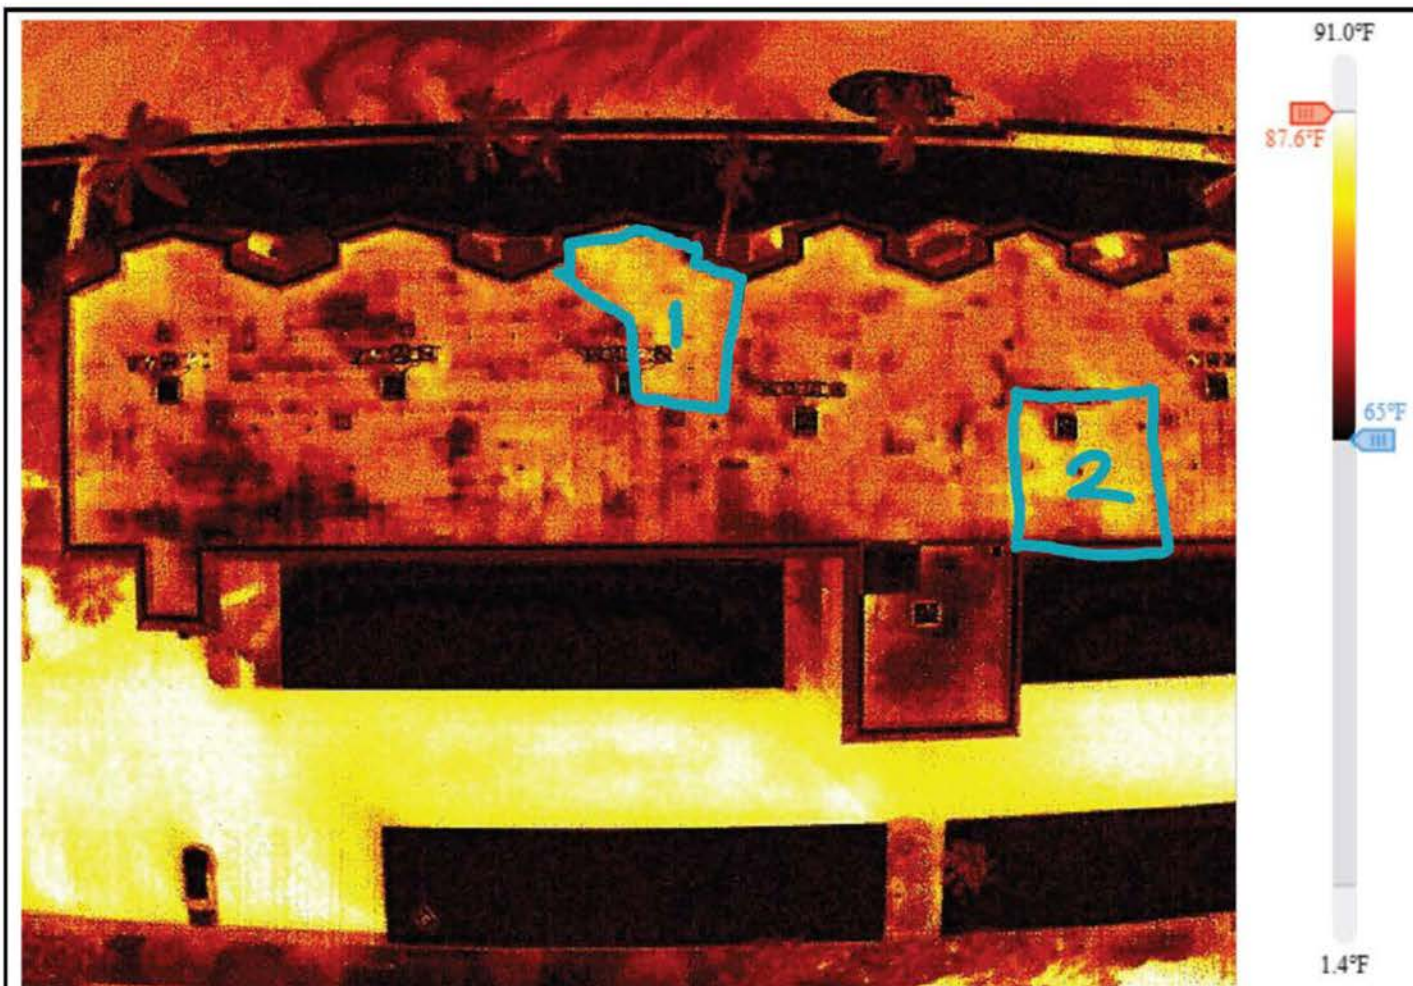
Picture 9: Thermogram of [REDACTED] Thermal anomalies consistent with wet insulation outlined in blue.

1: Approximately 326 sf.

2: Approximately 278 sf.

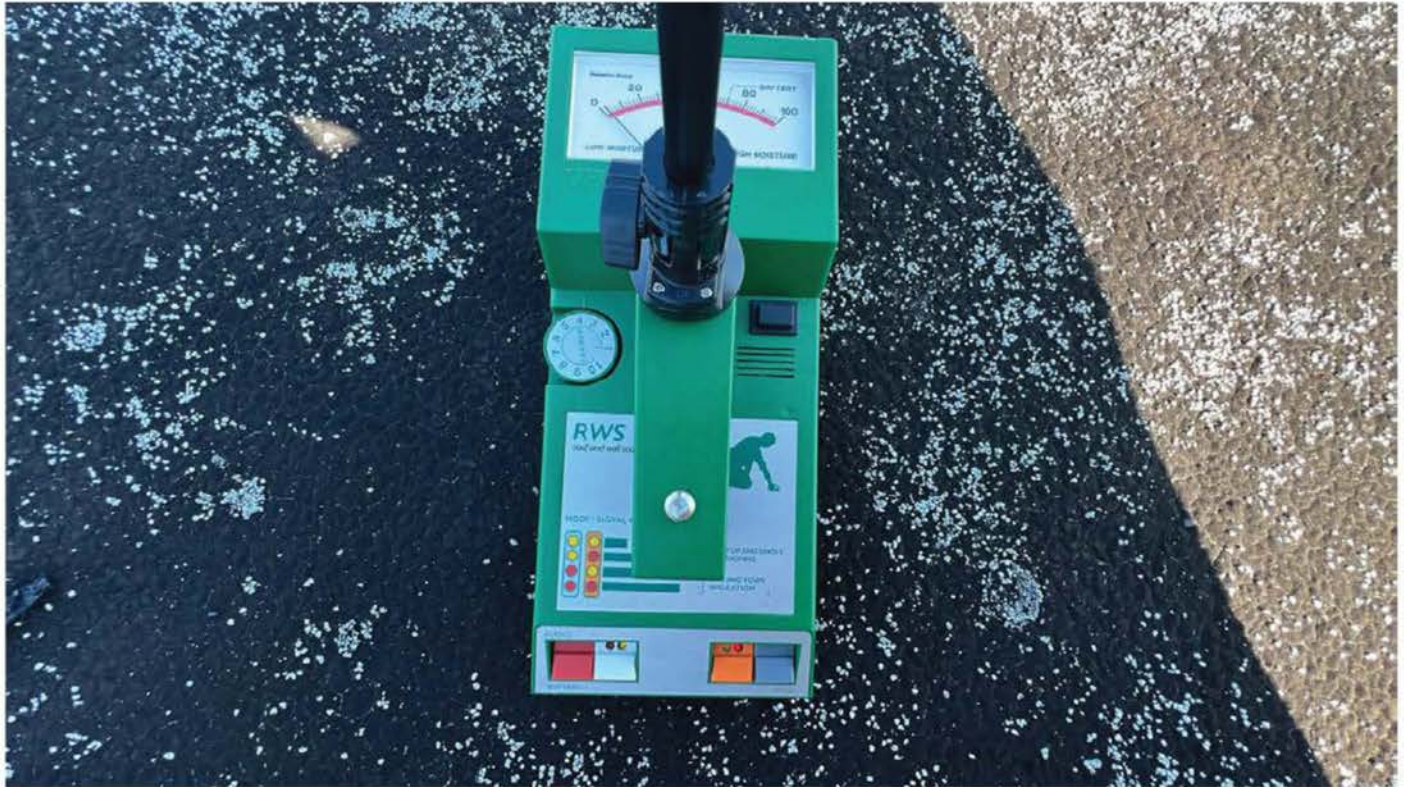
Picture 19: Dry insulation corroboration on The [REDACTED]

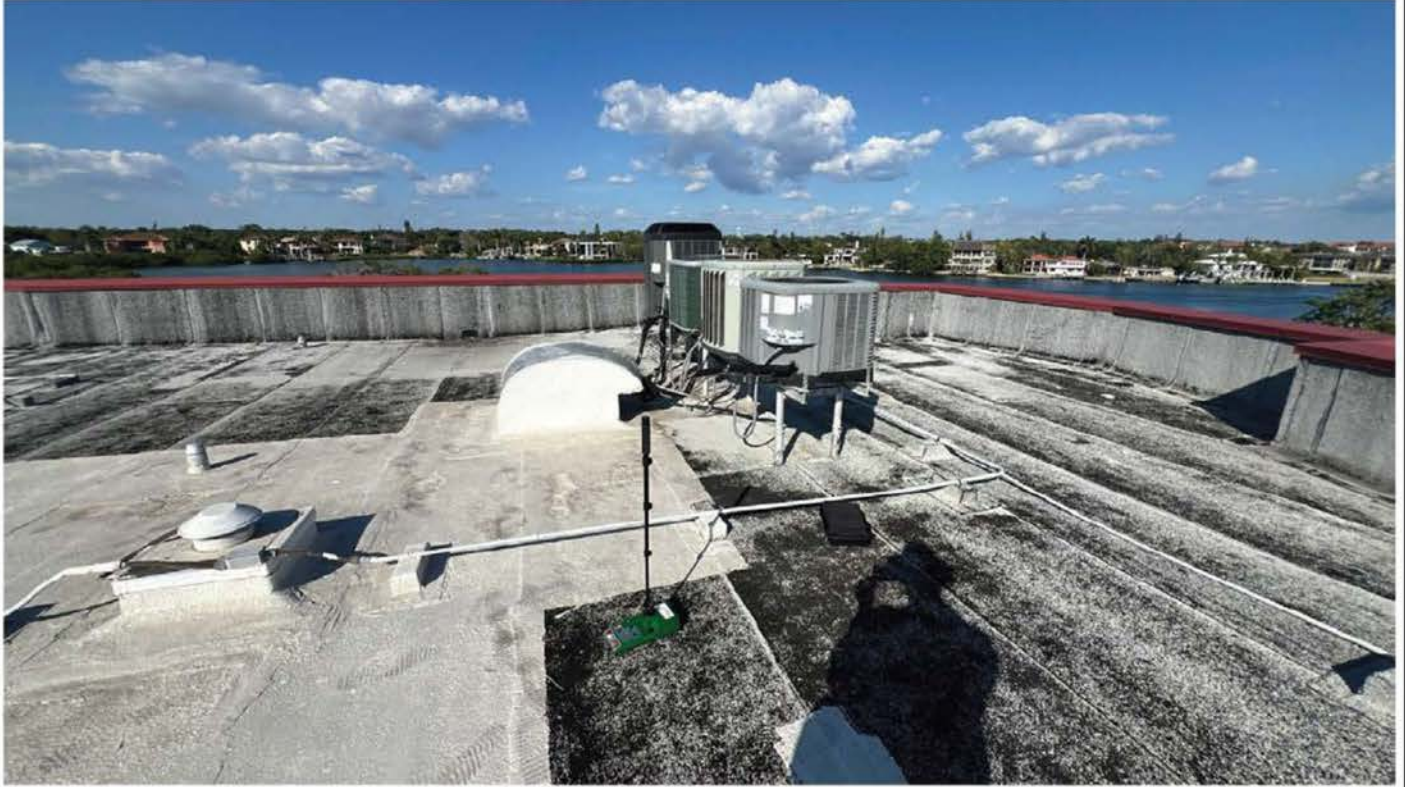
Picture 20: Wet insulation corroboration on The [REDACTED]
