PHASE I MILESTONE  
INSPECTION REPORT

**Property:** Condominium  
23-XXXX  
123 Main St  
Florida, FL 34205

**Regarding:** Phase I Milestone Inspection

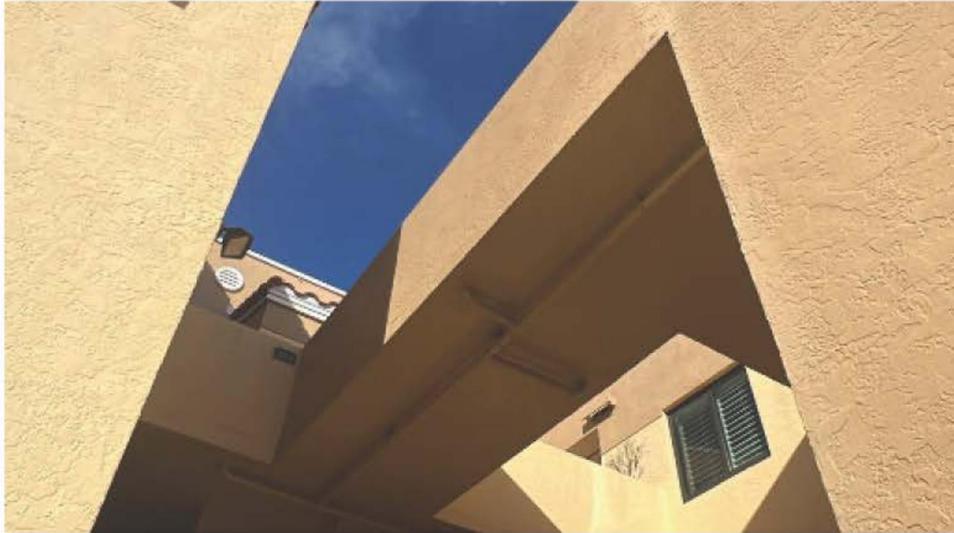
4.5. Cracks and spalls are present in the reinforced concrete, indicative of hidden concrete deterioration.

<p>Picture 28: minor cracking along slab edge of third floor walkway</p> <p>Lat: 26.25313          Long: -81.81593          Bearing: W          Date Taken: 10/06/2023          Weather: Sunny          Taken By: Matthew Mullins          Tags: N-592</p>
---	--

- 6.6.1. Resecure loose guardrails. This should include securing the loose rail-to-wall connections, loose top rails, and re-setting the railing posts in the grout pockets.
- 6.6.2. Secure screen enclosures that have corroded anchors. This should include replacing screen enclosures on private balconies with corroded anchors, or at a minimum, replacing the corroded anchors.
- 6.6.3. Replace damaged wood beams between the windows of the master bathrooms.
- 6.6.4. Replace the damaged wood beams on the balconies supporting the roof.
- 6.6.5. Repair the deteriorated concrete at isolated locations in accordance with ICRI standards and guidelines.

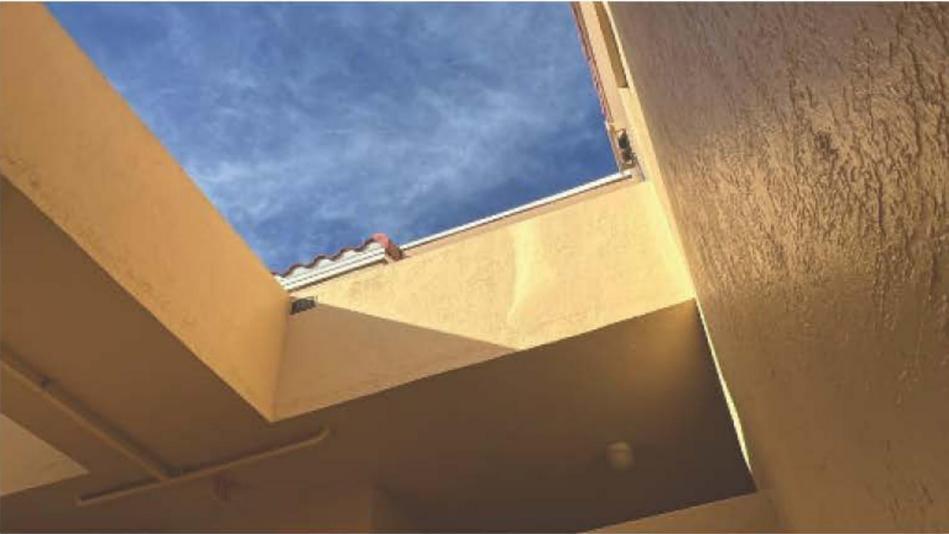
<p>Picture 29: minor cracking along slab edge of third floor walkway</p>
	<p>Lat: 26.25314          Long: -81.81602          Bearing: SW          Date Taken: 10/06/2023          Weather: Sunny          Taken By: Matthew Mullins          Tags: N-592</p>

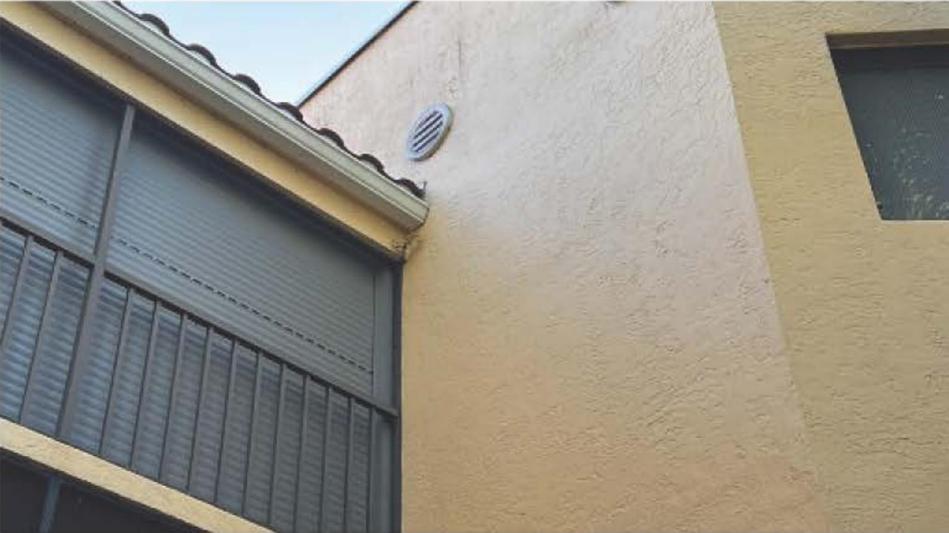
4.3. The wood beam supporting the roof trusses is damaged.

<p>Picture 30: plant growing from header beam</p>
	<p>Lat: 26.25346          Long: -81.81638          Bearing: SE          Date Taken: 10/06/2023          Weather: Sunny          Taken By: Matthew Mullins          Tags: N-592 ,301</p>

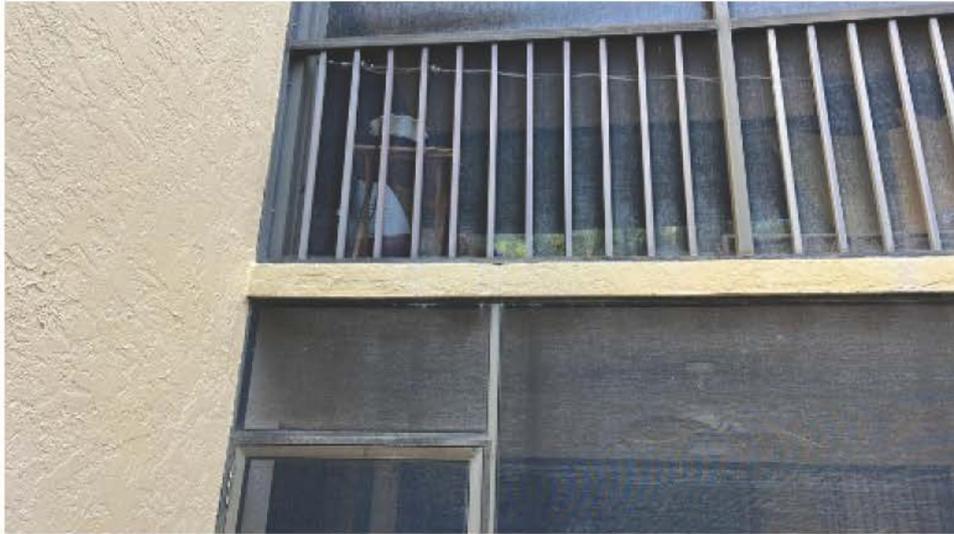
<p>Picture 31: Crack in slab edge</p> <p>Lat: 26.25334          Long: -81.81633          Bearing: NE          Date Taken: 10/06/2023          Weather: Sunny          Taken By: Matthew Mullins          Tags: N-592 ,202</p>
---	---

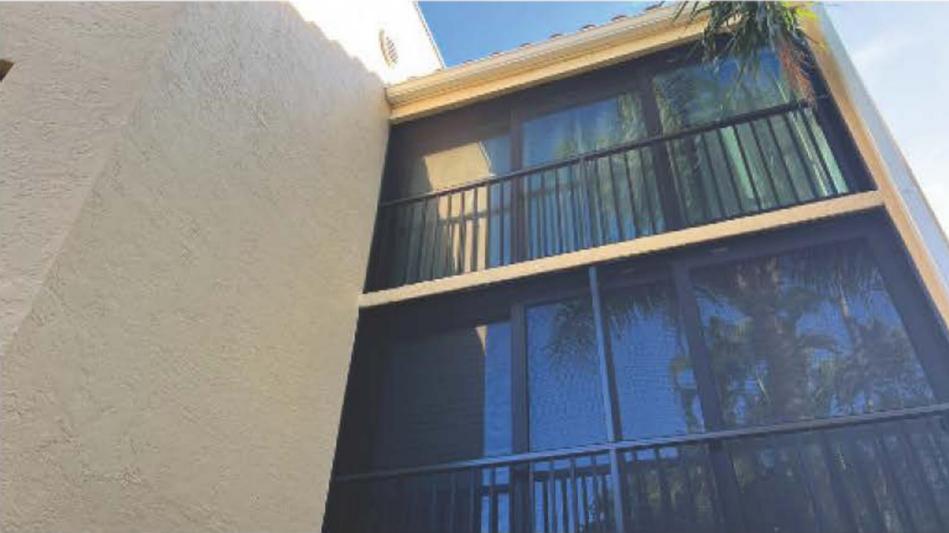
<p>Picture 34: crack in slab edge</p>
	<p>Lat: 26.25302          Long: -81.81614          Bearing: NE          Date Taken: 10/06/2023          Weather: Sunny          Taken By: Matthew Mullins          Tags: N-592 ,306</p>

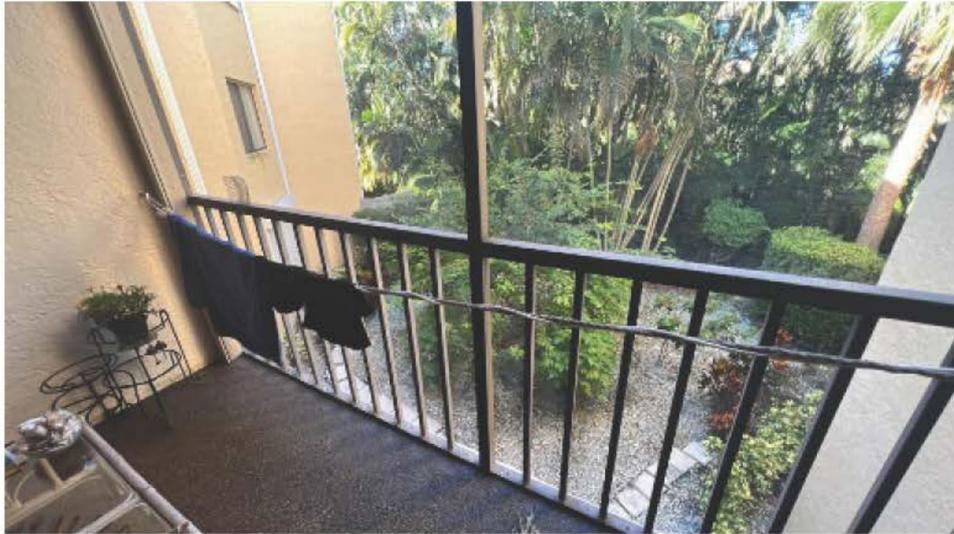
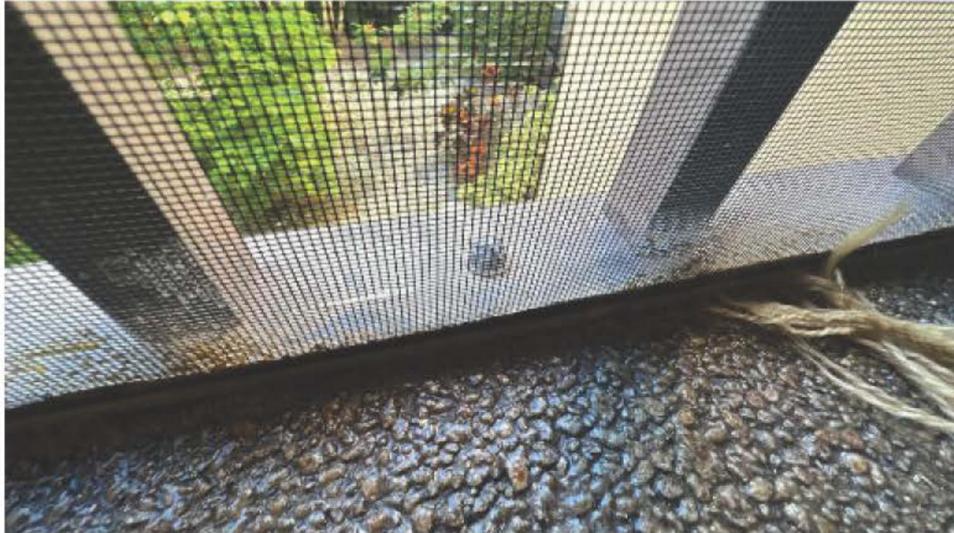
- 4.2. The anchors securing the screen enclosures are corroded.

- 5.1. Guards provide fall protection for occupants along elevated walking surfaces. Loose connections, corroded anchors, and other structural deficiencies reduce the ability of the guardrail to resist loads and provide protection.

<p>Picture 35: Screen enclosure anchors are corroded</p> <p>Lat: 26.25328          Long: -81.81642          Bearing: SW          Date Taken: 10/06/2023          Weather: Sunny          Taken By: Matthew Mullins          Tags: 202 ,N-592</p>
---	--

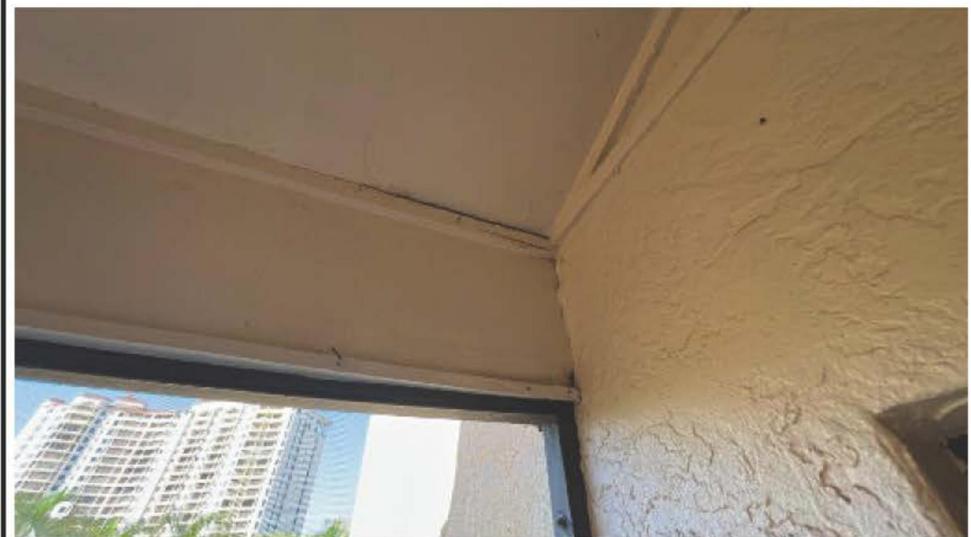
- 5.2. Strength losses during early stages of wood decay can be considerable. By the time weight losses resulting from decay have reached 10%, most strength losses may be expected to exceed 50%. At such weight losses (10% or less), decay is detectable only microscopically. It may be assumed that wood with visually discernible decay has been greatly reduced in all strength values<sup>1</sup>.

<p>Picture 37: Wood beam is damaged</p> <p>Lat: 26.25322          Long: -81.81615          Bearing: W          Date Taken: 10/06/2023          Weather: Sunny          Taken By: Matthew Mullins          Tags: 304 , N-592</p>
---	---

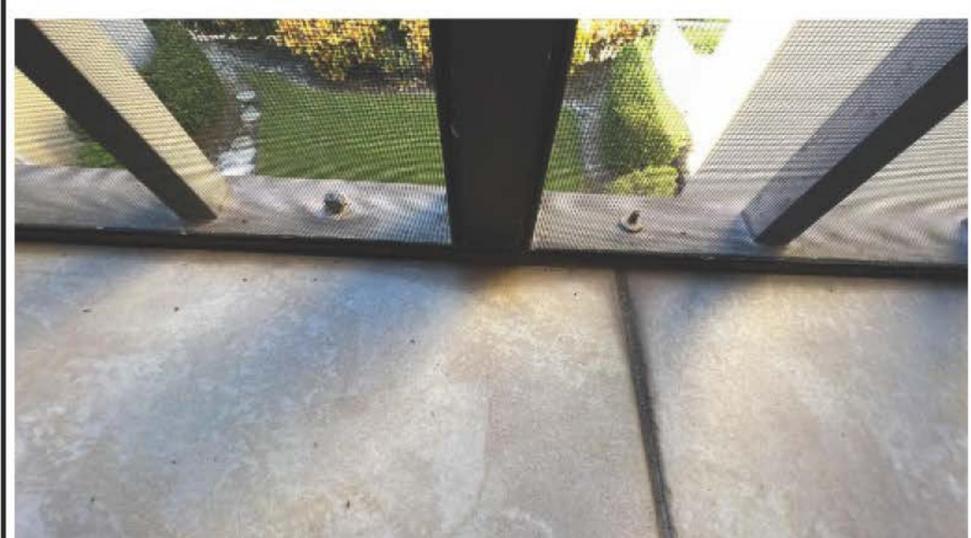
<p>Picture 38: Screen enclosure anchors are corroded</p> <p>Lat: 26.25318          Long: -81.81618          Bearing: W          Date Taken: 10/06/2023          Weather: Sunny          Taken By: Matthew Mullins          Tags: 304 , N-592</p>
---	--

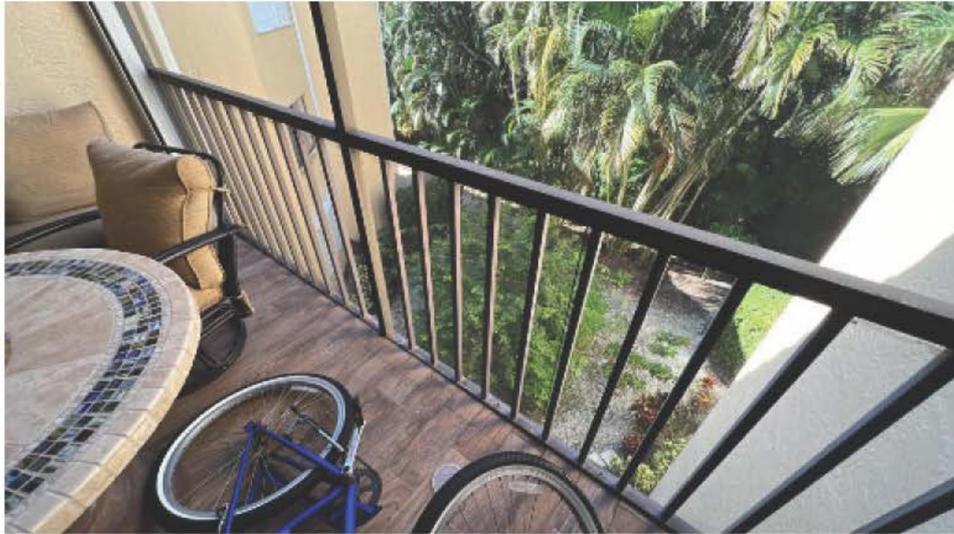
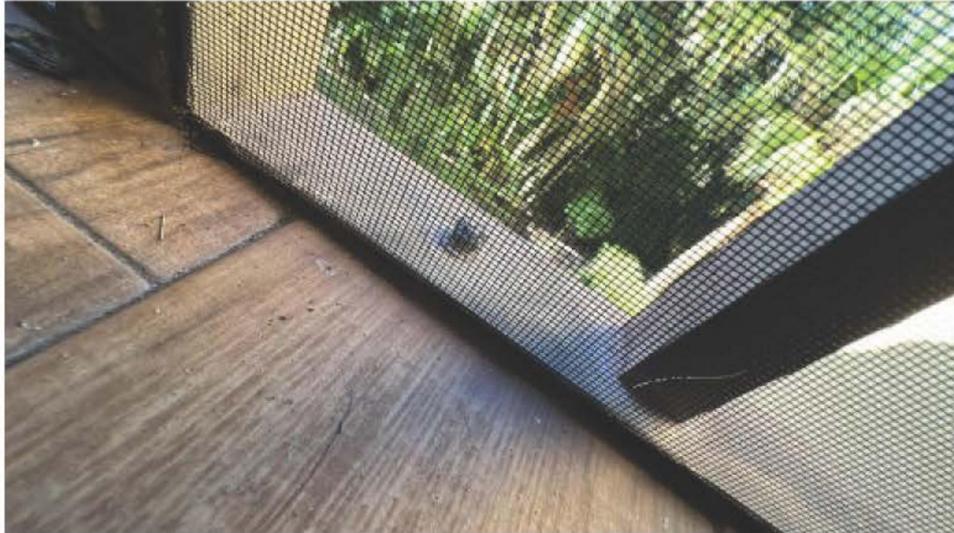
<p>Picture 39: Screen enclosure anchors are corroded</p> <p>Lat: 26.25336          Long: -81.81629          Bearing: SW          Date Taken: 10/06/2023          Weather: Sunny          Taken By: Matthew Mullins          Tags: 302 ,N-592</p>
---	--

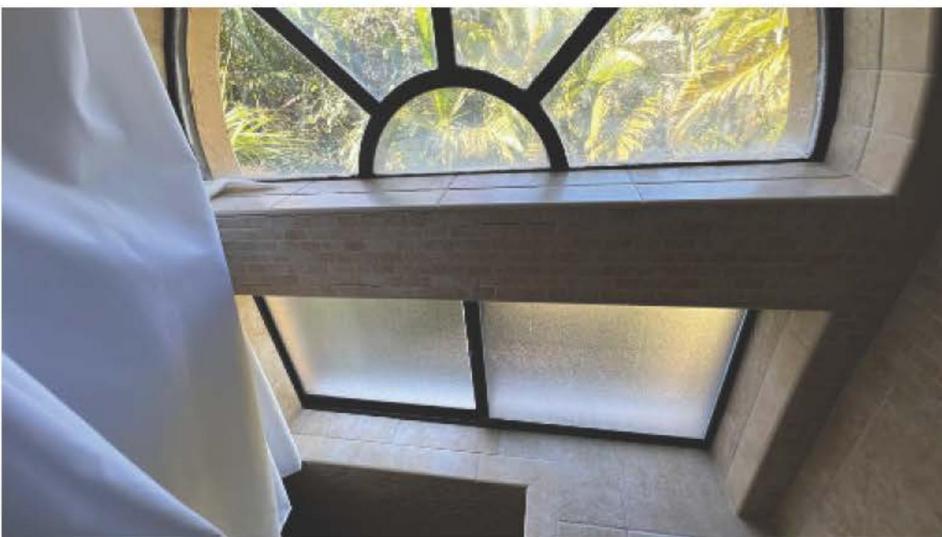
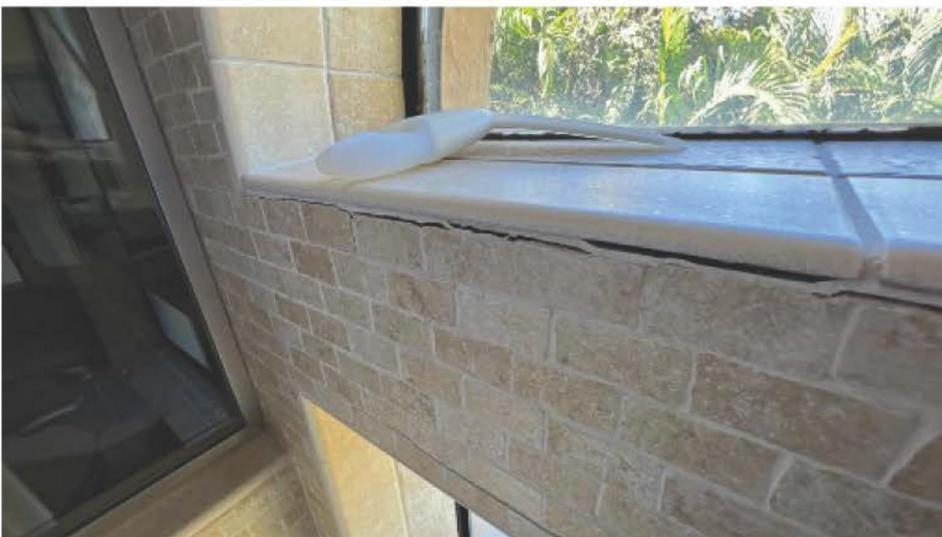
4.4. The finishes over the beam between the windows in the master bathroom are cracked, indicative of hidden wood frame damage.

<p>Picture 41: Wood beam in bathroom appears to be damaged</p> <p>Lat: 26.25339          Long: -81.81635          Bearing: SW          Date Taken: 10/06/2023          Weather: Sunny          Taken By: Matthew Mullins          Tags: 302 , N-592</p>
---	---

- 6.5.1. Remove the finishes and investigate the cause of cracking in the beams between the windows in the bathrooms. Based on our knowledge of previous similar repairs and the buildings' construction, these cracks are likely the result of damage to the structural wood beams.

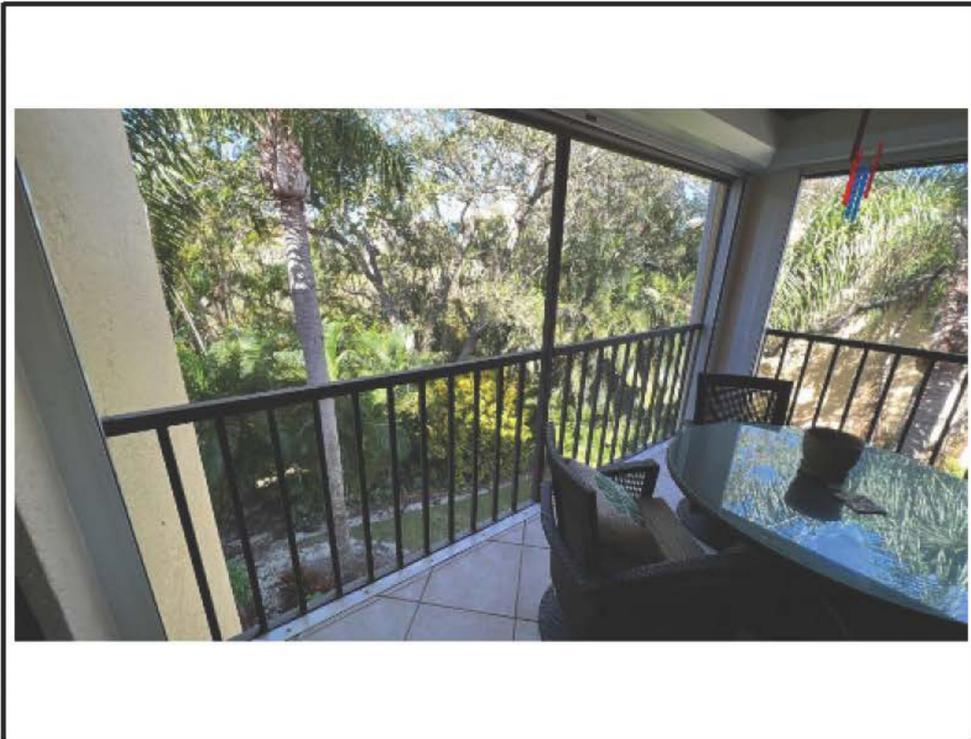
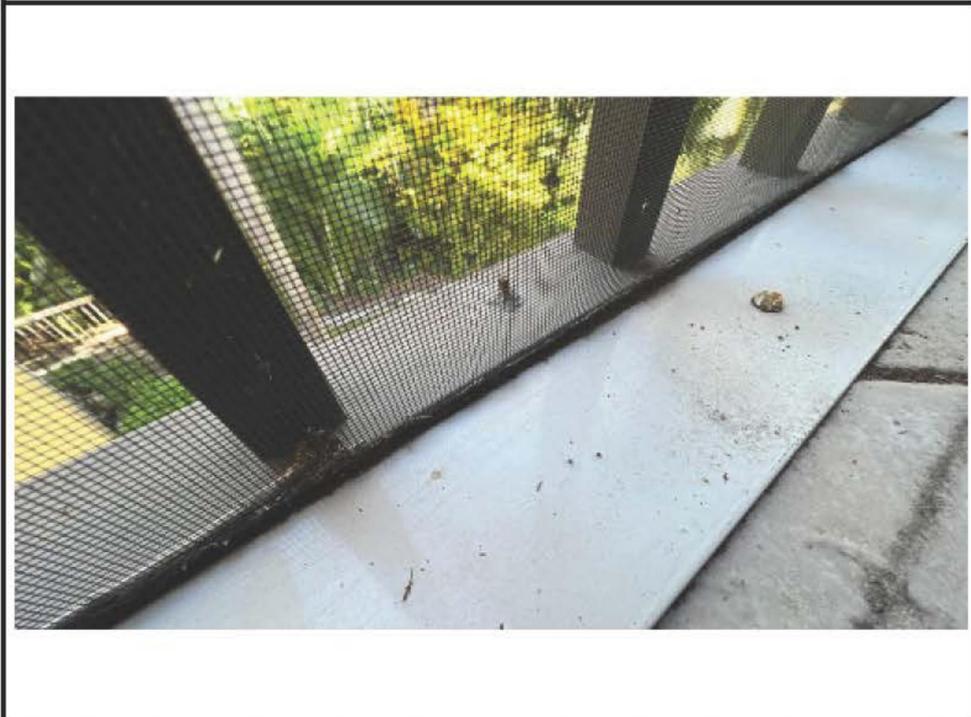
Picture 43: screen enclosure fasteners are corroded.

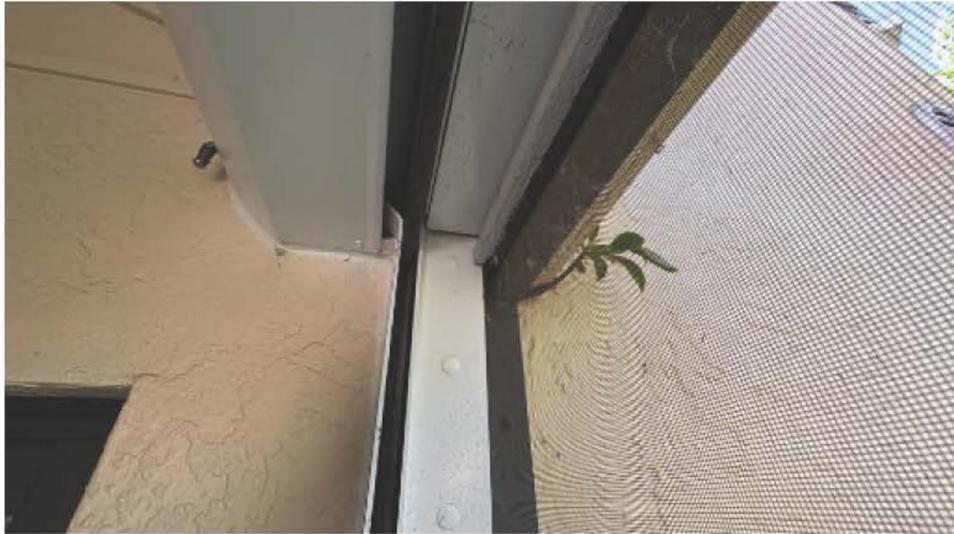
<p>Picture 45: Plant is growing out of beam. Indicates damage to the beam</p> <p>Lat: 26.25348          Long: -81.81637          Bearing: S          Date Taken: 10/06/2023          Weather: Sunny          Taken By: Matthew Mullins          Tags: 301 ,N-592</p>
---	--

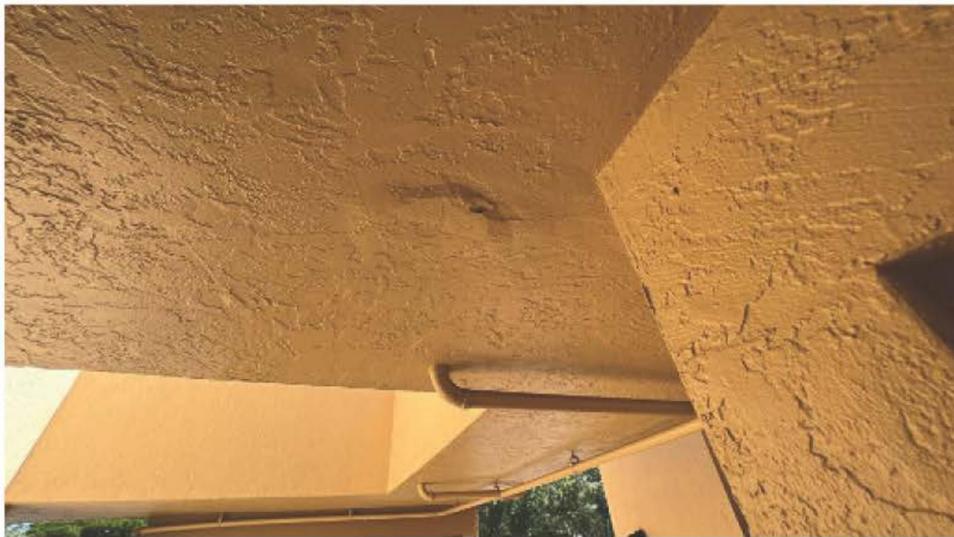
- 5.3. Concrete deterioration is caused by a variety of reasons, but the most common cause in coastal regions is corrosion of the reinforcing steel. [REDACTED]  
[REDACTED]  
[REDACTED]  
[REDACTED]  
[REDACTED] Concrete deterioration will compromise the structural integrity of the building and will become substantial structural deterioration over time, if not addressed<sup>2</sup>.

<p>Picture 46: Concrete spall outside 205</p> <p>Lat: 26.25312          Long: -81.81608          Bearing: E          Date Taken: 10/06/2023          Weather: Sunny          Taken By: Matthew Mullins          Tags: N-592 ,205</p>
---	--
