[REDACTED] Condominium Association, Inc.

Regarding: [REDACTED] Condominium Structural Assessment
4.24-[REDACTED]

1. Purpose and Scope

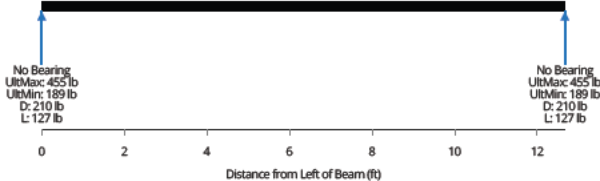
Client:		Date:	Jun 28, 2024
Author:	Matthew Mullins	Job #:	4,24
Project:		Subject:	Drop Beam - Original Conditions
References:	ACI 318-19

FAIL

55%	Positive Moment Capacity	$\phi M_n^+ = 2640 \text{ lb} \cdot \text{ft}$
38%	Shear Capacity	$\phi V_n = 1200 \text{ lb}$
51%	Critical Live / Short-Term Deflection	$\delta_{ST} = -0.215 \text{ in}$
	Critical Live / Short-Term Deflection Ratio	$(L/)\delta_{ST} = 707$
180%	Critical Long-Term Deflection	$\delta_{LT} = -1.14 \text{ in}$
	Critical Long-Term Deflection Ratio	$(L/)\delta_{LT} = 133$

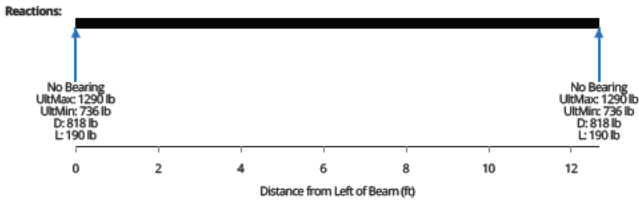
Client:		Date:	Jun 28, 2024
Author:	Matthew Mullins	Job #:	
Project:		Subject:	Drop Beam - with Sliding Glass Door FAIL
References:	ACI 318-19

154%	Positive Moment Capacity	$\phi M_n^+ = 2640 \text{ lb} \cdot \text{ft}$
107%	Shear Capacity	$\phi V_n = 1200 \text{ lb}$
104%	Critical Live / Short-Term Deflection	$\delta_{ST} = -0.437 \text{ in}$
	Critical Live / Short-Term Deflection Ratio	$(L/\delta)_{ST} = 348$
732%	Critical Long-Term Deflection	$\delta_{LT} = -4.64 \text{ in}$
	Critical Long-Term Deflection Ratio	$(L/\delta)_{LT} = 32.8$
