# SAMPLE CLIENT

PHASE I MILESTONE  
INSPECTION REPORT

**Regarding:** Phase I Milestone Inspection

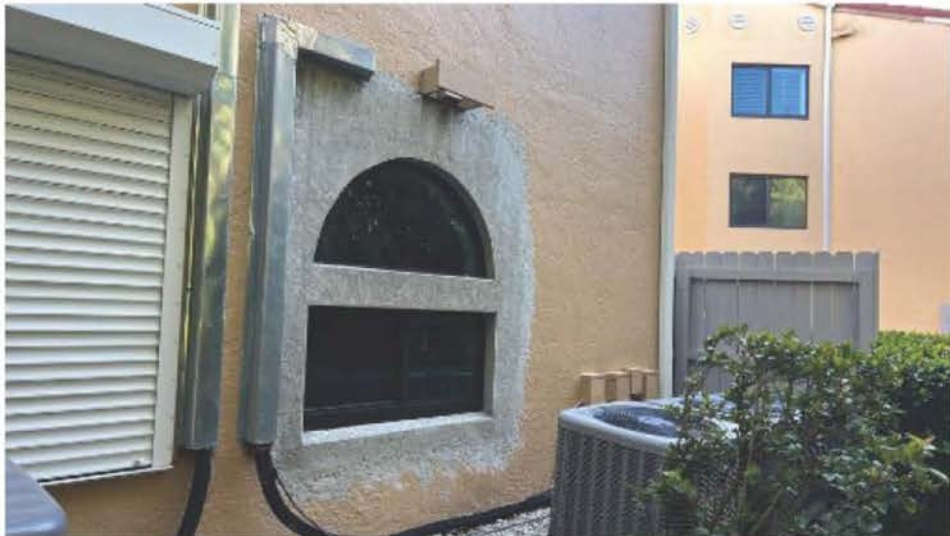
Picture 32: Window replaced. New Stucco
	Lat: 26.25324 Long: -81.81635 Bearing: SE Date Taken: 10/06/2023 Weather: Sunny Taken By: Matthew Mullins Tags: N-592 ,103
