PHASE I MILESTONE  
INSPECTION REPORT

**Property:** Condominium  
23-XXXX  
123 Main St  
Florida, FL 34205

**Regarding:** Phase I Milestone Inspection

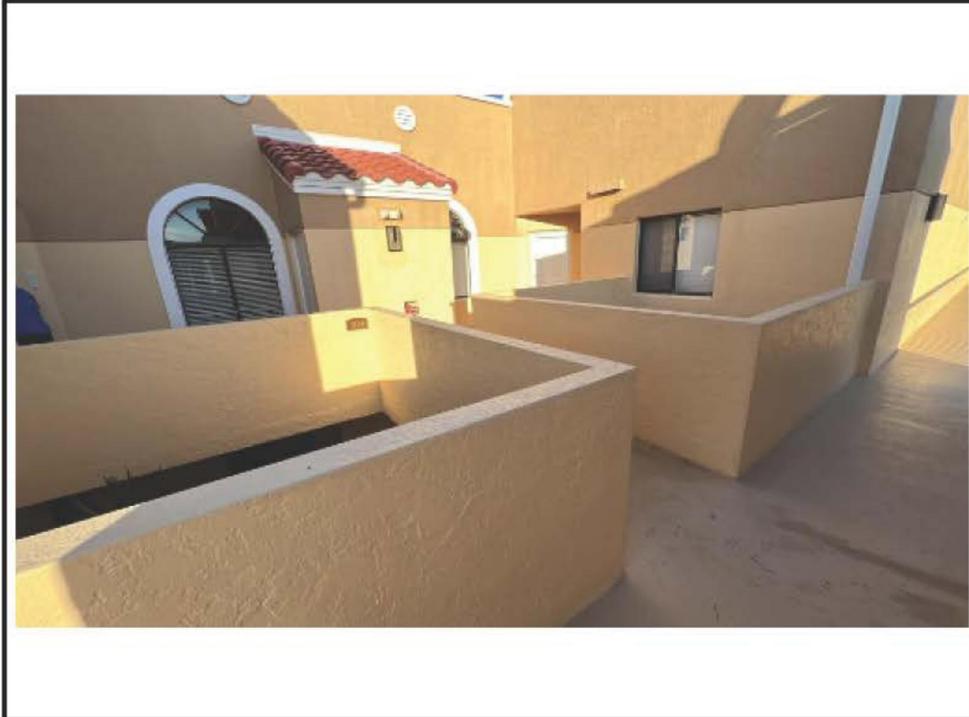
Picture 26: Typical third floor walkway overview

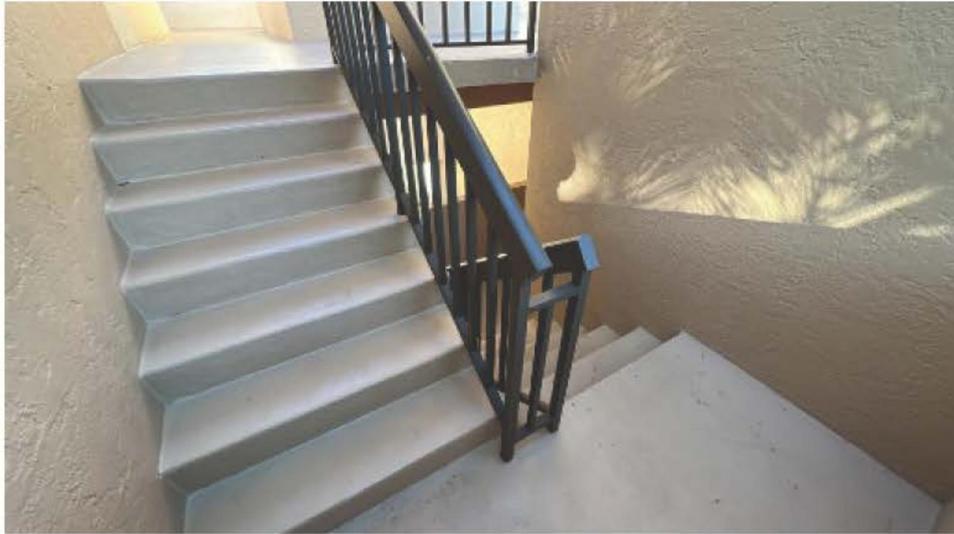
<p>Picture 27: Typical stair, landing and railing</p> <p>Lat: 26.25341          Long: -81.81566          Bearing: W          Date Taken: 10/06/2023          Weather: Mist          Taken By: Matthew Mullins          Tags: N-592</p>
---	--

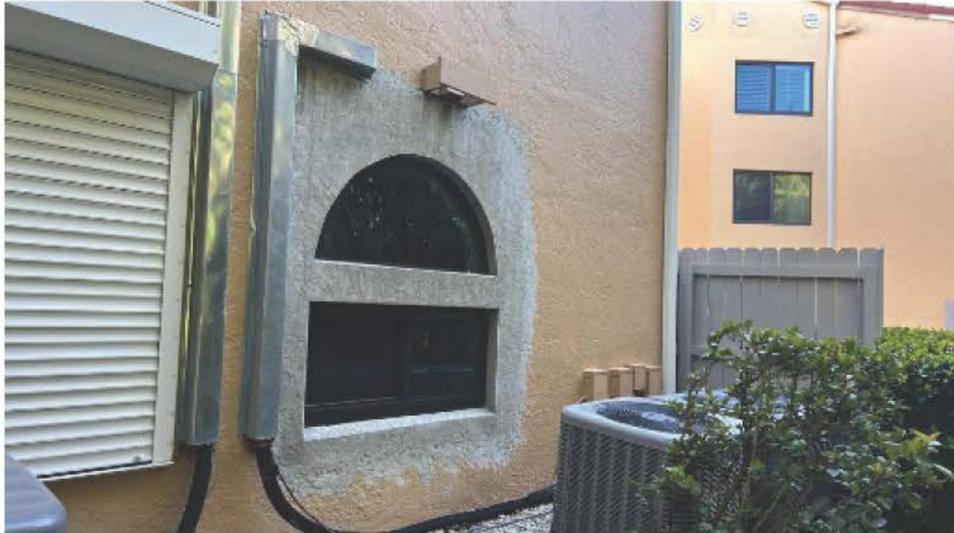
<p>Picture 32: Window replaced. New Stucco</p> <p>Lat: 26.25324          Long: -81.81635          Bearing: SE          Date Taken: 10/06/2023          Weather: Sunny          Taken By: Matthew Mullins          Tags: N-592 ,103</p>
---	--

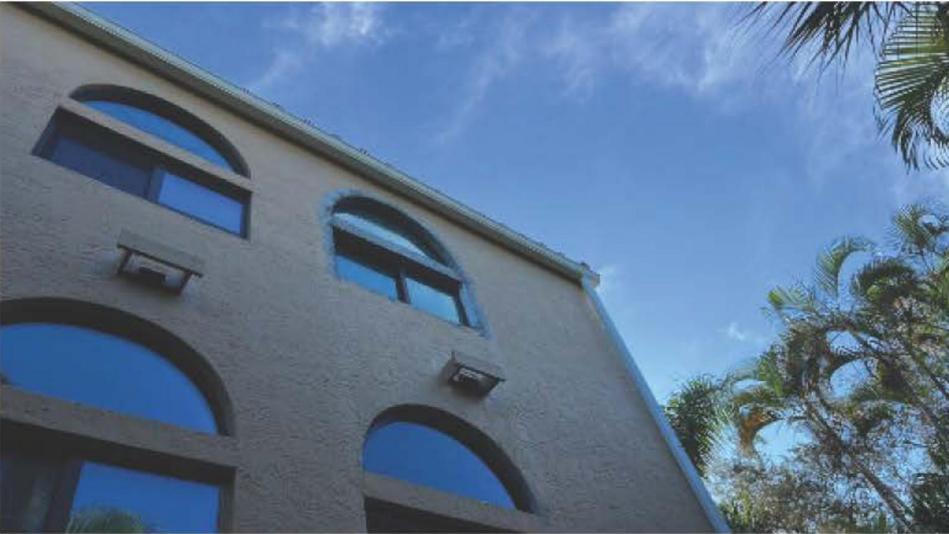
<p>Picture 33: Window replaced. New Stucco</p>
	<p>Lat: 26.25309          Long: -81.81625          Bearing: E          Date Taken: 10/06/2023          Weather: Sunny          Taken By: Matthew Mullins          Tags: N-592 ,303</p>
