# SAMPLE REPORT

## EXTERIOR WALL CONDITION ASSESSMENT REPORT

May 12, 2024

**Regarding:** Exterior Wall Condition Assessment

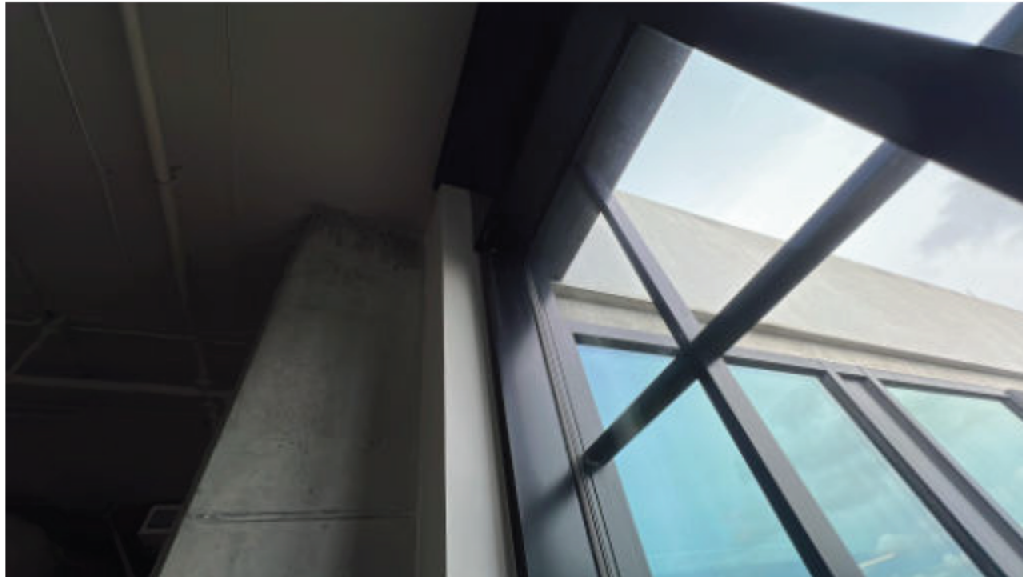
Picture 2: Outside 622/625. Evidence of water intrusion

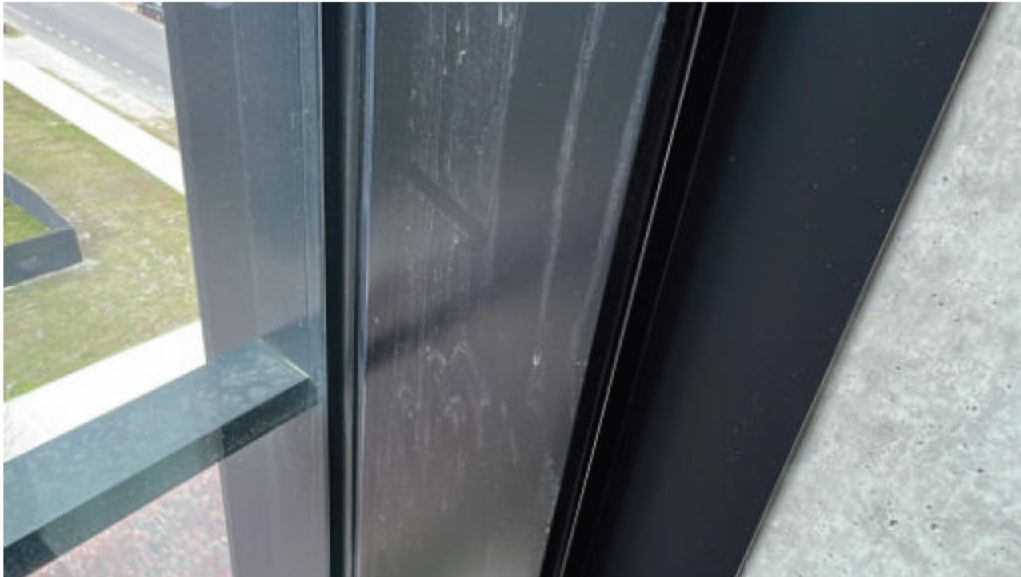
Picture 24: Common area, south elevation. Evidence of water intrusion

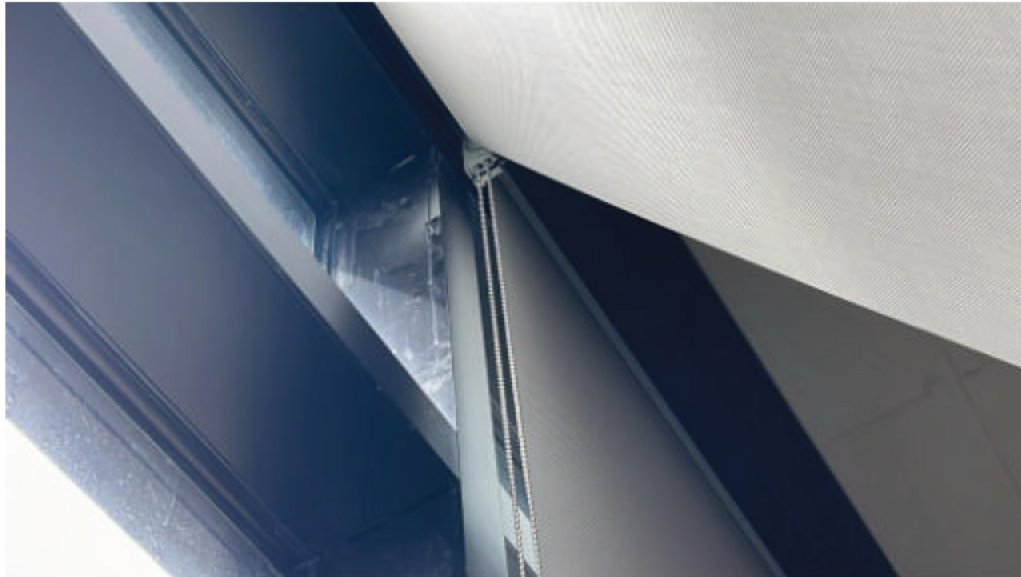
Picture 30: Common area, south elevation. Evidence of water intrusion

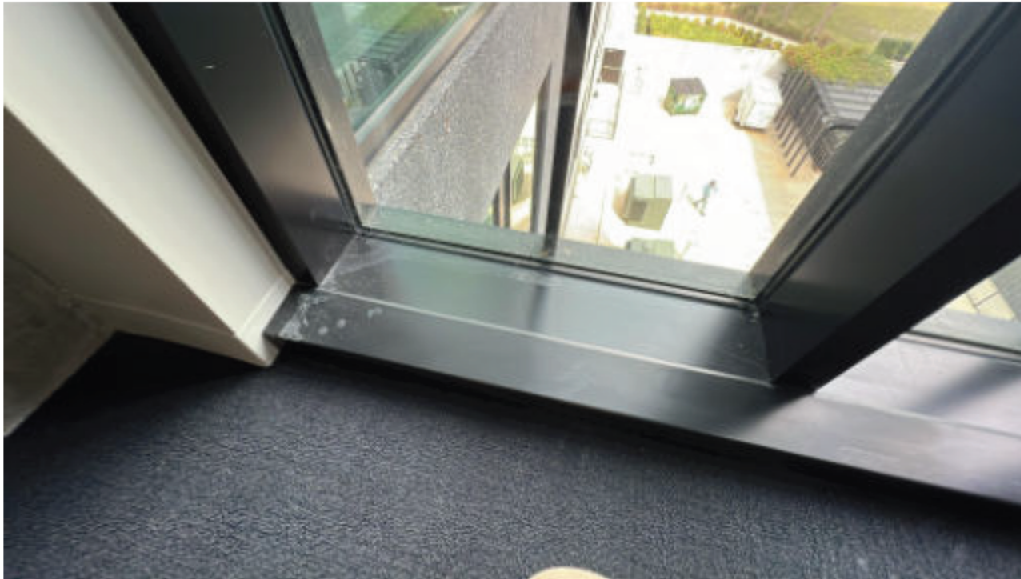
Picture 76: North Elevation.  
Evidence of water intrusion

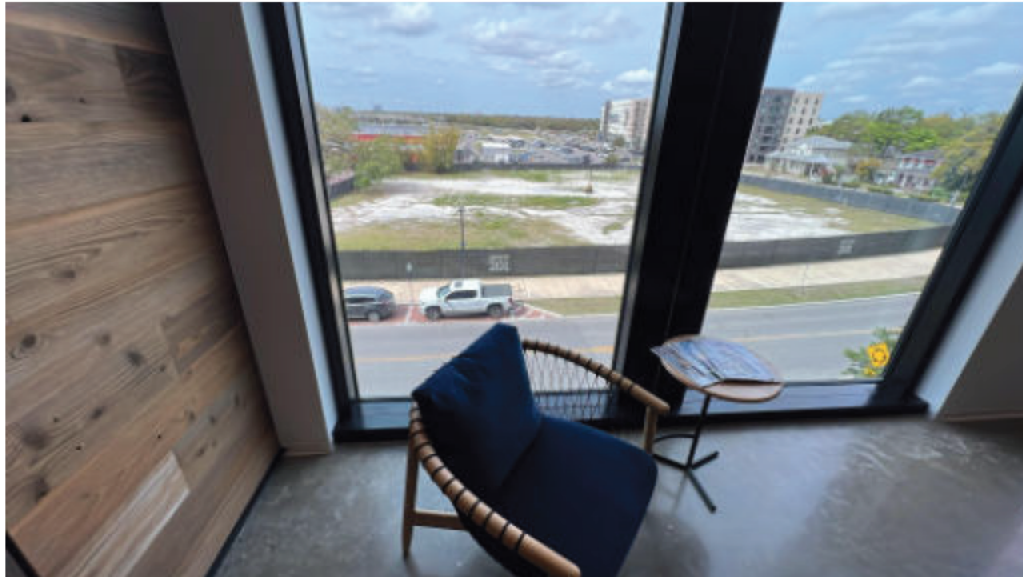
Picture 90: West elevation, Evidence of water intrusion

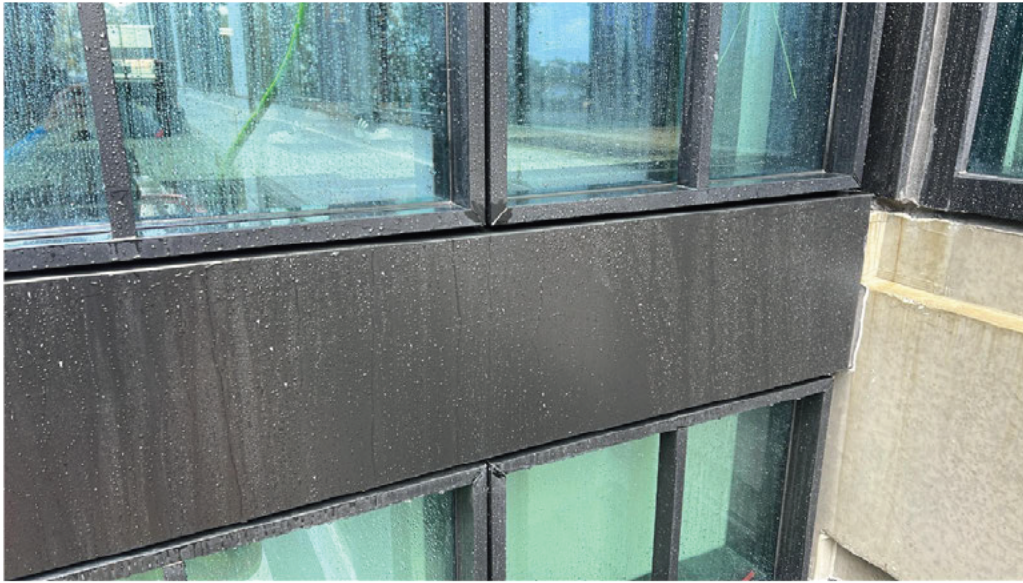
Picture 3: Conclusion of test 1, for 5 minutes. No water intrusion observed

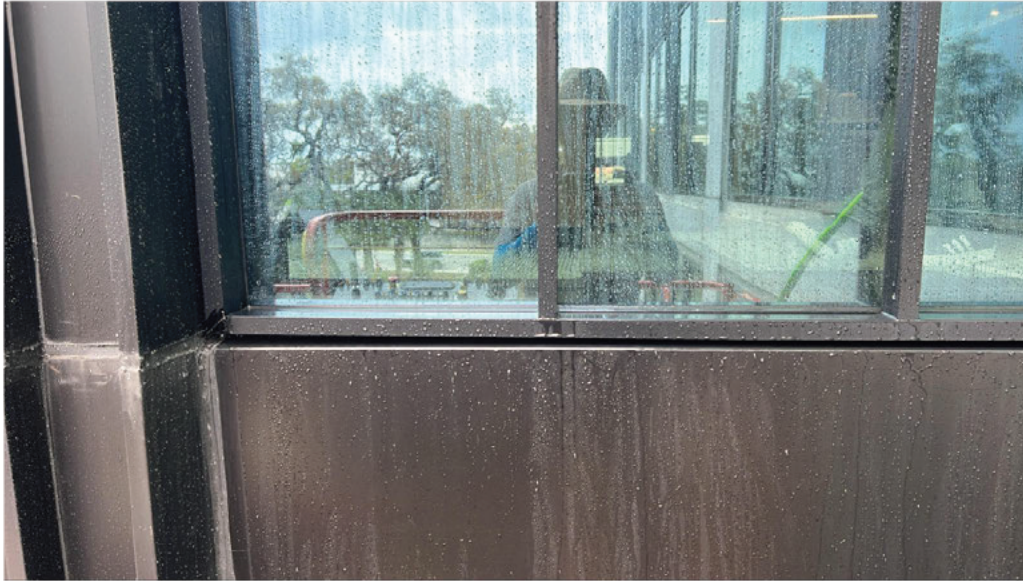
Picture 4: Conclusion of test 2, 2.5 minutes. No water intrusion observed

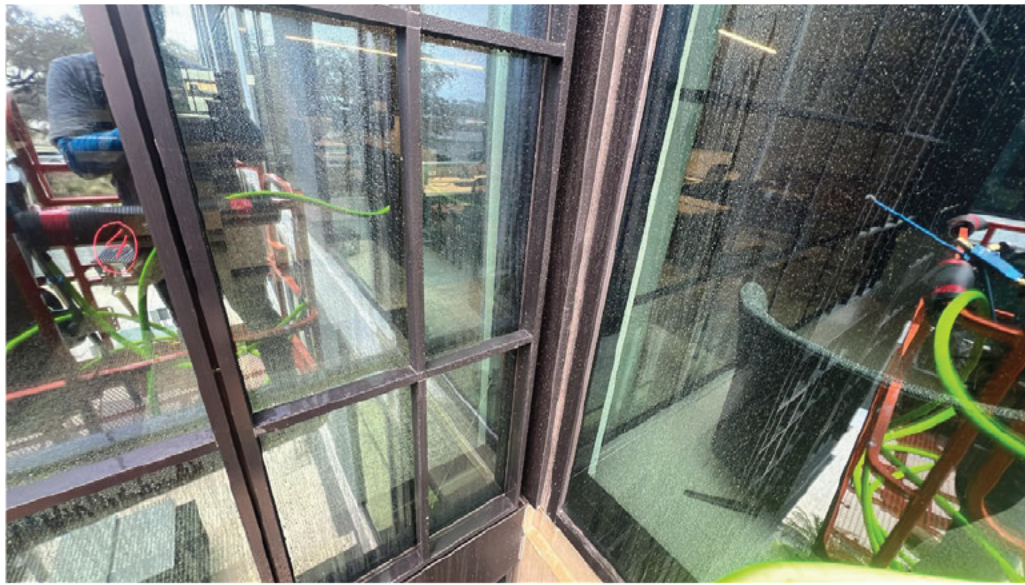
Picture 5: Test 3 at jamb. 5 minutes. No water intrusion observed

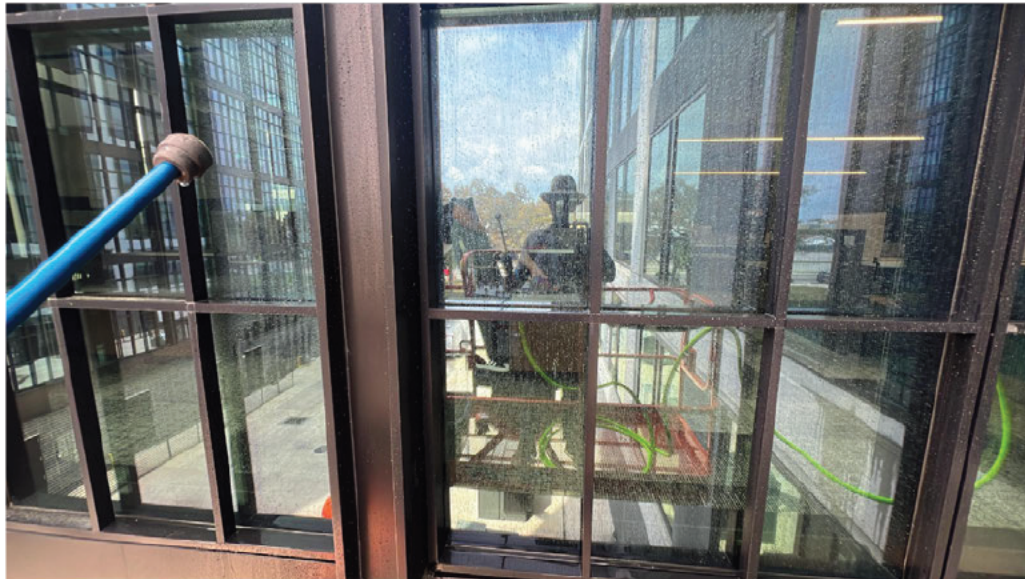
Picture 6: Conclusion of test 5. Left jamb. 5 minutes. No water intrusion observed

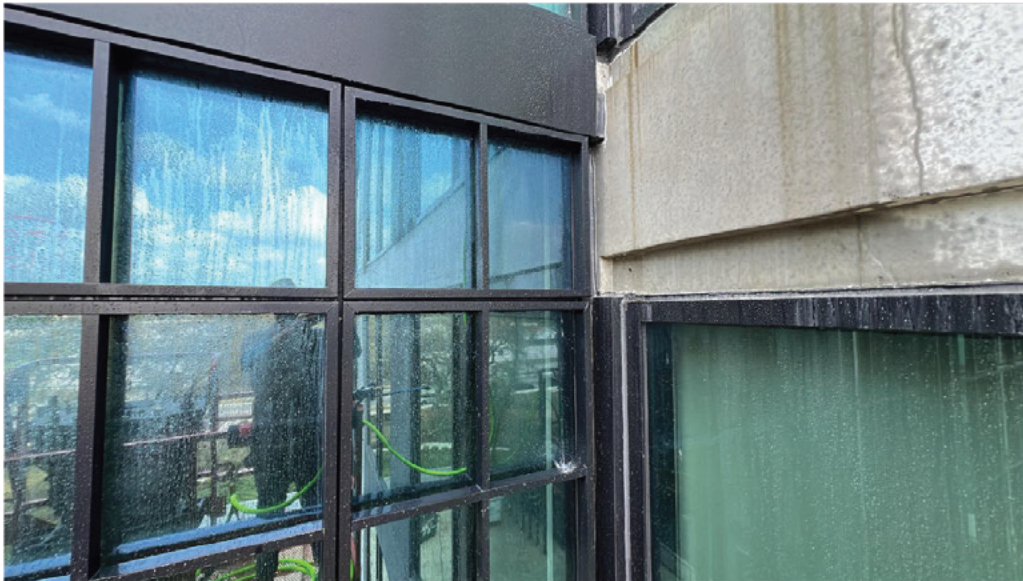
Picture 28: Conclusion of test 26, right transom, two and a half minutes, no signs of water intrusion.

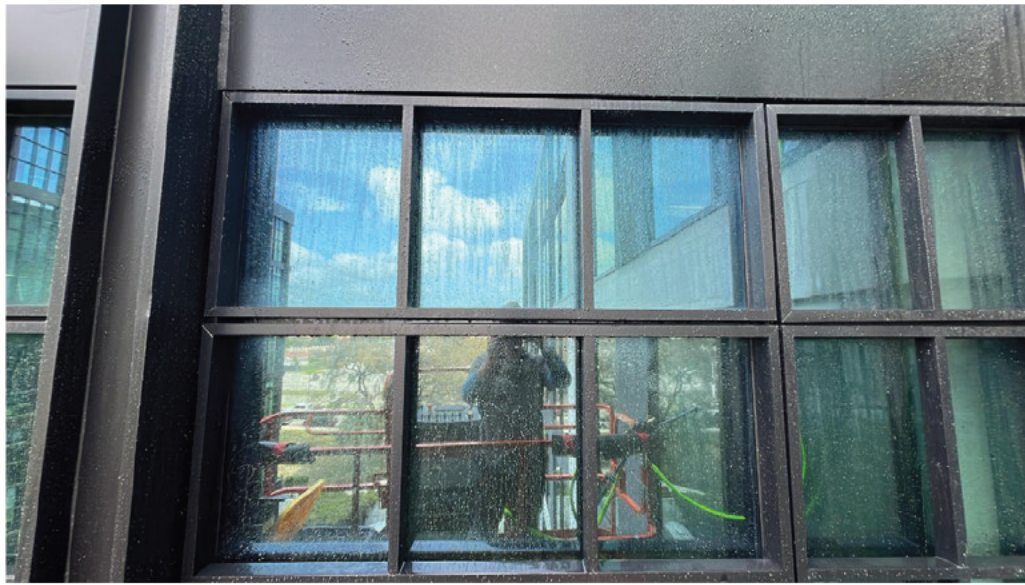
Picture 29: Conclusion of test 27. Left transom. Five minutes. No signs of water intrusion.

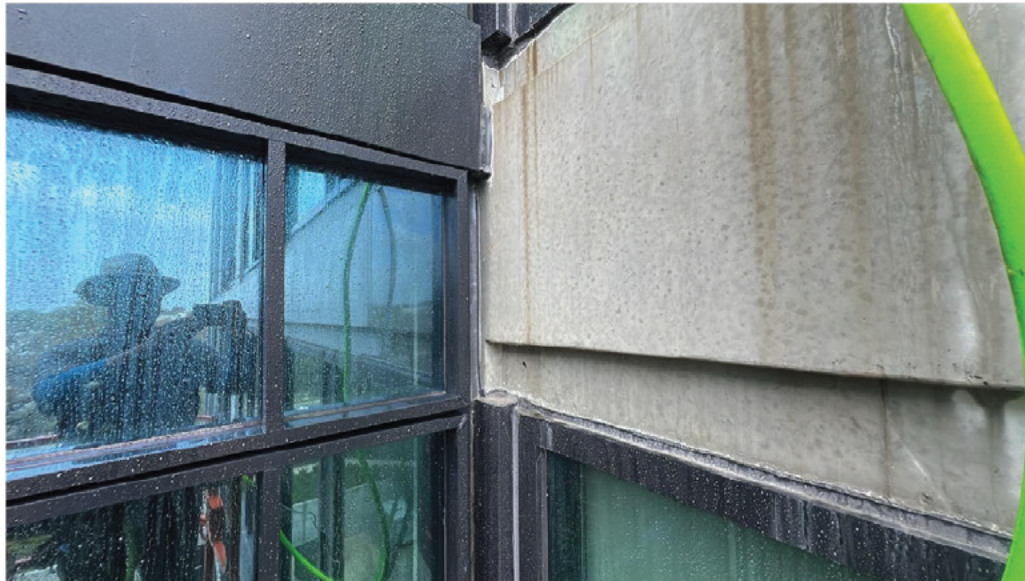
Picture 30: Conclusion of test 28. Right jamb. Two minutes. No signs of water intrusion.

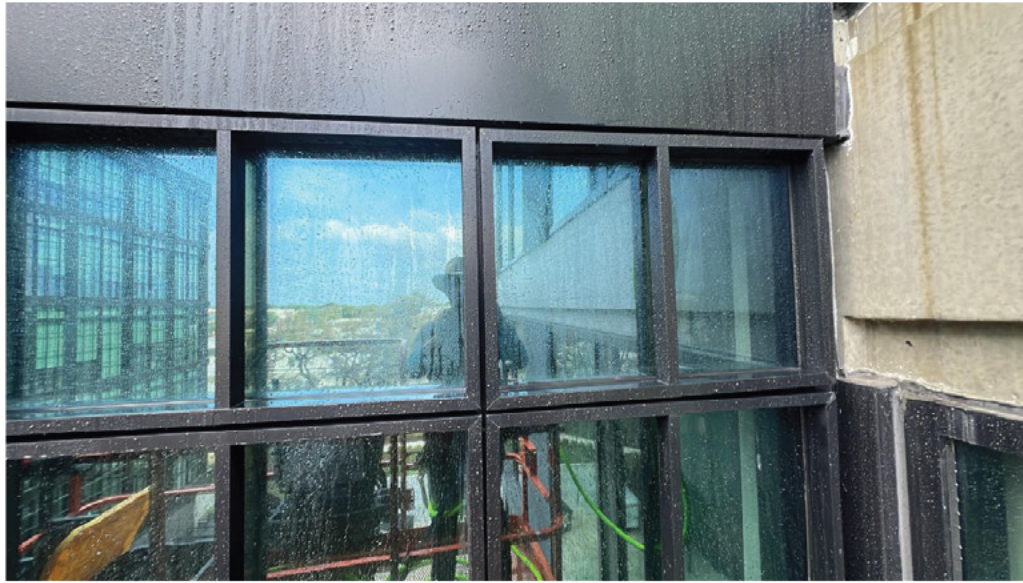
Picture 31: Conclusion of test 29. Two minutes. Mullion. No signs of water intrusion.

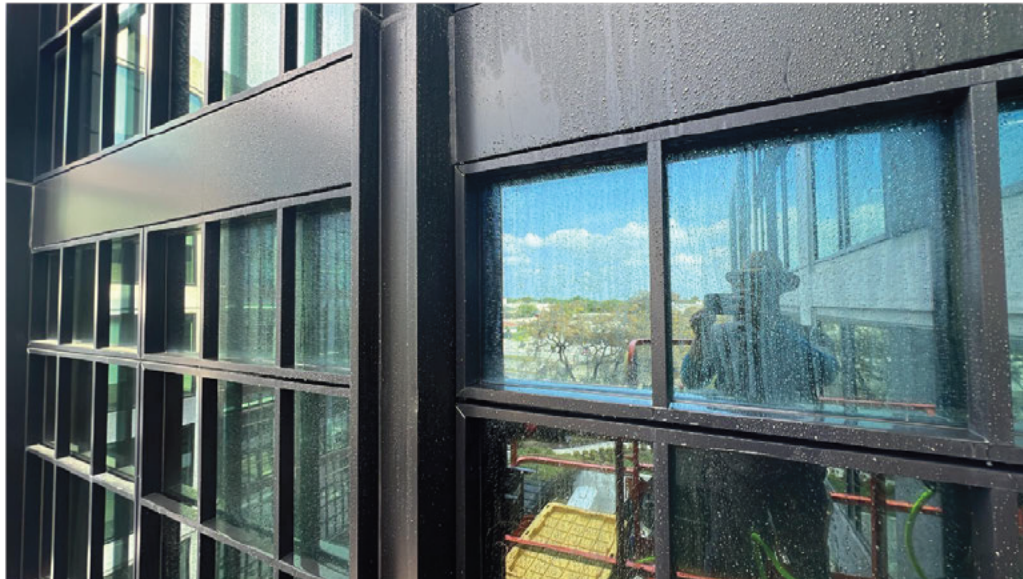
Picture 32: Conclusion of test 30. Two minutes, left jamb, no signs of water intrusion.

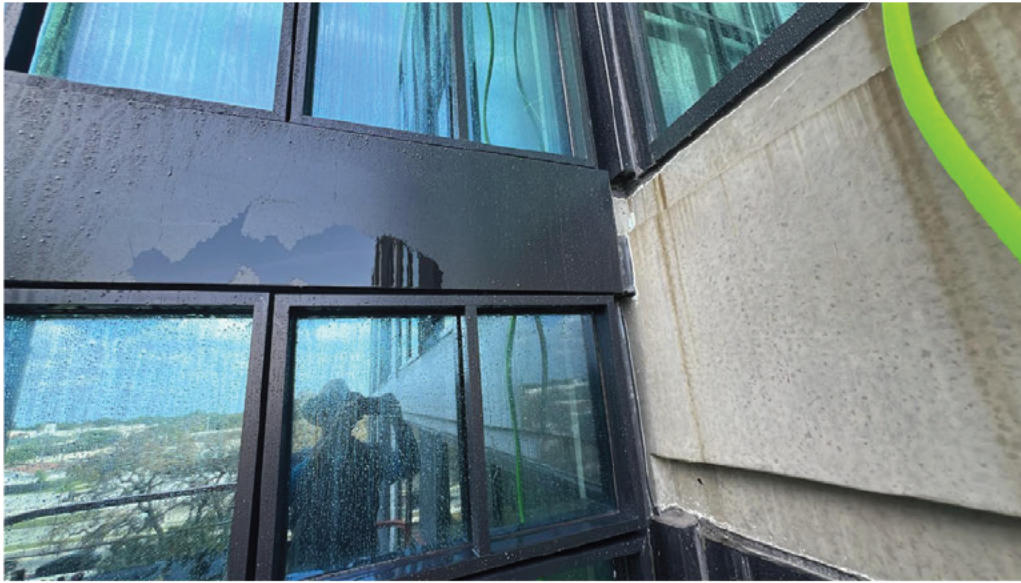
Picture 33: Conclusion of test 31, two and a half minutes, window head, no signs of water intrusion.

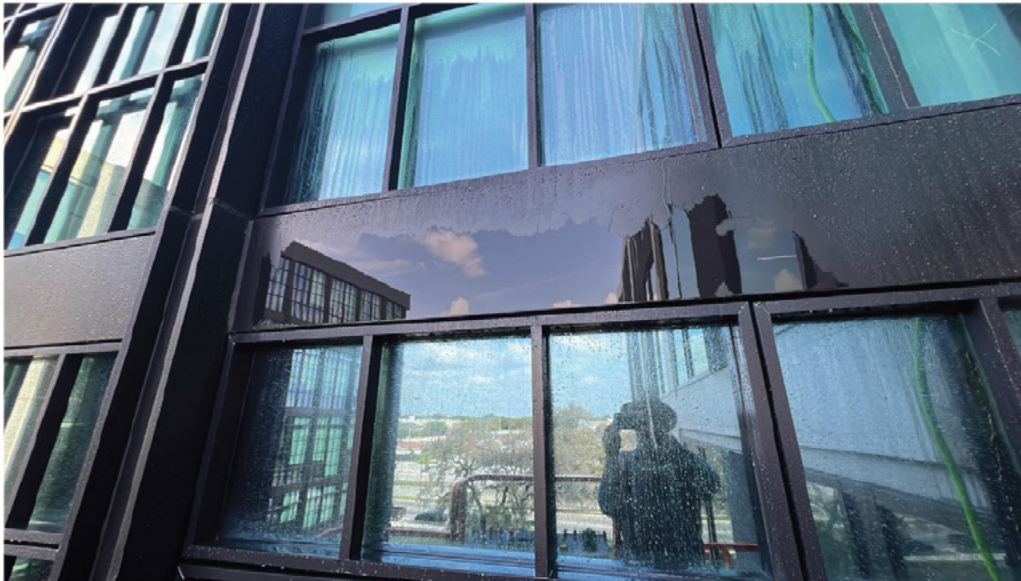
Picture 34: Conclusion of test 32, window head, 5 minutes, no signs of water intrusion.

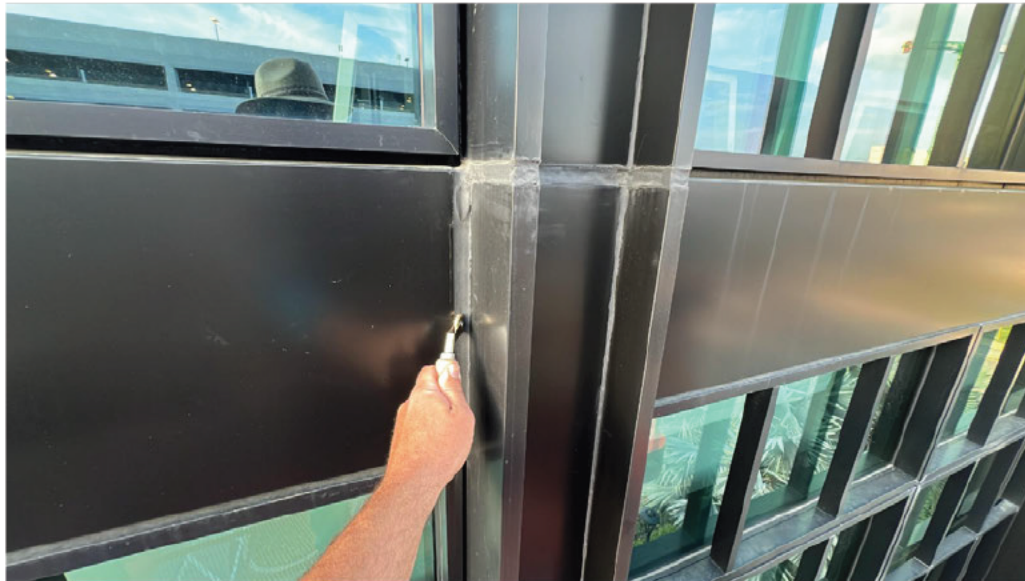
Picture 14: Sealants checked at isolated locations.

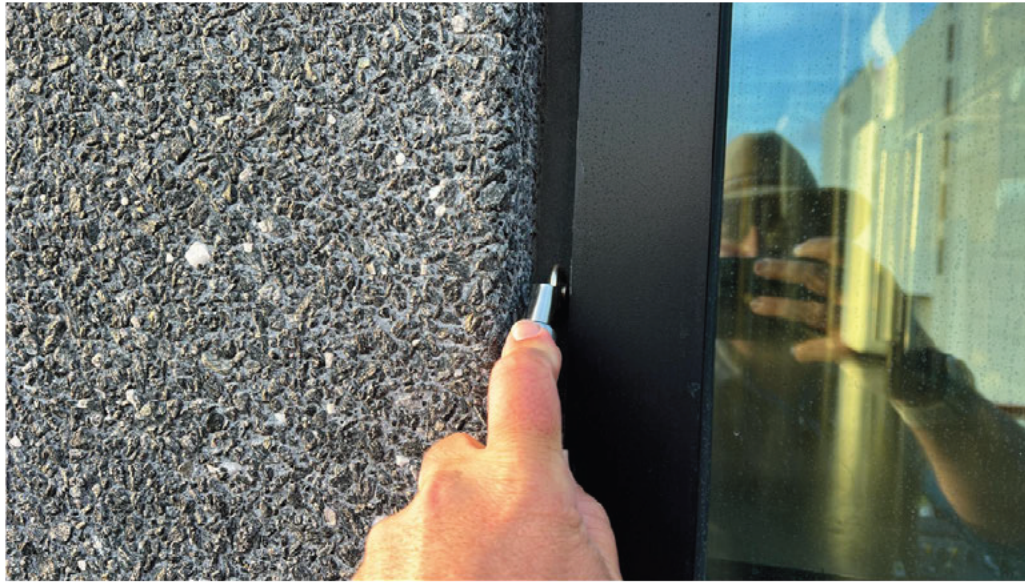
Picture 15: Sealants checked at isolated locations

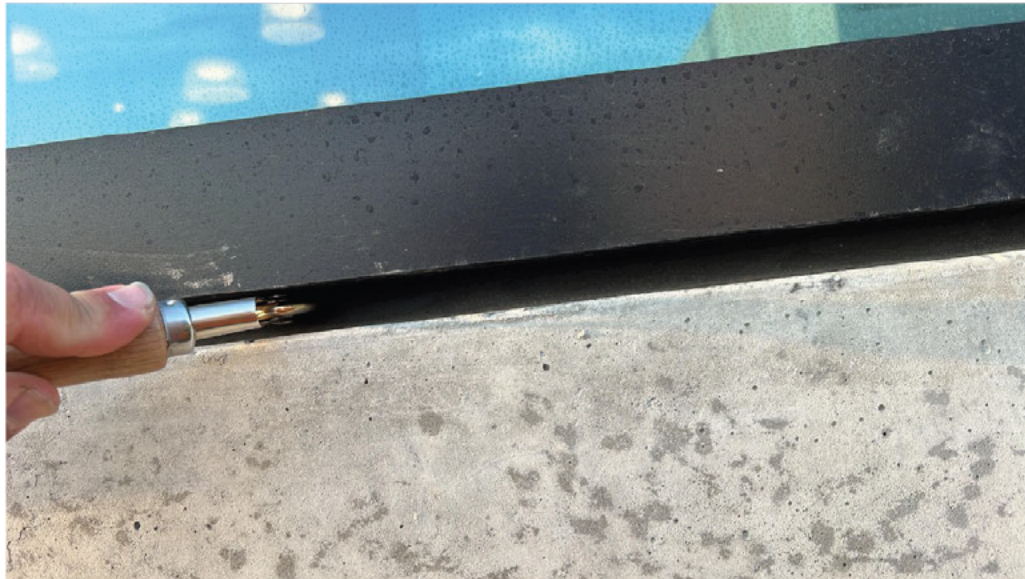
Picture 16: Sealants checked at isolated locations
